# WA Coastal Erosion Hotspots

## Review of Coastal Management History - 12 Sites

Document no. Rev 1: 311012-02081-CS-REP-001

12 June 2025

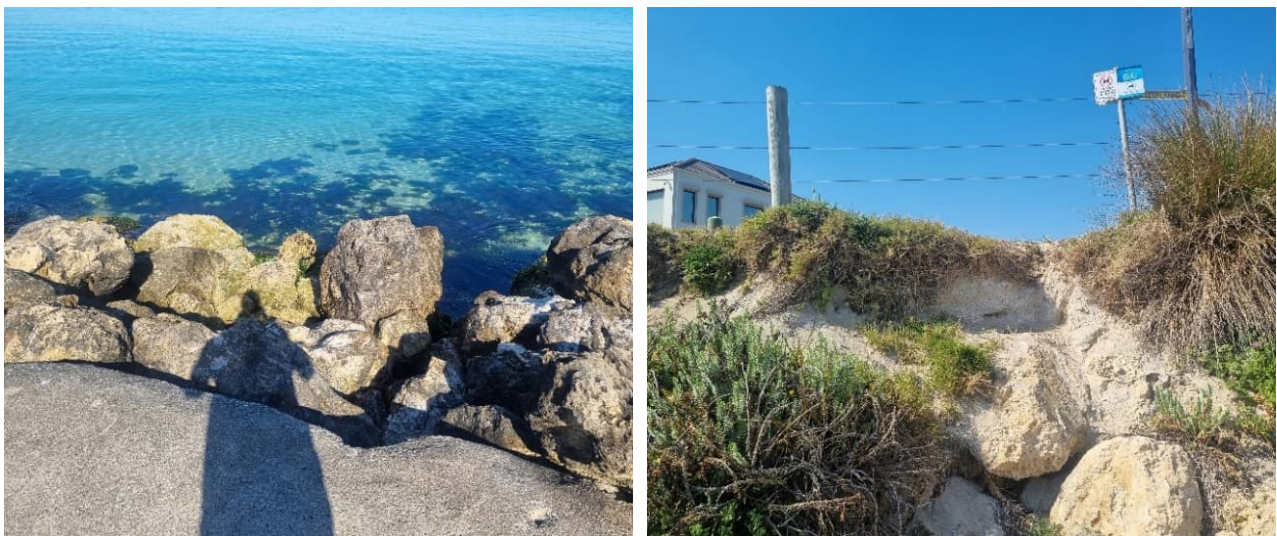
*Figure 2-3: (left) Wells Park headland/revetment (Kwinana Beach) with poor interlocking of armour material (right) Informal seawall at Hymus St. (Rockingham Town Beach) with erosion from overtopping and omission of lack of filter layer and geotextile*

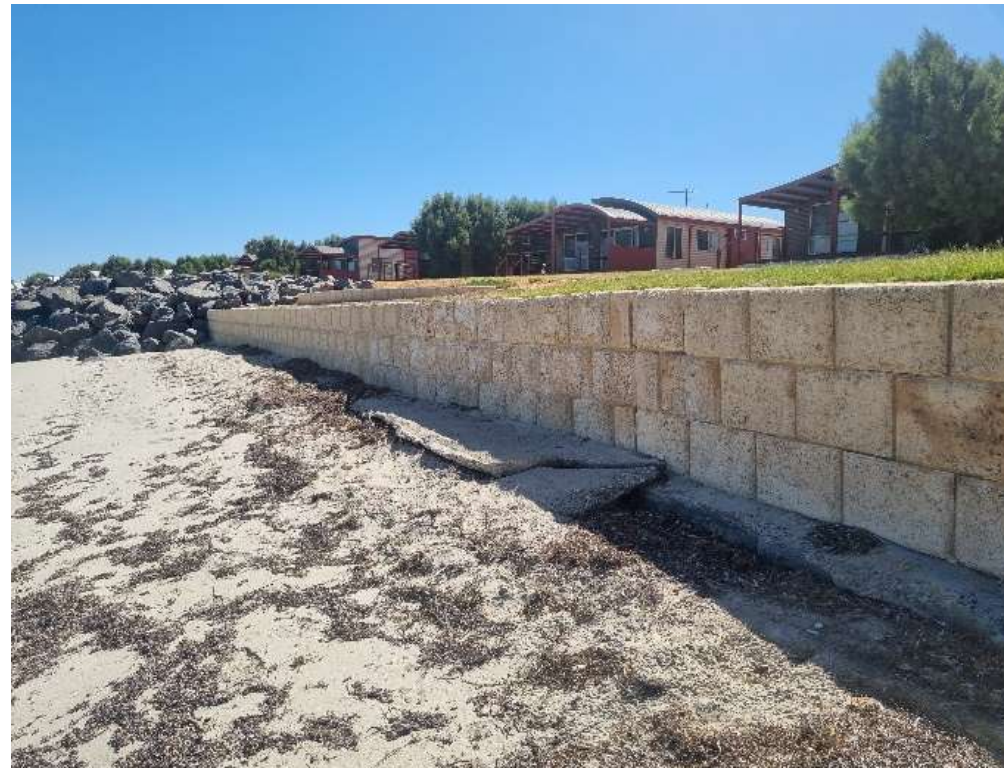
*Figure 1-5: Ad hoc repairs/cracking of poured concrete supporting retaining wall at Grannies beach (taken during site visit 29 January 2024)*

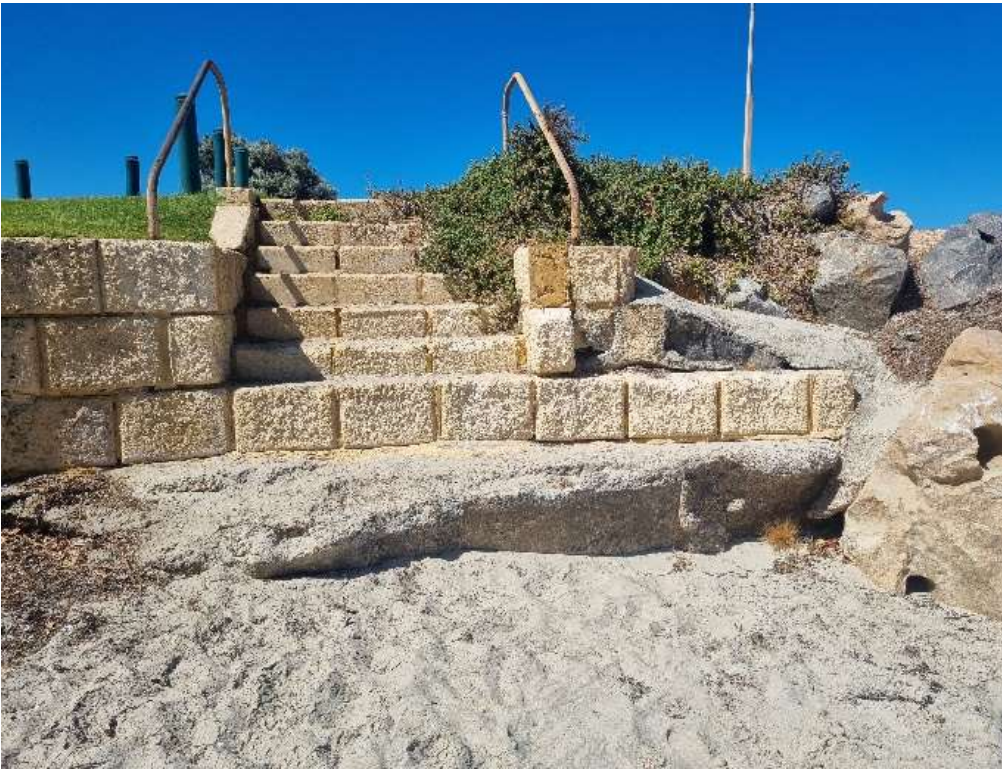
*Figure 1-6: Ad hoc repairs of limestone stair access/retaining wall at Grannies beach (taken during site visit 29 January 2024)*

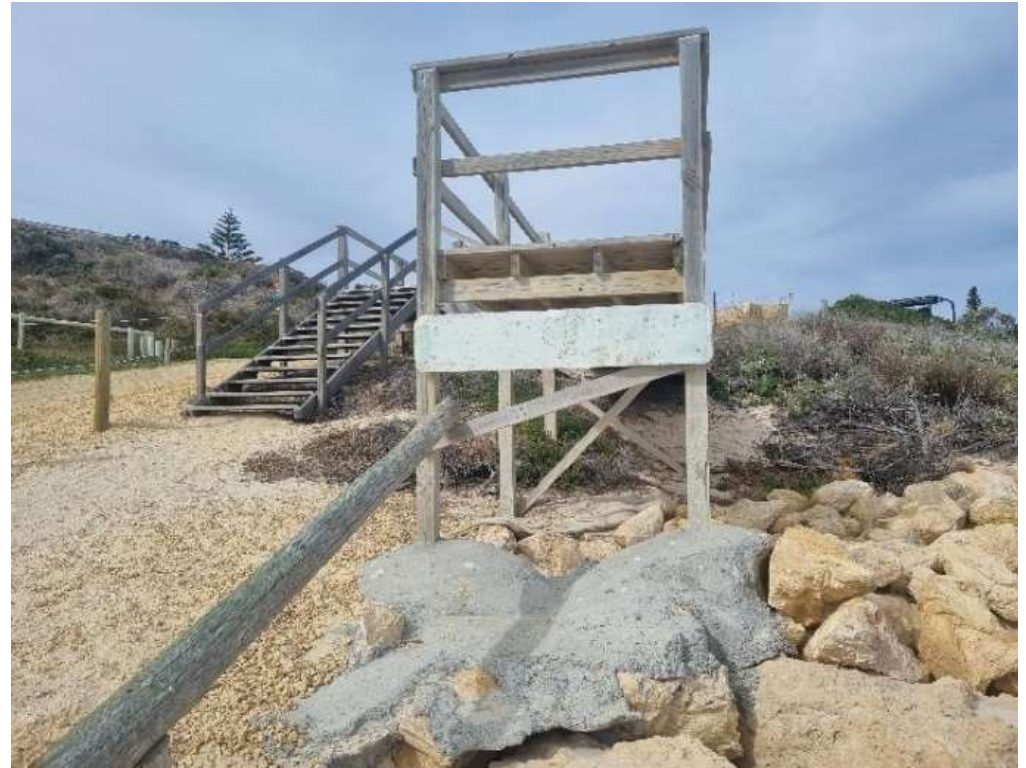
*Figure 3-5: Pedestrian boardwalk/lookout at the Edwards St beach access ramp. northern terminus of the rock revetment. Concrete foundations exposed indicating likely erosion since initial construction. Photo taken facing south-east during site visit 20 May 2024.*

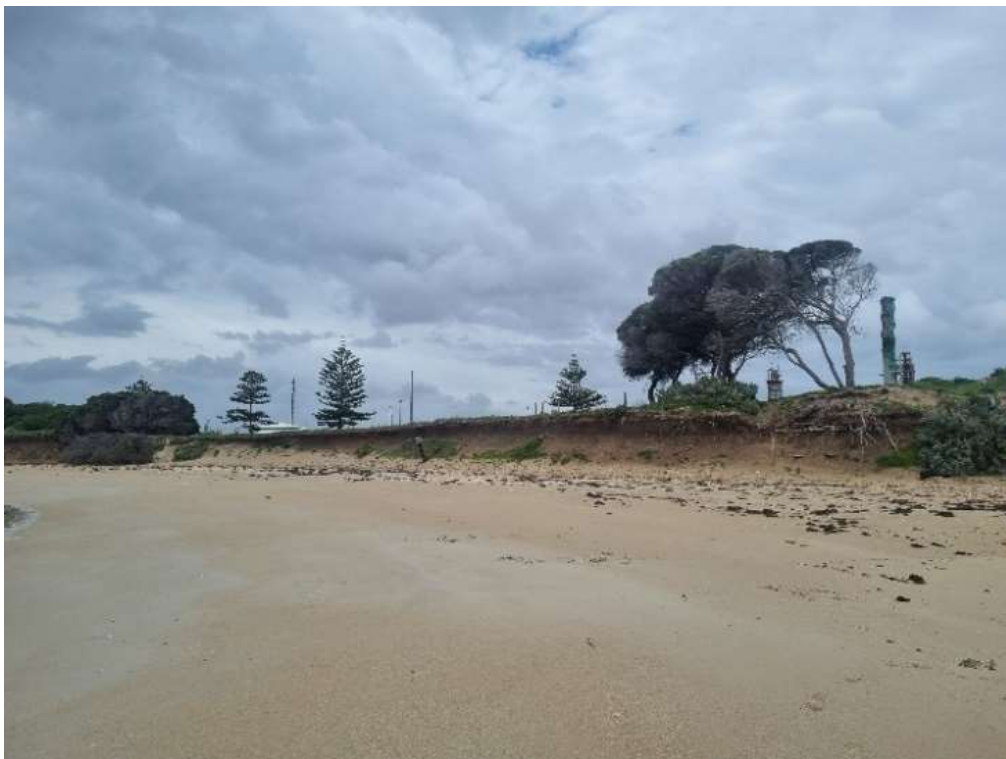
*Figure 6-3: Coastal scarping and damaged ground water monitoring wells (chainage +2725m), taken during site visit 14 August 2024*

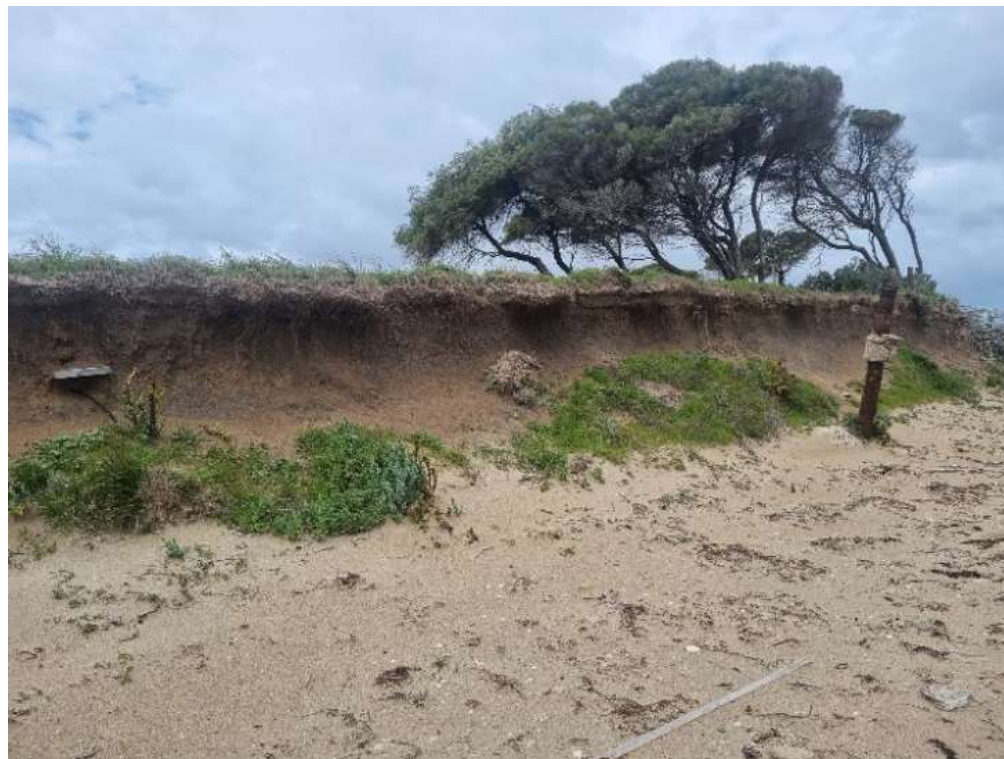
*Figure 6-4: Coastal scarping and damaged ground water monitoring wells (chainage +2750m), taken during site visit 14 August 2024.*

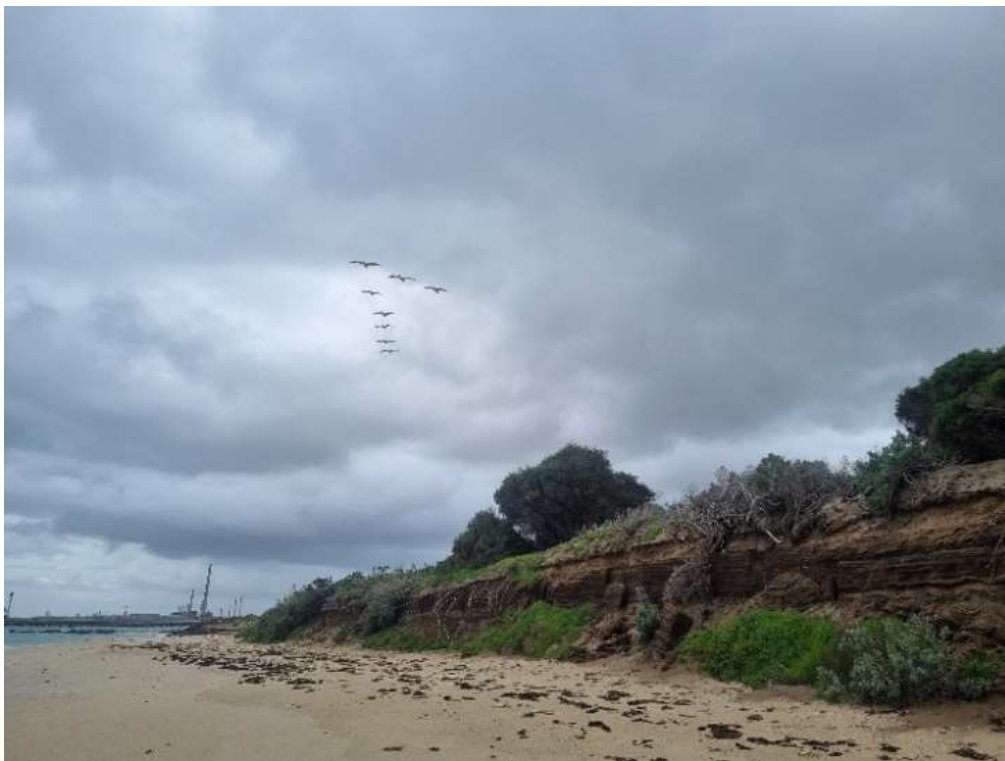
*Figure 6-5: Coastal scarping and vegetation reestablishment along BP refinery foreshore (chainage +3000m), facing north during site visit 14 August 2024.*

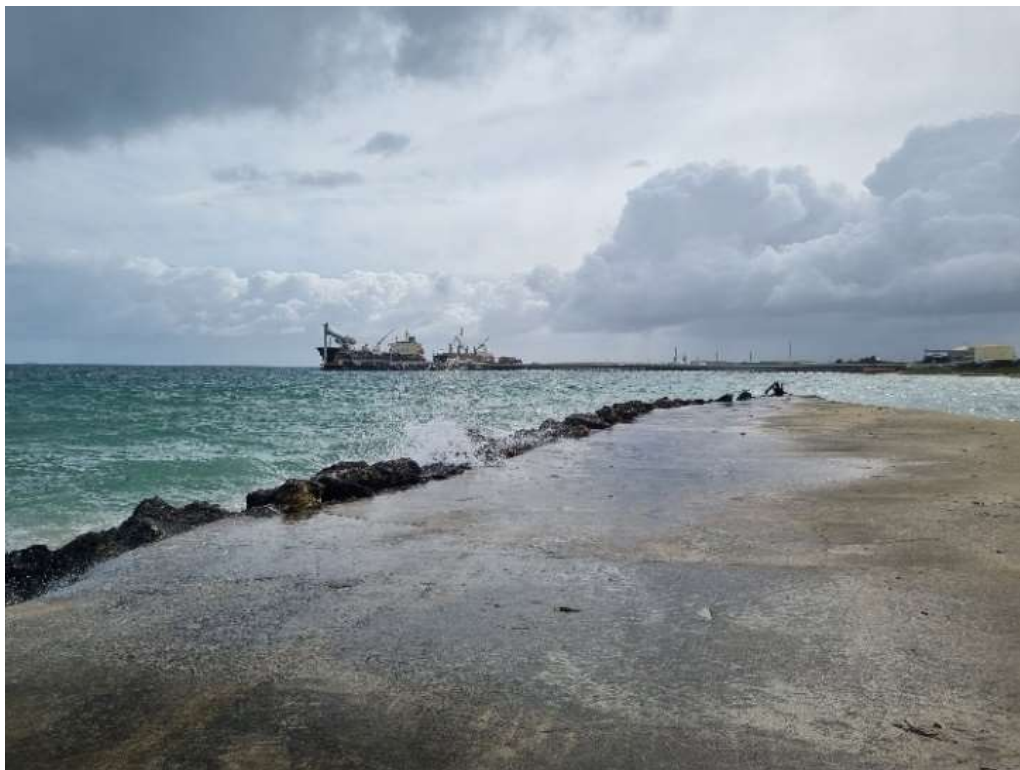
*Figure 7-1: Photo taken of Wells Park headland (+1350m) showing overtopping during site visit 14/08/2024.*

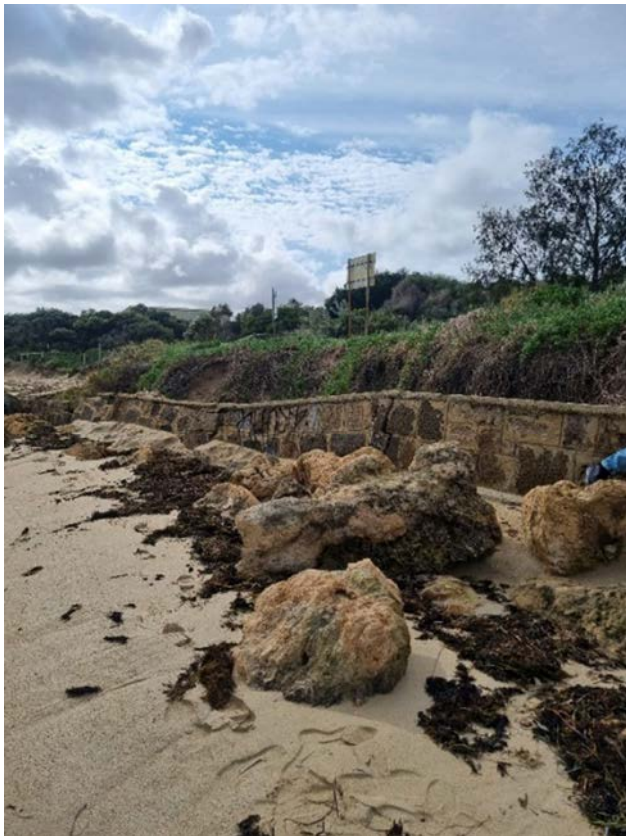
*Figure 7-3: Photo taken of damaged limestone retaining wall (+1500m) with scattered armour loosely placed adjacent, facing east during site visit 14/08/2024.*

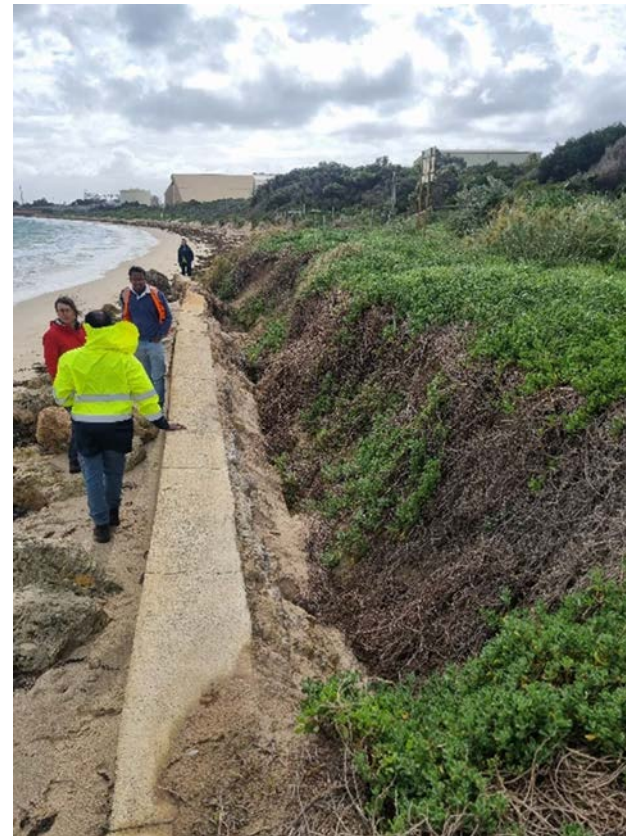
*Figure 7-4: Photo taken of damaged limestone retaining wall (+1500m) eroded slope behind, facing northeast during site visit 14/08/2024.*

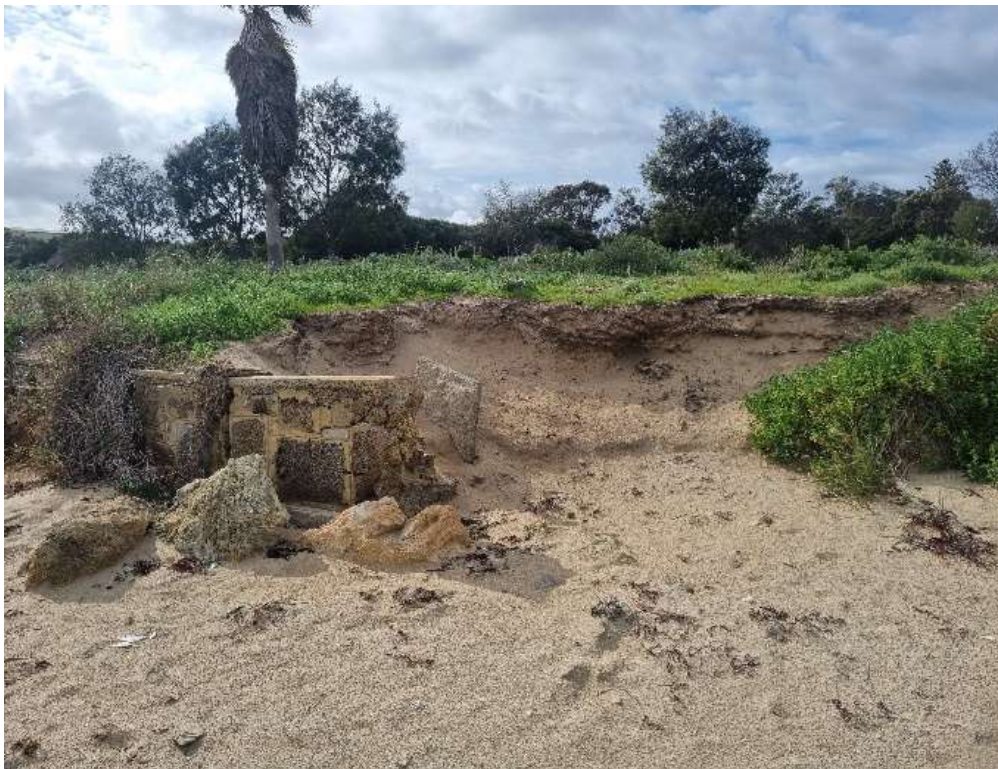
*Figure 7-5: Photo taken of damaged limestone retaining wall (+1500m) with scattered armour loosely placed adjacent, facing east during site visit 14/08/2024.*

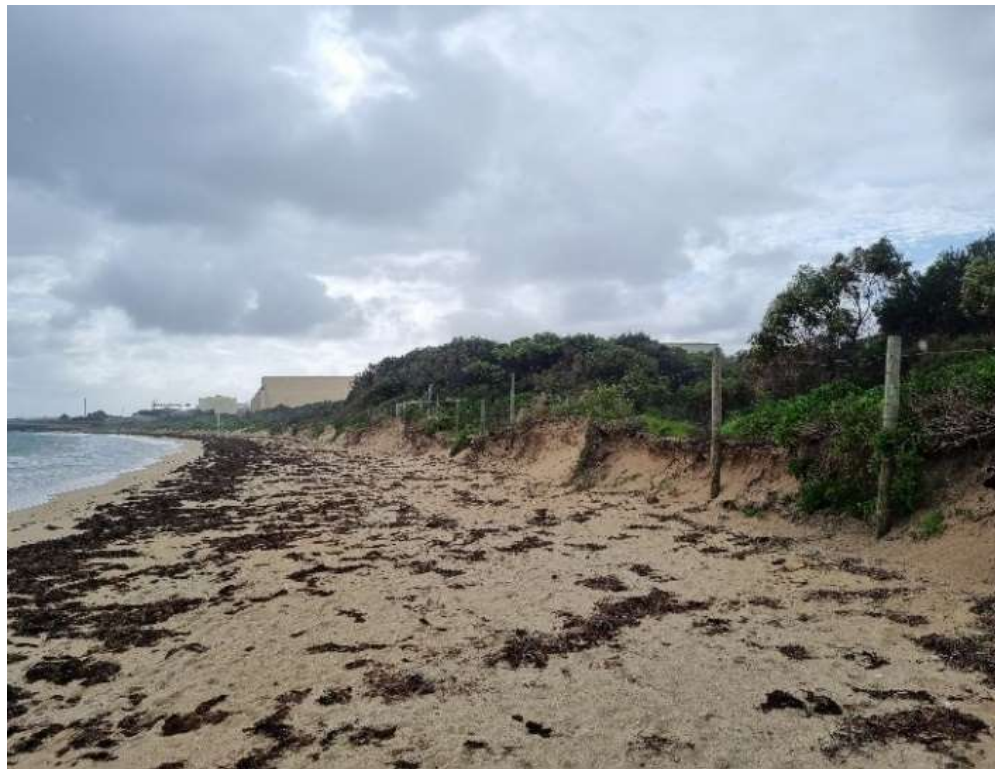
*Figure 7-6: Scarping along dune toe (+1550m), north of Wells Park, during site visit 14/08/2024.*

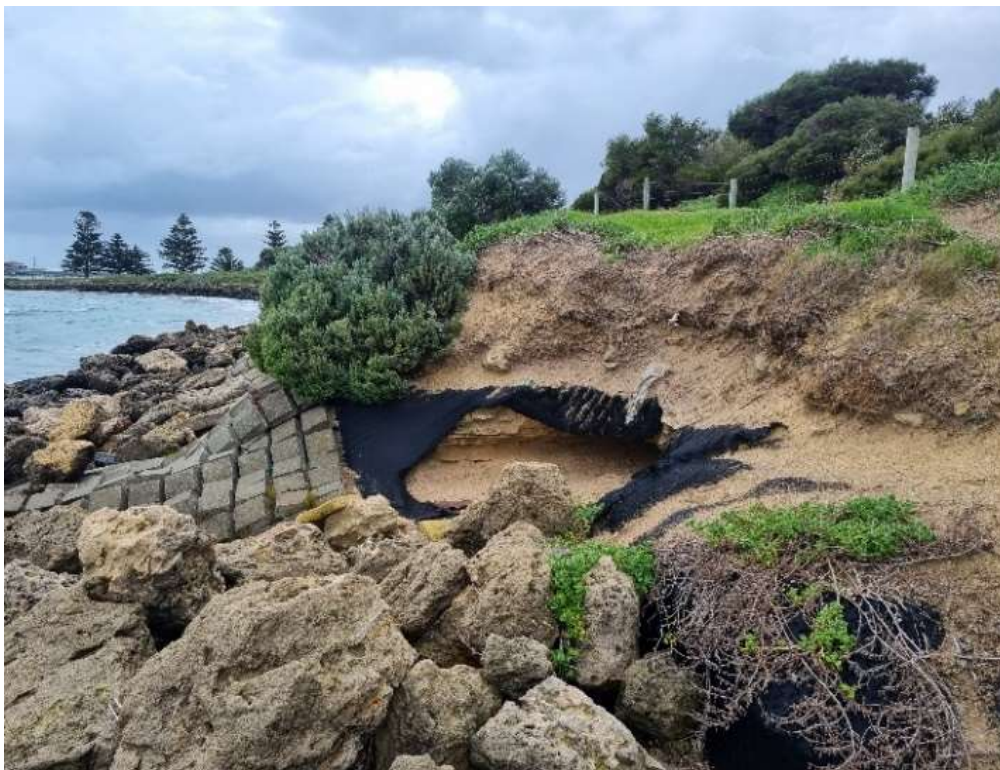
*Figure 7-9: Damaged geotextile along seawall crest (+1100m), adjacent to old boat ramp, taken during site visit 14/08/2024.*

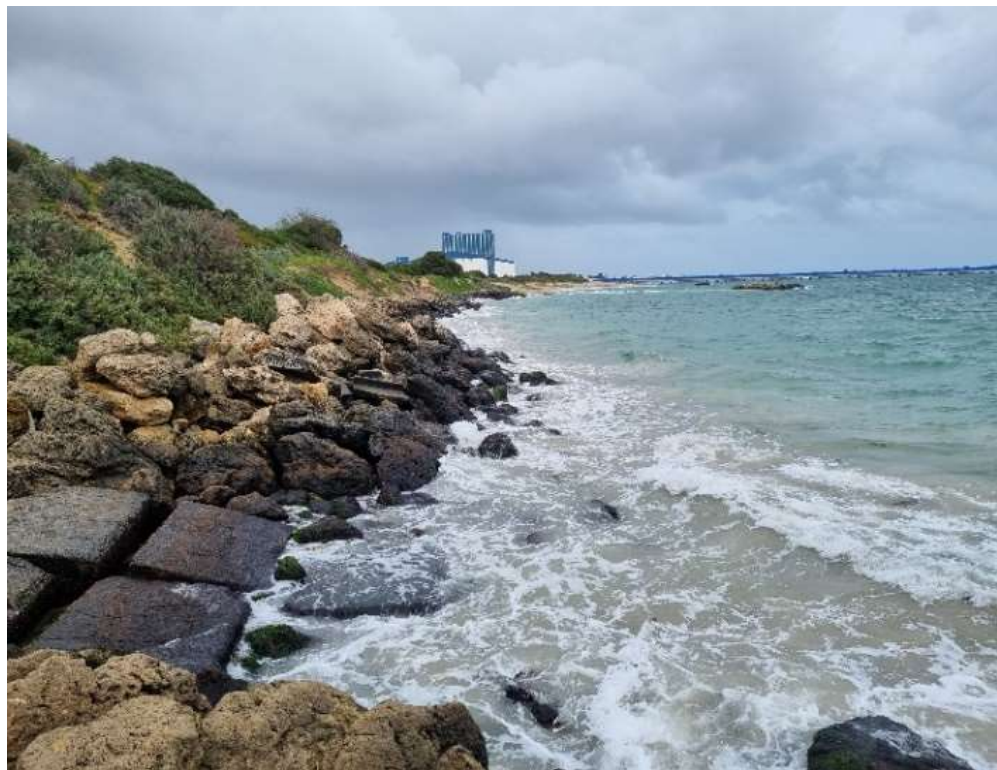
*Figure 7-10: Limestone seawall south of Wells Park (+1100m), showing eroded dune face above, facing south during site visit 14/08/2024.*

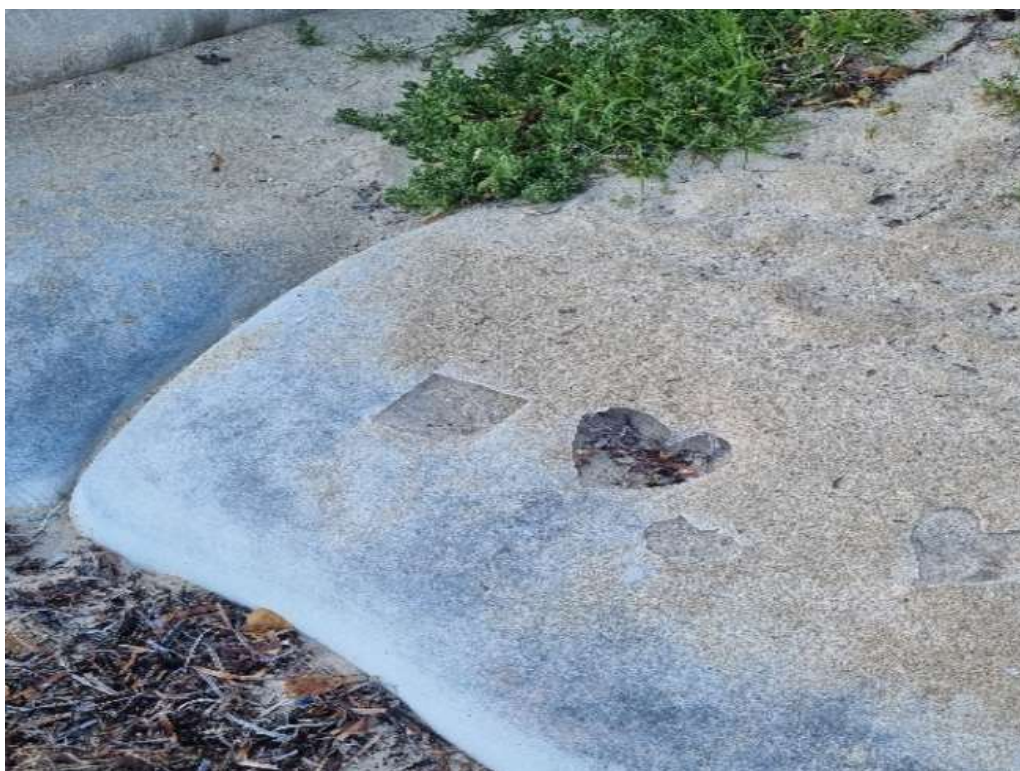
*Figure 8-1: Photo taken of vandalised GSC located within the Flinders Ln seawall, approximate chainage +3300 m. Taken during site visit 18 September 2024.*

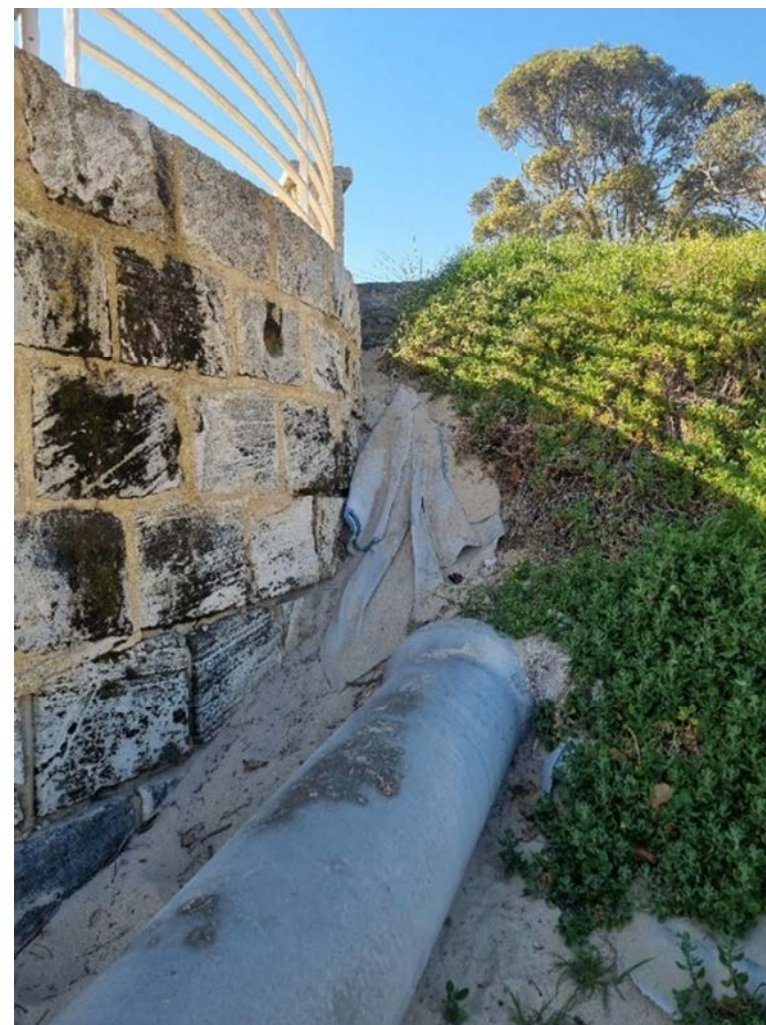
*Figure 8-2: Photo taken of empty/damaged GSC within the Flinders Ln seawall, approximate chainage +3300 m. Taken during site visit 18 September 2024.*

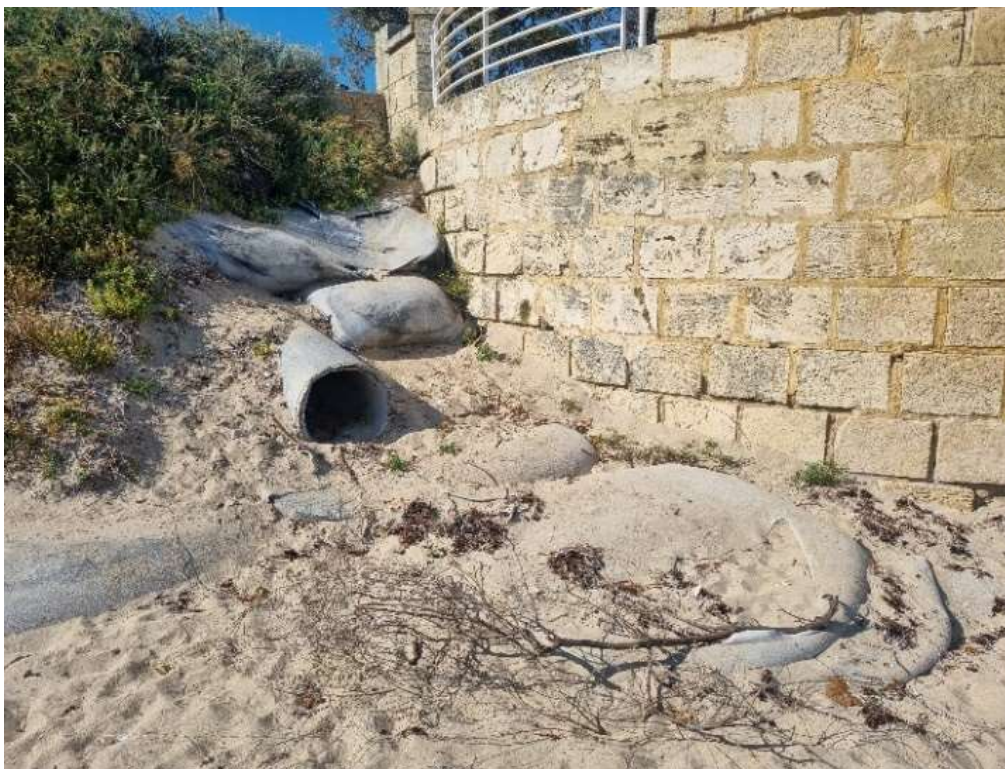
*Figure 8-3: Photo taken of empty/damaged GSC within the Flinders Ln seawall, approximate chainage +3300 m. Taken during site visit 18 September 2024*

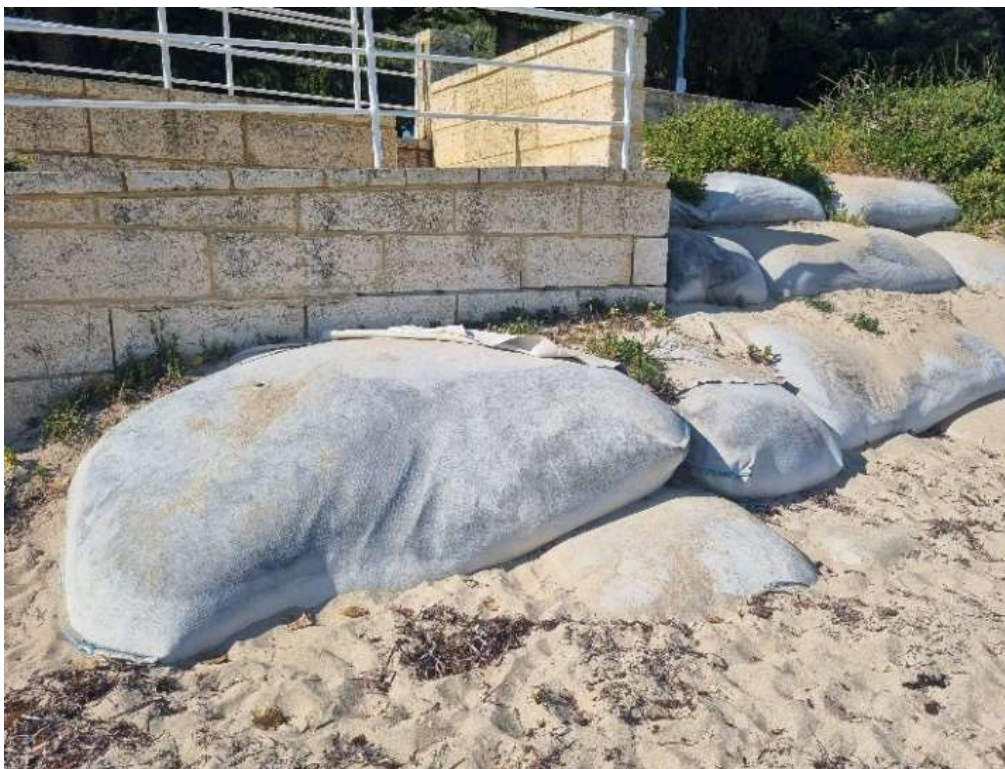
*Figure 8-5: Photo taken of damaged GSC within the Flinders Ln seawall, approximate chainage +3375 m. Taken during site visit 18 September 2024.*

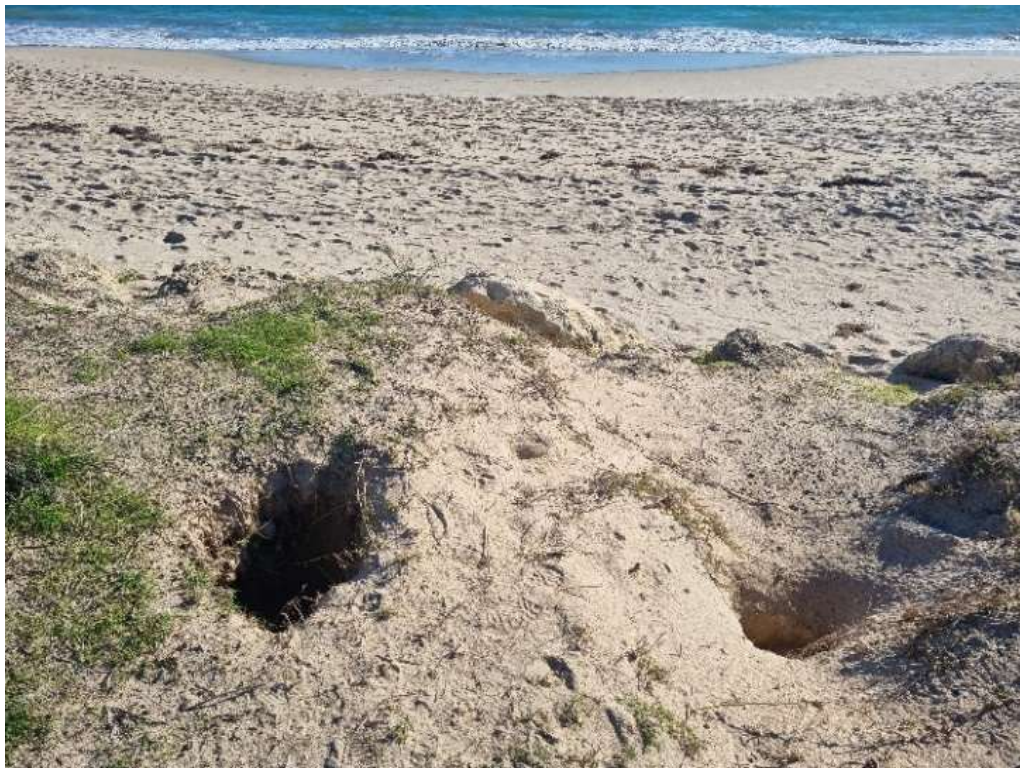
*Figure 10-1: Photo taken of voids at crest of Town Beach seawall, approximate chainage +325 m. Taken during site visit 1 July 2024.*

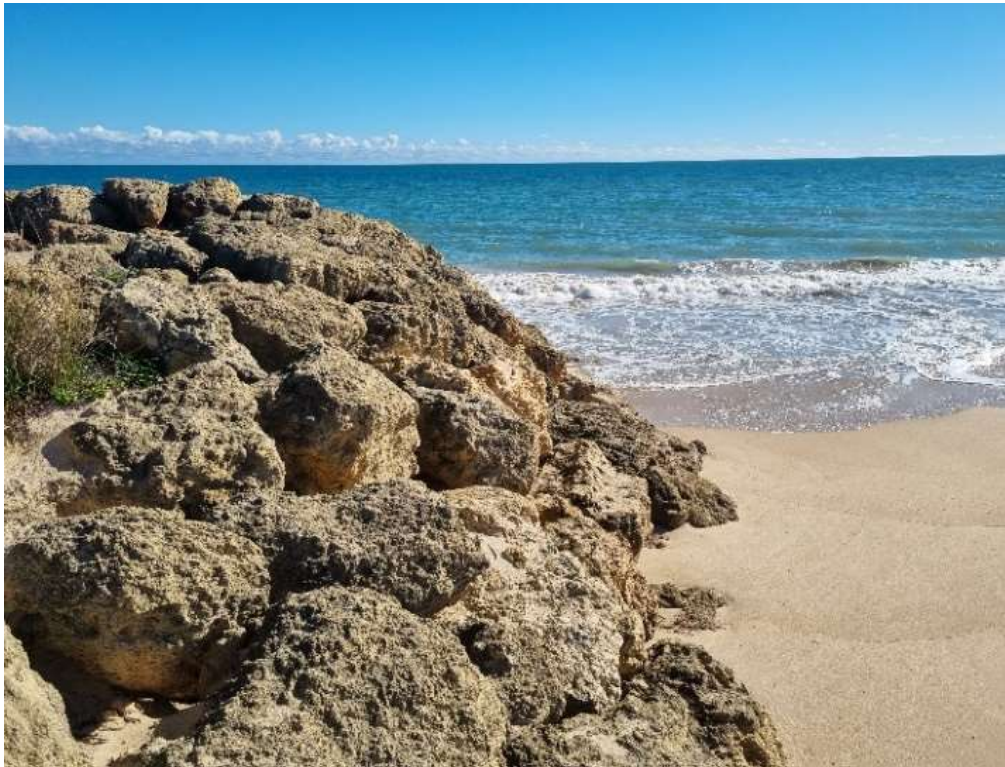
*Figure 10-9: Groyne 5 (San Remo) in good condition. Taken during site visit 1 July 2024.*

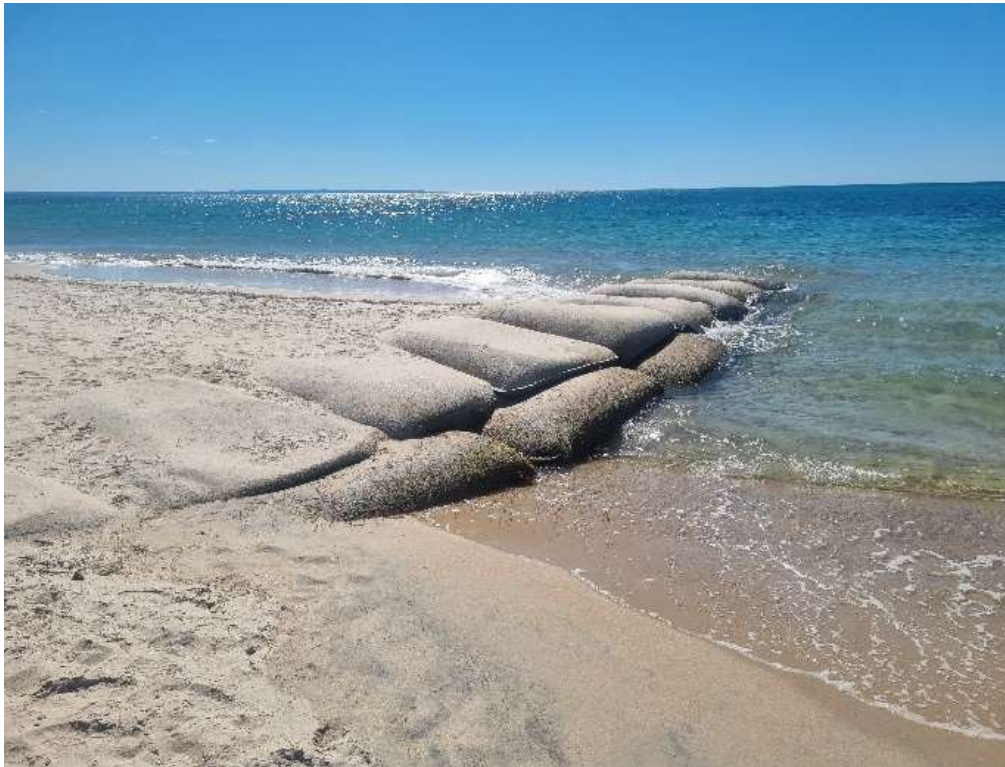
*Figure 11-25: GSC Groyne 9 with damaged bag spilling sand (+1240m) taken during site visit 27 November 2024.*

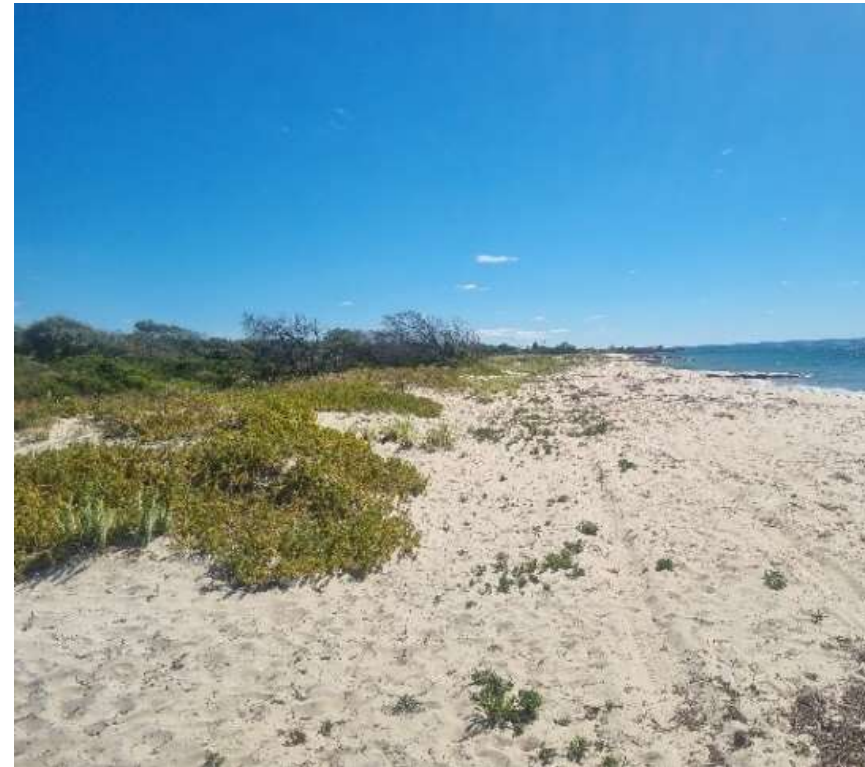
*Figure 11-26: Vehicle tracks into primary dune vegetation (+1040) taken during site visit 27 November 2024.*

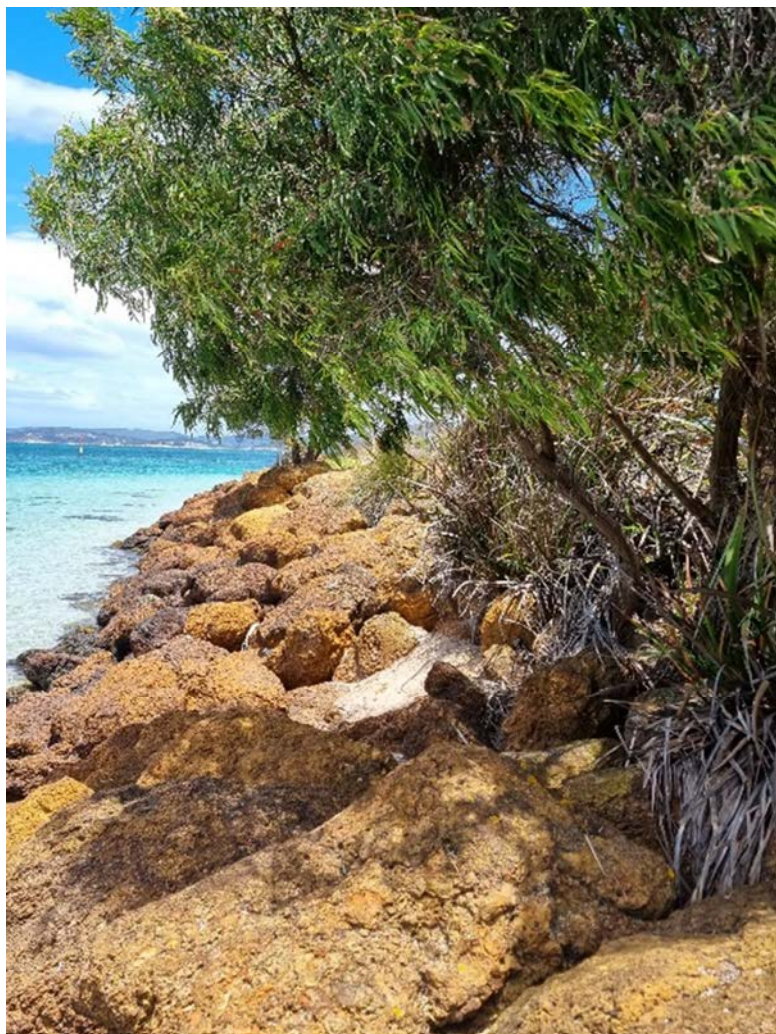
*Figure 12-5: Exposed underlayer/slope failure along training wall (chainage +75m). Taken facing southwest during site visit 5 December 2024.*

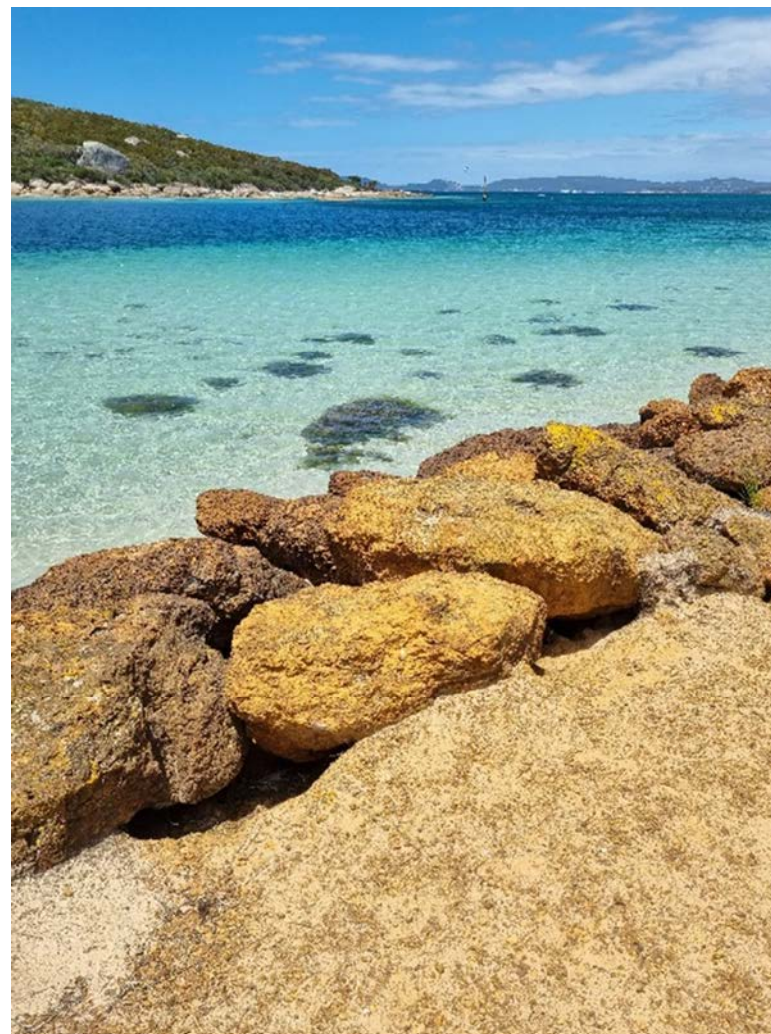
*Figure 12-6: Scattered armour offshore of training wall. Taken facing south during site visit 5 December 2024.*

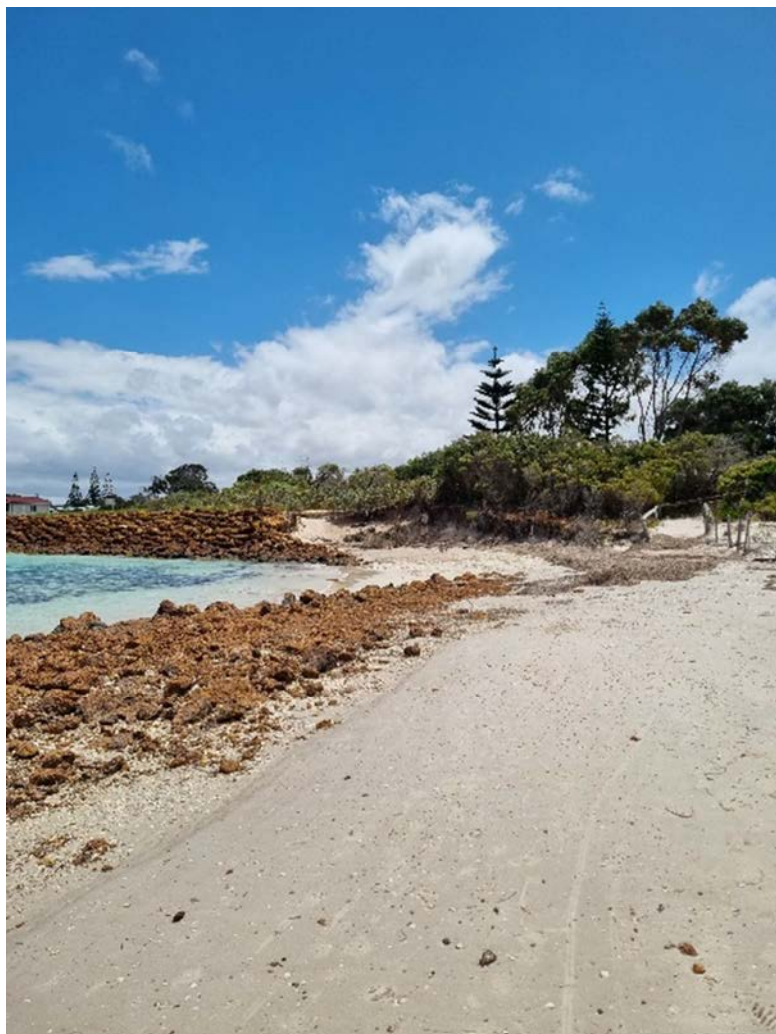
*Figure 12-11: Exposed rock along artificial headland tombolo. Damaged seawall and dune erosion in background. Taken facing northwest during site visit 5 December 2024*

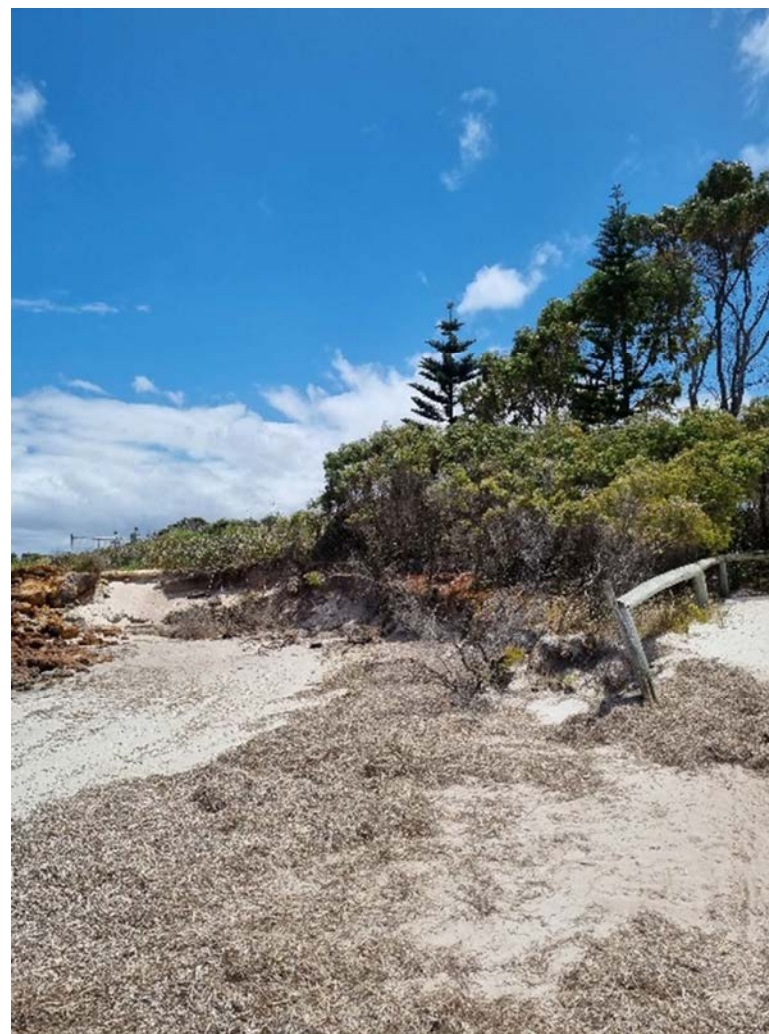
*Figure 12-12: Damaged seawall and dune erosion (~+475m). Taken facing northwest during site visit 5 December 2024.*

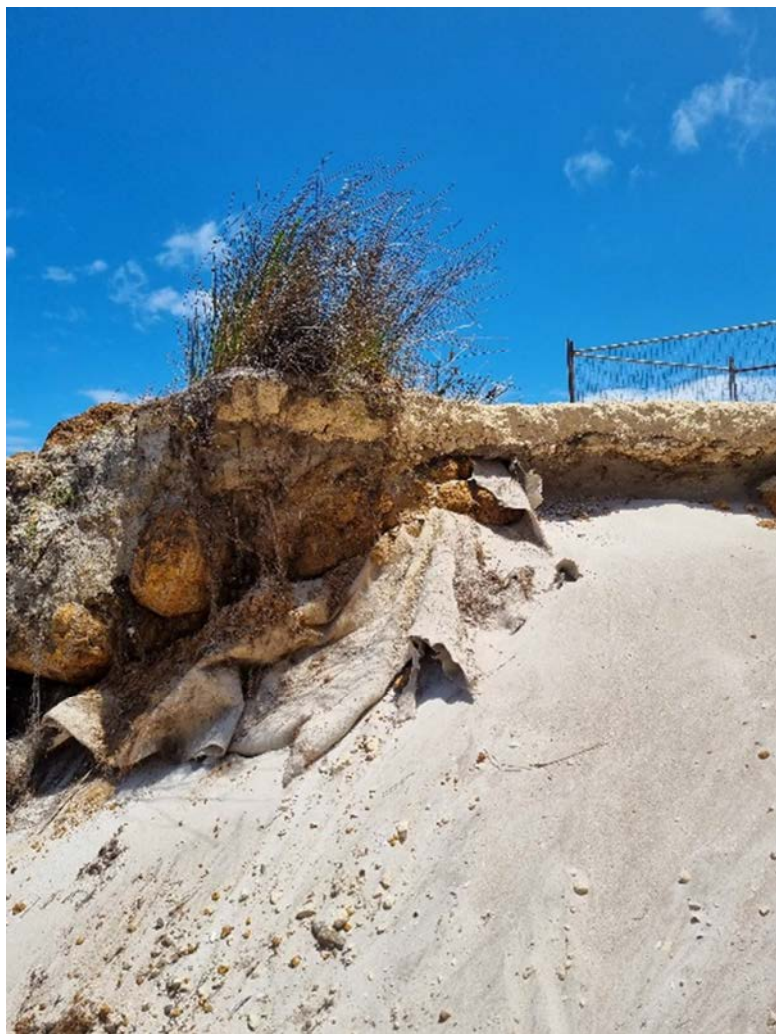
*Figure 12-13: Damaged seawall with slope failure and geotextile exposed (~+475m), taken during site visit 5 December 2024.*

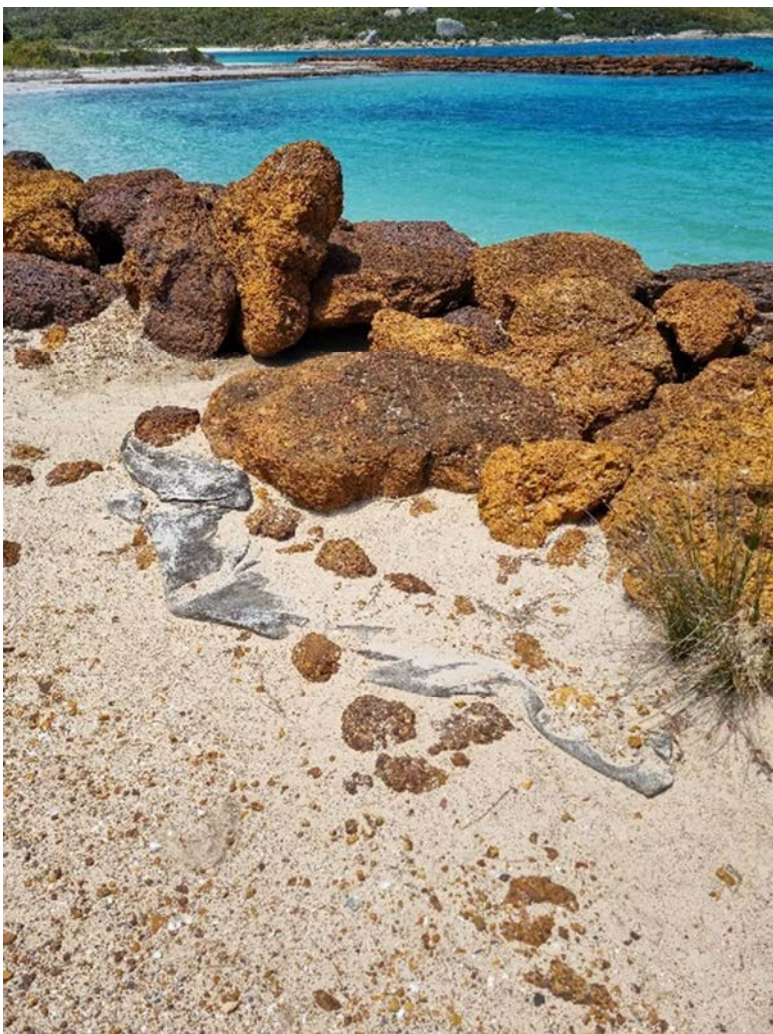
*Figure 12-15: Exposed geotextile along seawall (+600m) taken during site visit 5 December 2024.*
