Trinacria Consulting

**Carnarvon One Mile Jetty
Damage Assessment Post Cyclone Seroja
21st & 22nd April 2021**

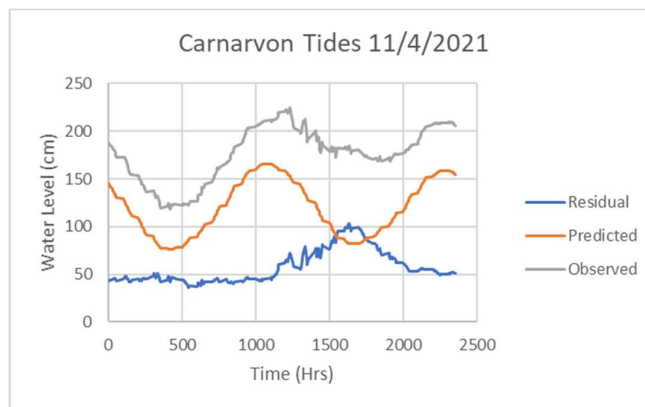
Figure 2: Carnarvon tides on the day of Cyclone Seroja

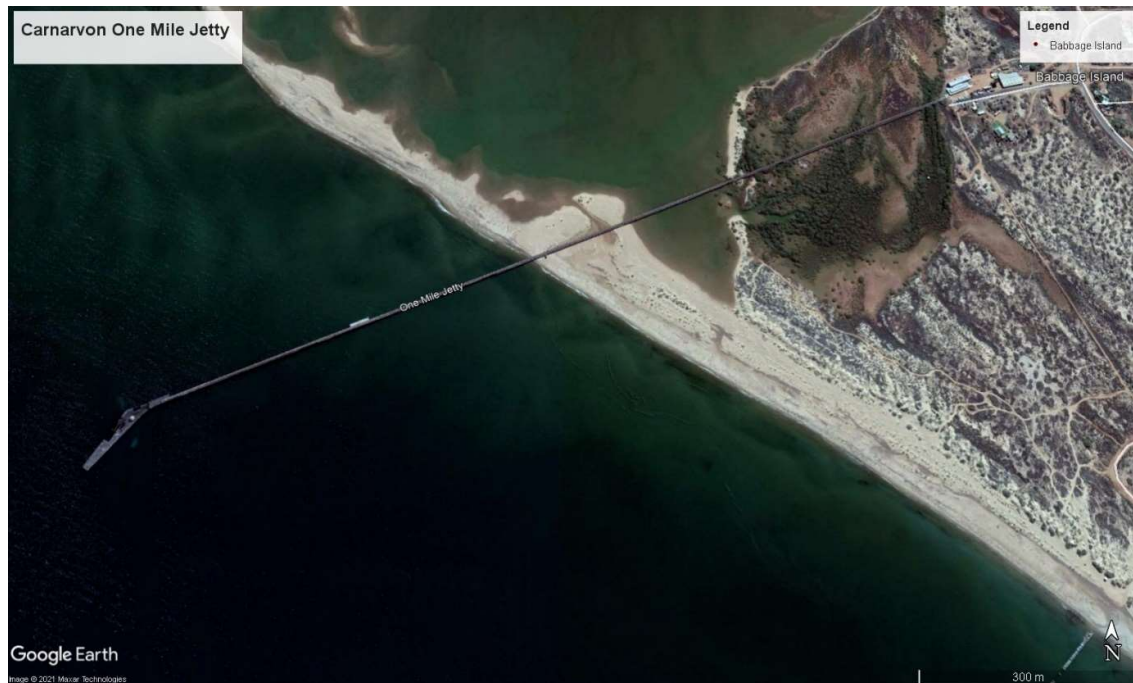
Figure 3: Carnarvon One Mile Jetty. Old Prawning Jetty can be seen on bottom right corner (Google Earth 2017)

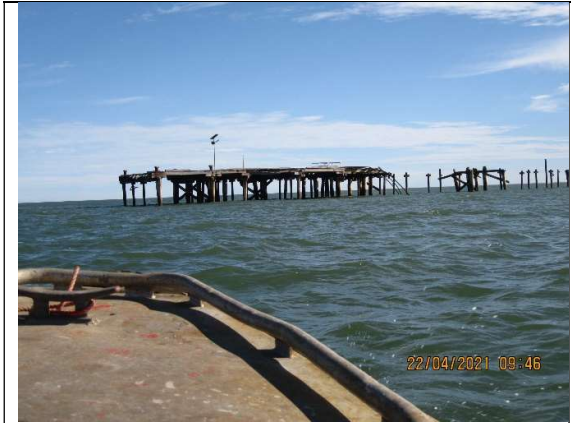
Photo 1 Jetty Head - 5 bays remaining.

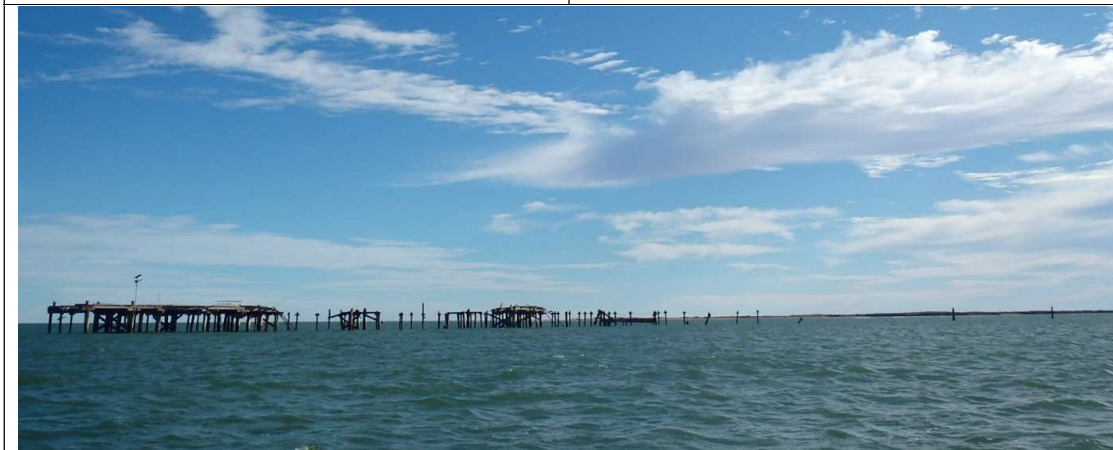
Photo 3: Panoramic view of jetty head and end of approach jetty showing missing sections

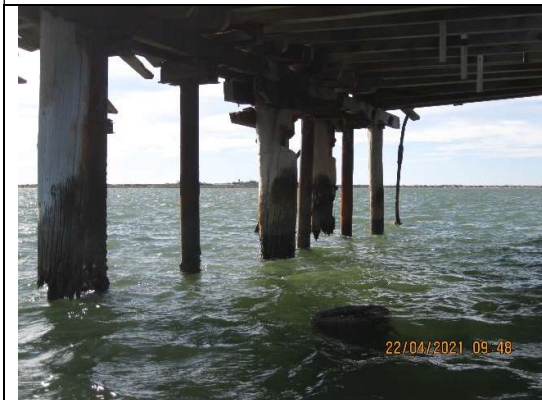
Photo 4: Underside of jetty head showing timber piles completely rotted at water line

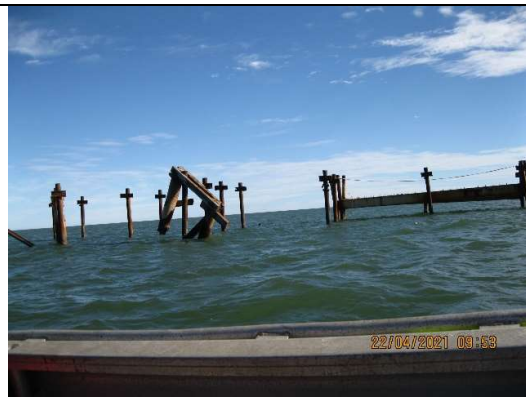
Photo 5: Broken Pier showing broken timber pile with crosshead still attached to steel pile

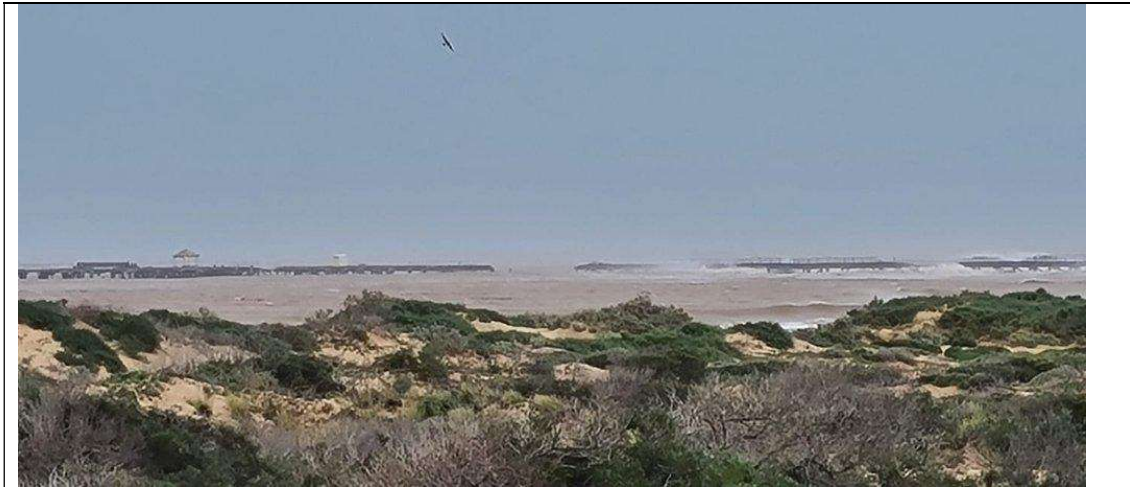
Photo 6: Photo taken during the storm - approx 10 AM - note waves breaking over approach jetty (Courtesy Eddie Smith)

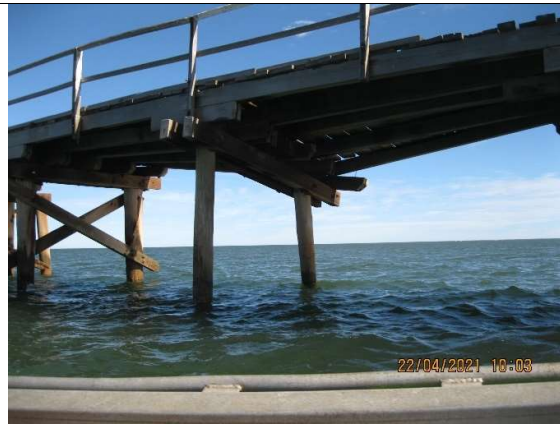
Photo 11: Broken pile causing jetty to collapse

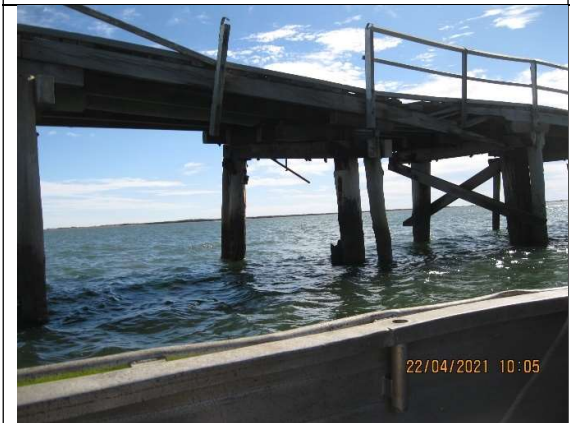
Photo 12: Broken Stringer and missing braces

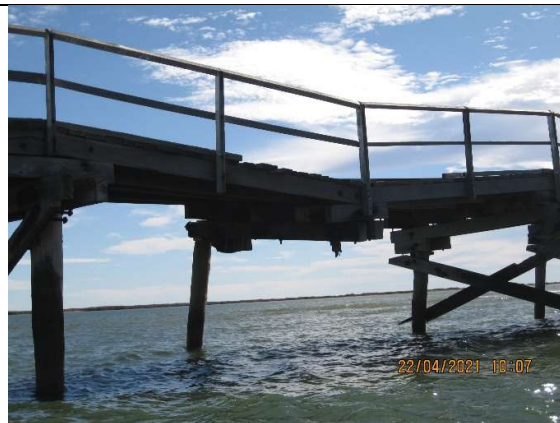
Photo 13: Missing pile and cross braces

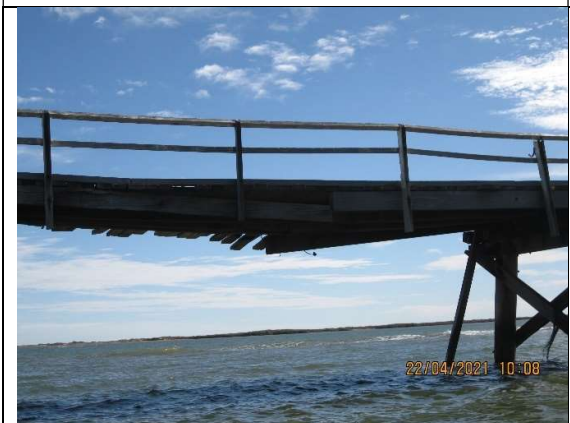
Photo 14: Missing Pier

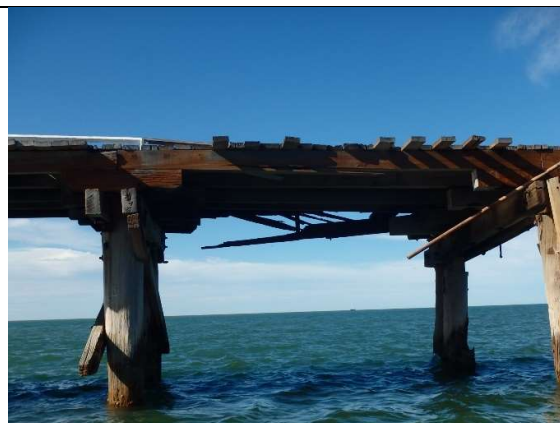
Photo 15: Broken Stringer and missing handrail

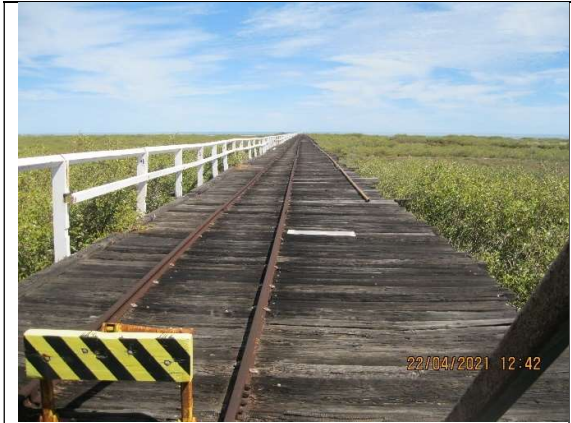
Photo 16: View of approach jetty from abutment to end of mangroves - no storm damage evident

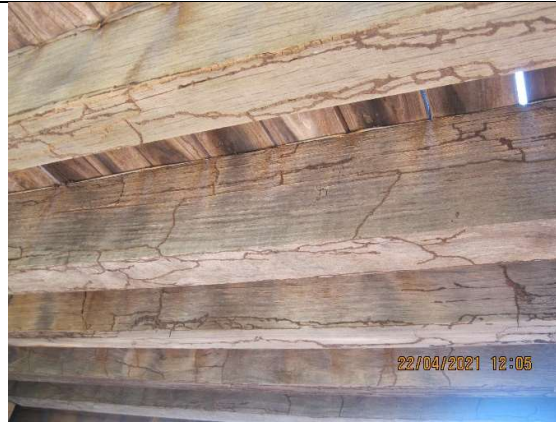
Photo 17: Evidence of termite on stringers near abutment

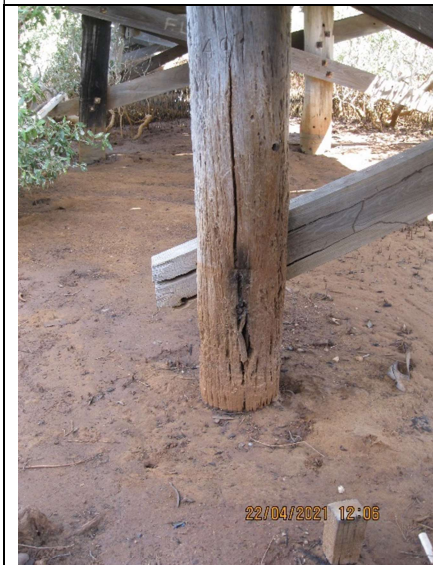
Photo 18; Pile near abutment showing evidence of rot. Likelihood of necking below the mudline when mud level was lower.

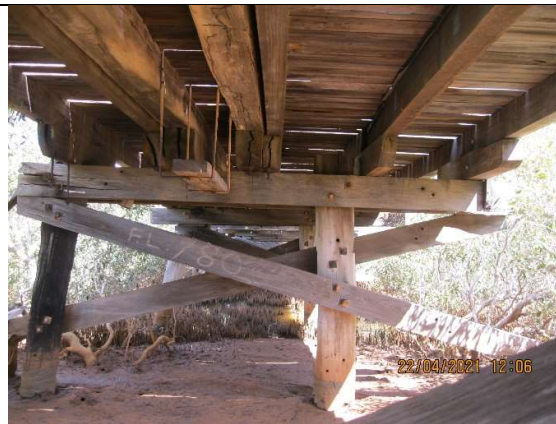
Photo 19: Abutment pile showing evidence of previous fire. Note also split corbel which is prevalent throughout.

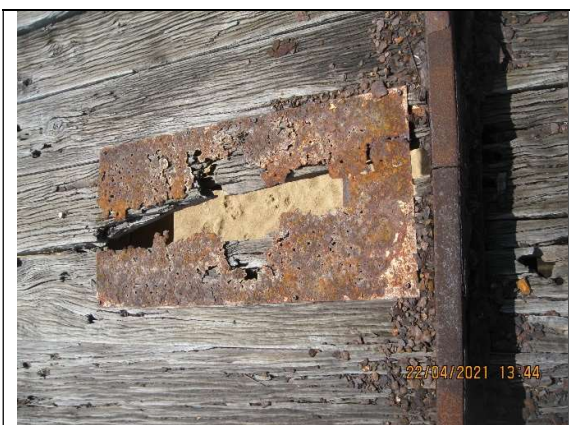
Photo 20: Typical condition of deck planks

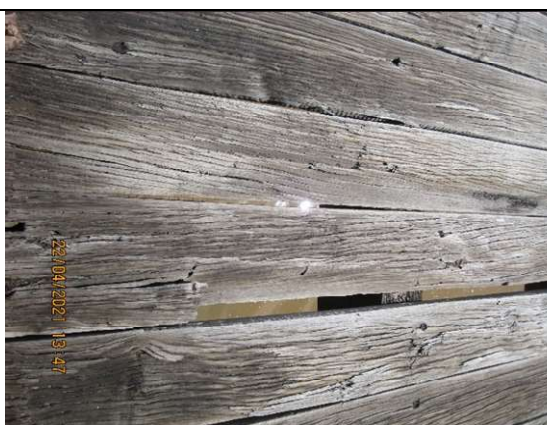
Photo 21: Split and worn deck planks

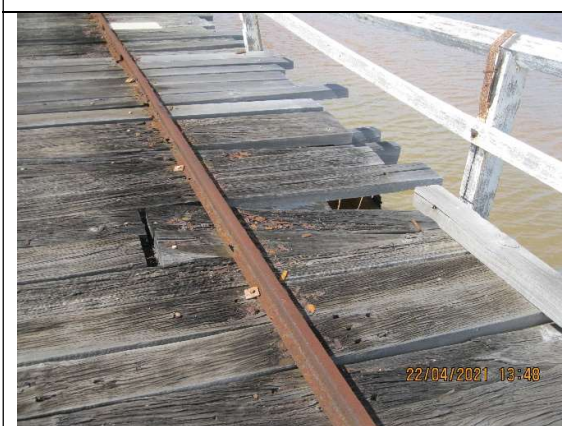
Photo 22: Unsafe deck planks - replaced deck planks can be seen in the background

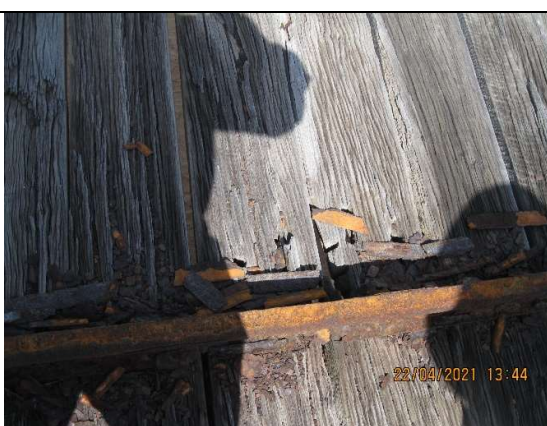
Photo 23: General deterioration of decking and rail line

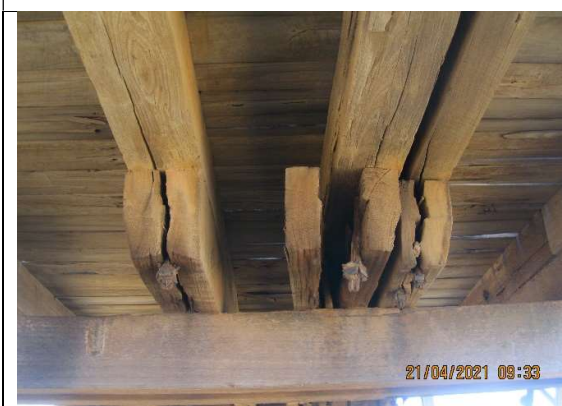
Photo 24: Typical detail of split corbels resulting in separation of corbels and stringers from the crossheads

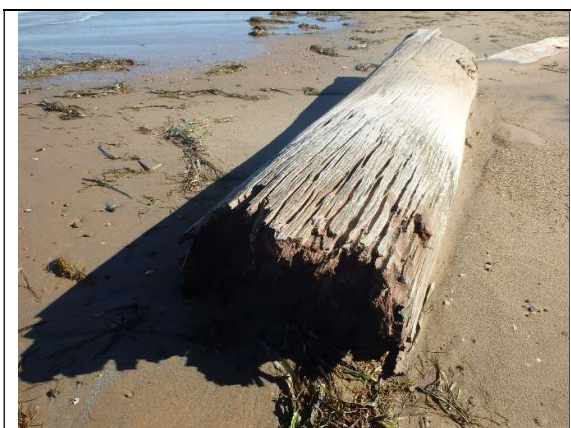
Photo 25: Typical pile showing break at waterline due to rot and Linnoria attack.

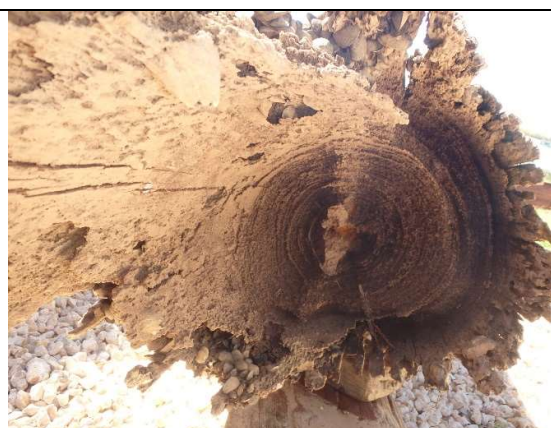
Photo 26: View inside snapped pile

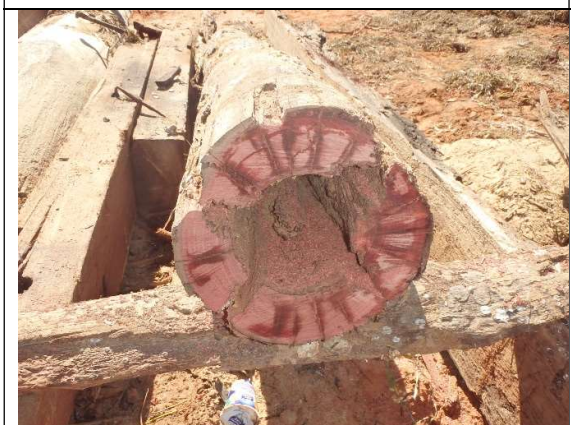
Photo 27: Salvaged pile cut just above necked area where pile snapped showing internal rot

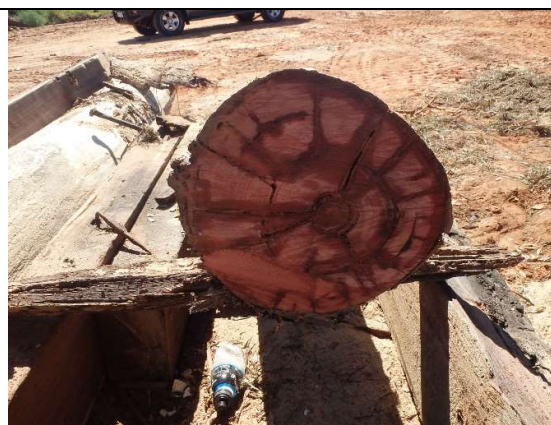
Photo 28: Further section above rot area confirming that Teredo not present

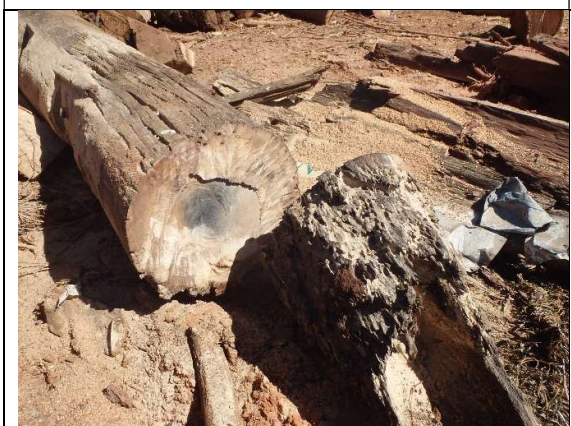
Photo 29: Salvaged pile cut just above necked area (MSL) – no evidence of Teredo

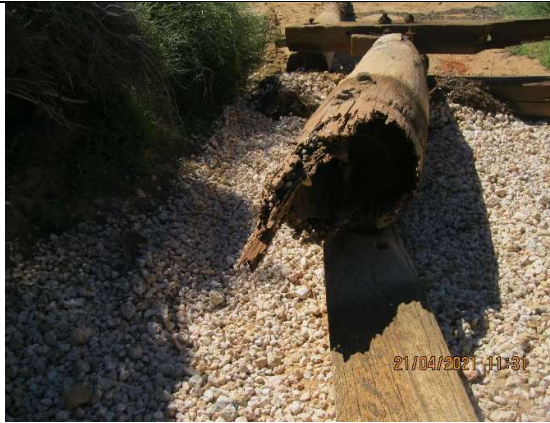
Photo 31: Salvaged timber piles still attached to broken crossheads. Pile at top of photo has rotated. Both piles snapped at mid tide level due to rot and attack by marine organisms - predominantly Limnoria.

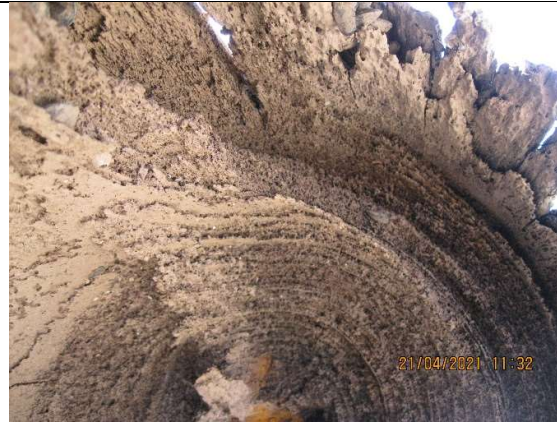
Photo 32: End view of pile at top of photo (Photo 31)
