AUGUSTA BOAT HARBOUR: ENVIRONMENTAL COMPLIANCE ASSESSMENT REPORT (2018) - EPBC APPROVAL 2008/4506

Augusta Boat Harbour 2018 Annual Rehabilitation Assessment

Prepared for Department of Transport
11 December 2018

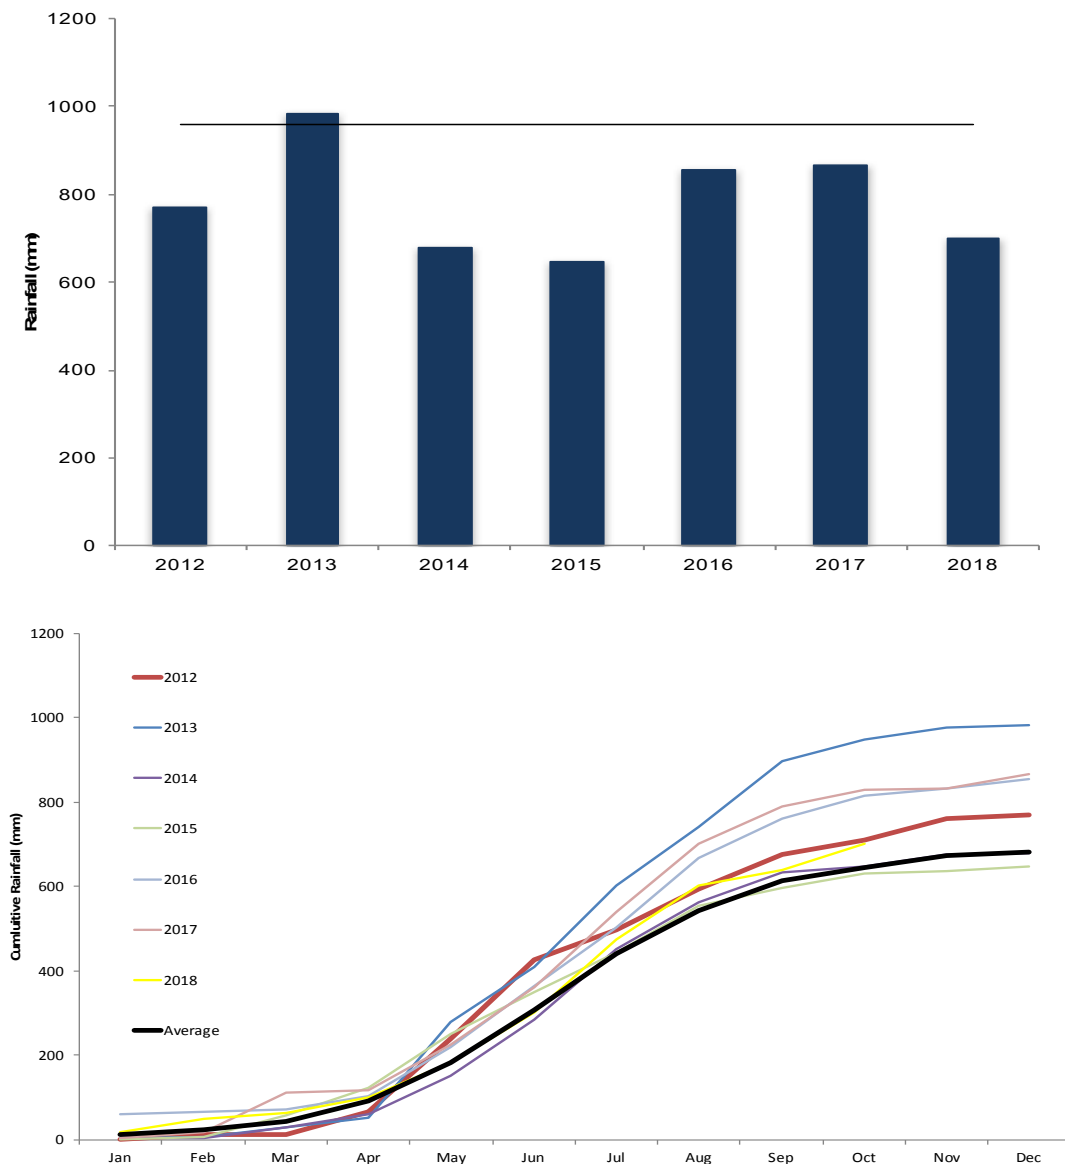
Figure 3 Cumulative monthly rainfall totals for Cape Leeuwin Weather Station (approximately 6 km south-west of the Augusta Boat Harbour) for 2012 to 2017 and January to October 2018.

Annual rainfall for Augusta was well below the long-term average of 962 mm for 2012 (770 mm), 2014 (680 mm), 2015 (648 mm), 2016 (856 mm) and 2017 (866.2mm) (Figure 3). In contrast, the 2013 annual total of 983 mm was slightly above the long-term average.

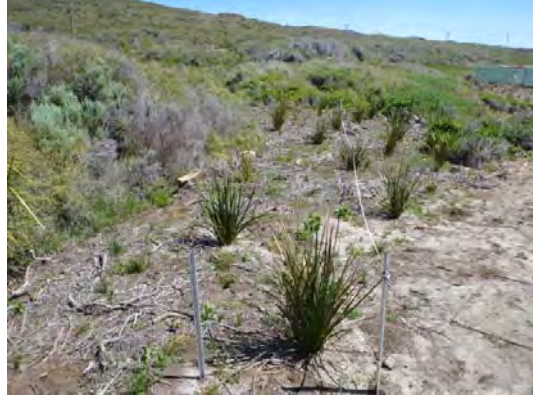
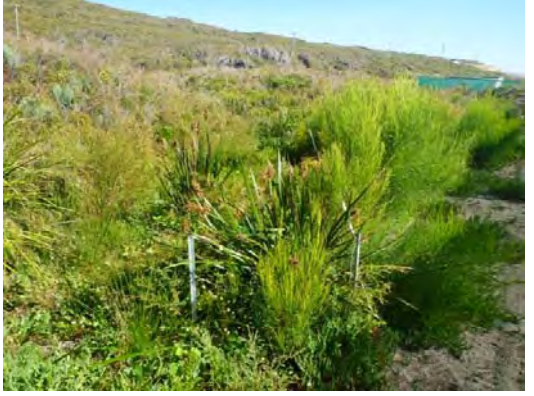
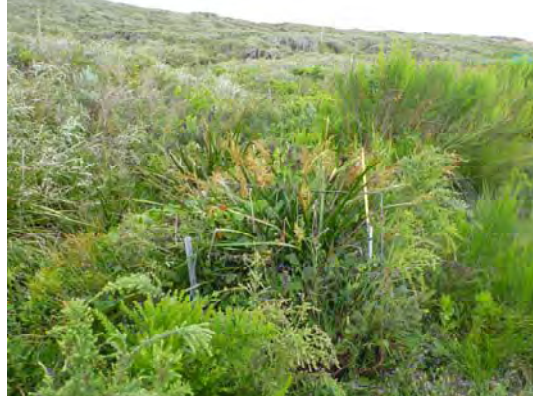
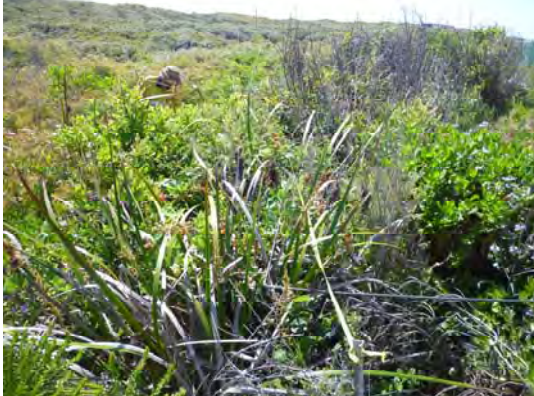
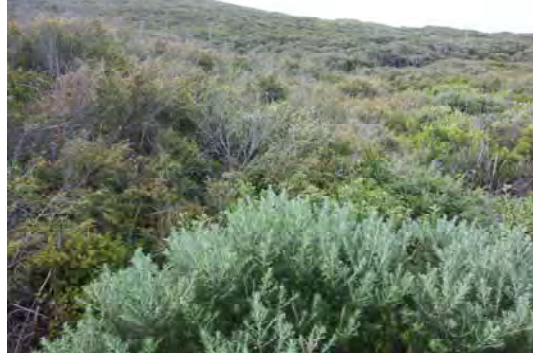
Transect 1 - 2012 Rehabilitation Block

November 2012 - 5 months	November 2013 - 17 months

October 2014 - 28 months	October 2015 - 40 months

October 2018 - 76 months

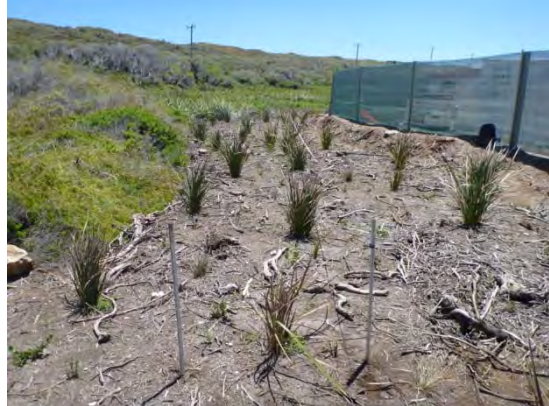
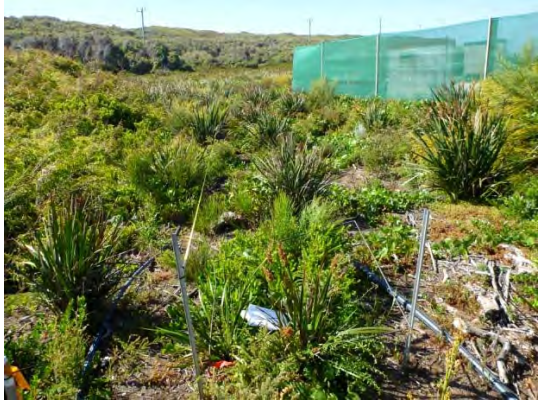
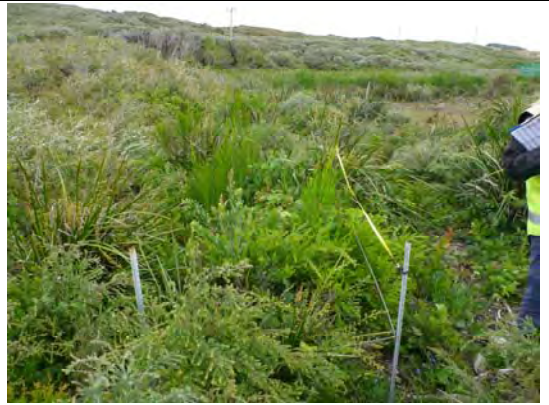
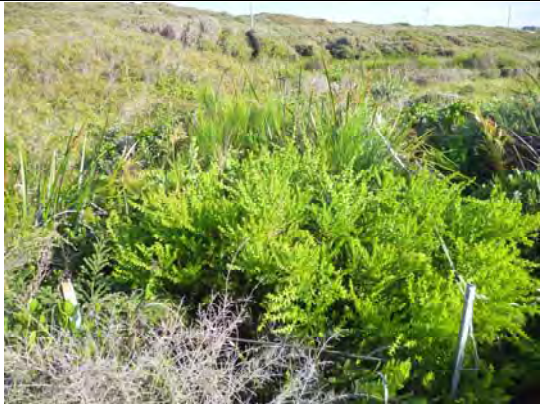
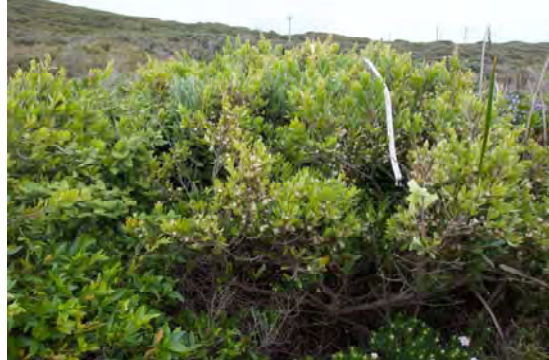
Transect 2 - 2012 Rehabilitation Block

November 2012 - 5 months	November 2013 - 17 months

October 2014 - 28 months	October 2015 - 40 months

October 2018 - 76 months

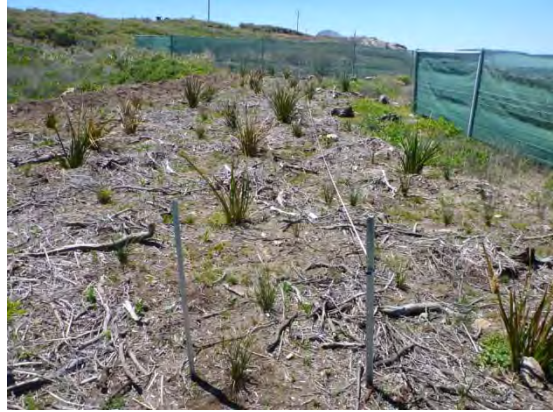
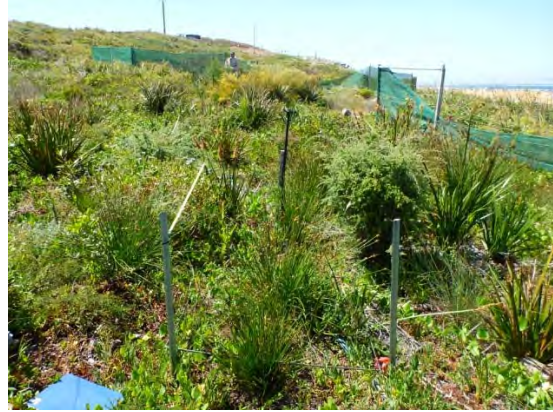
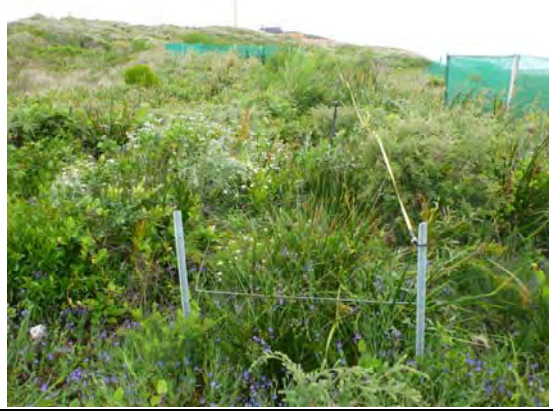
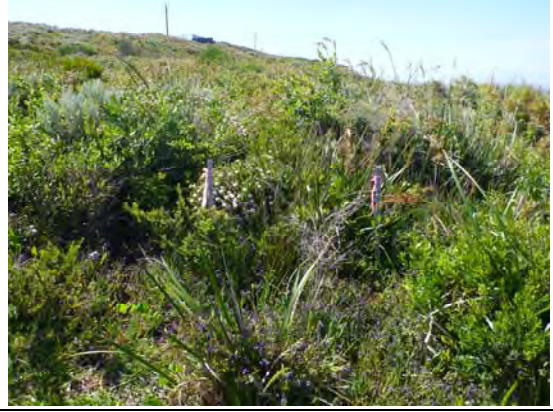
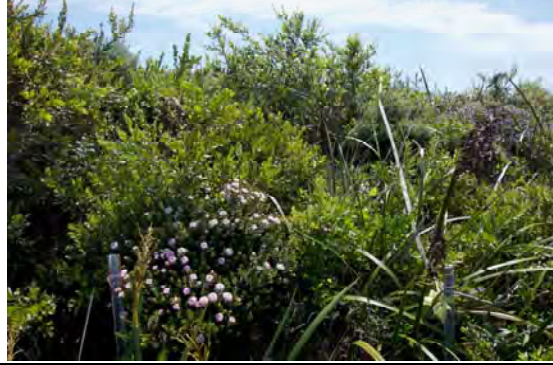
Transect 3 - 2012 Rehabilitation Block

November 2012 - 5 months	November 2013 - 17 months

October 2014 - 28 months	October 2015 - 40 months

October 2018 - 76 months

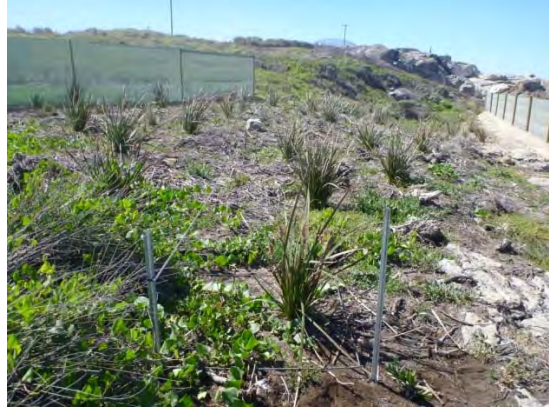
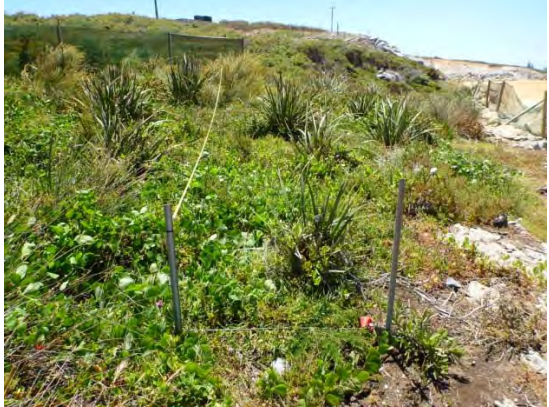
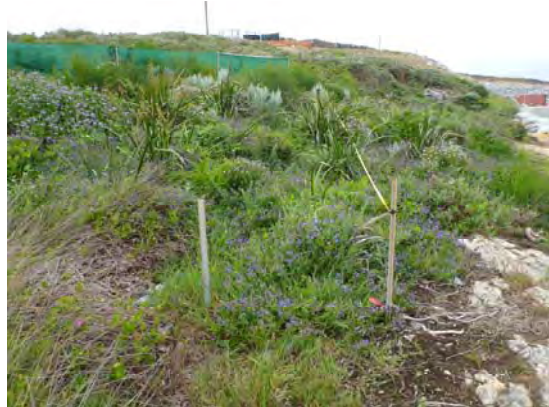
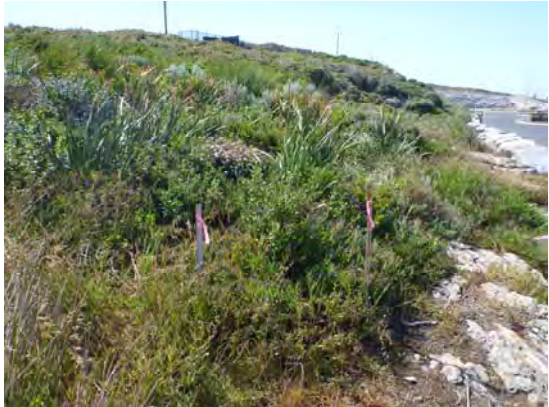
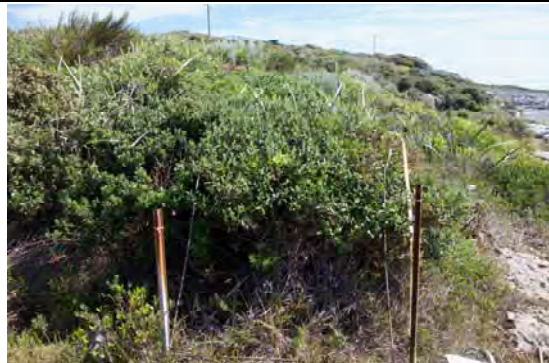
Transect 4 - 2012 Rehabilitation Block

November 2012 - 5 months	November 2013 - 17 months

October 2014 - 28 months	October 2015 - 40 months

October 2018 - 76 months

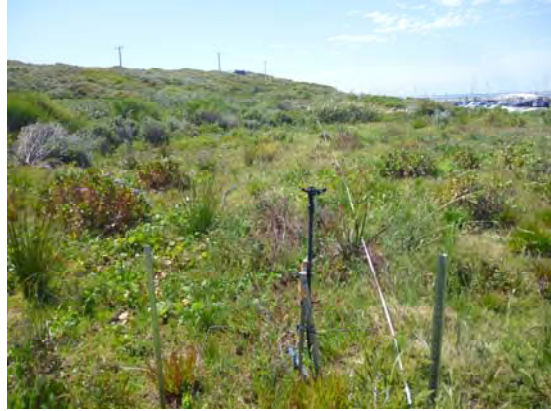
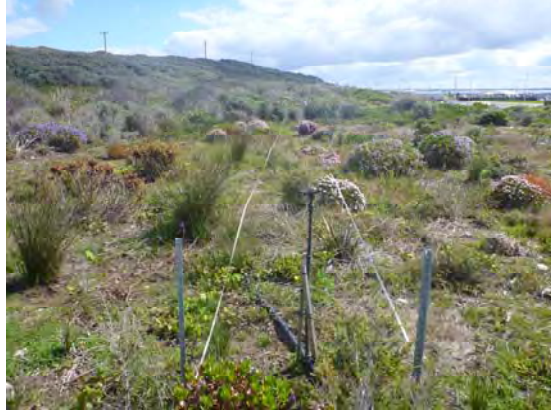
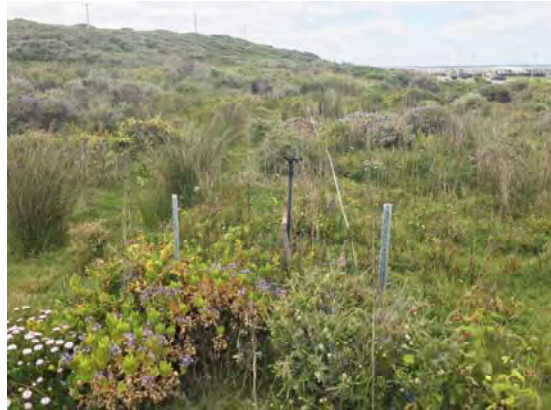
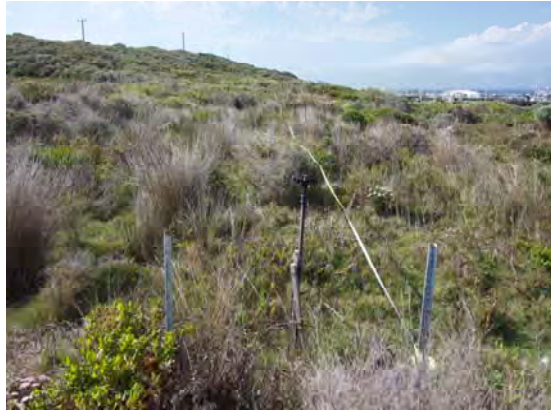
Transect 1 - 2014 Rehabilitation Block

October 2015 – 16 months	October 2016 – 28 months

October 2017 – 40 months	October 2018 – 52 months

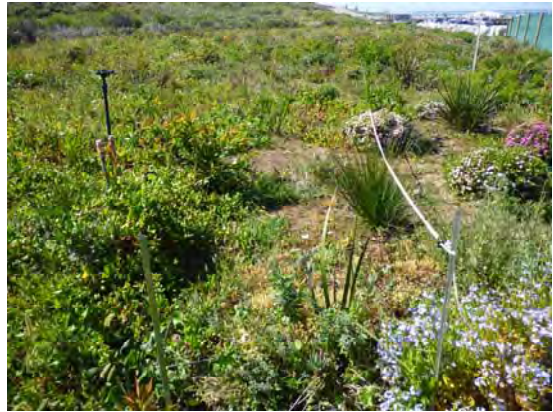
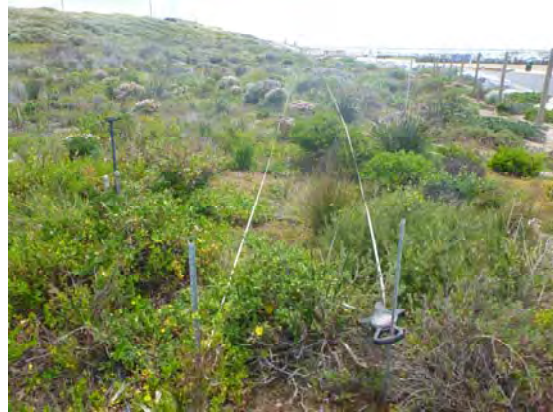
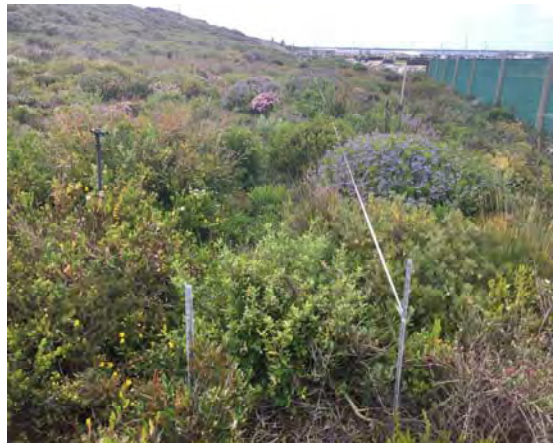
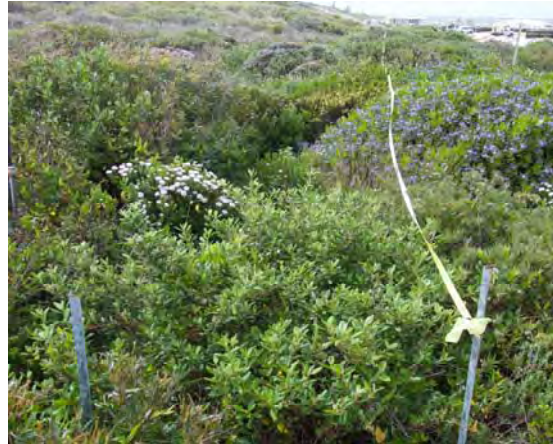
Transect 2 - 2014 Rehabilitation Block

October 2015 – 16 months	October 2016 – 28 months

October 2017 – 40 months	October 2018 – 52 months

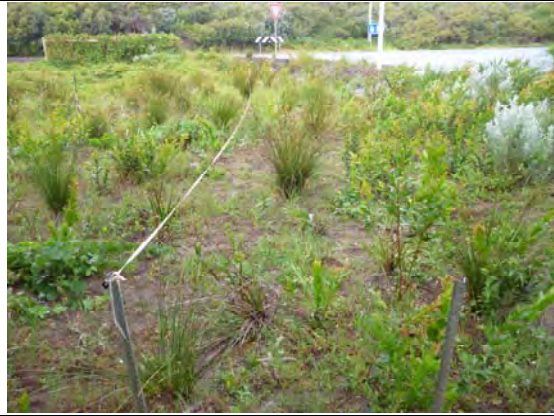
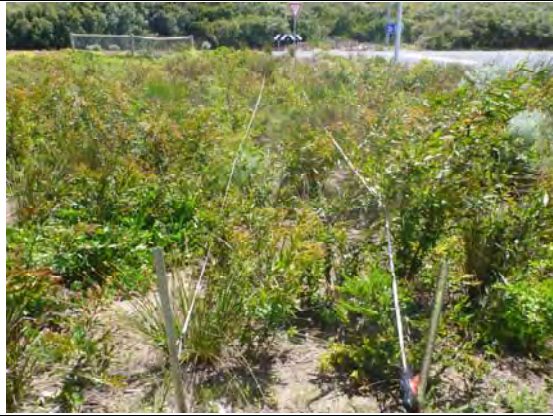
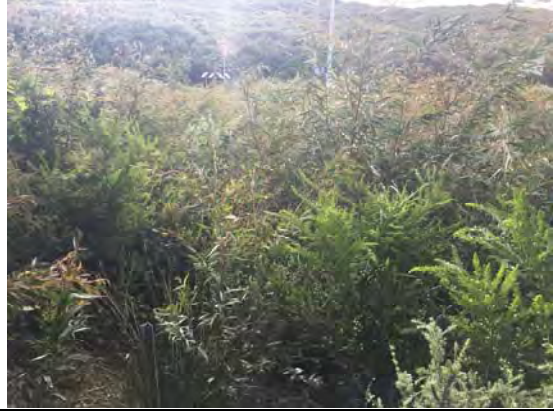
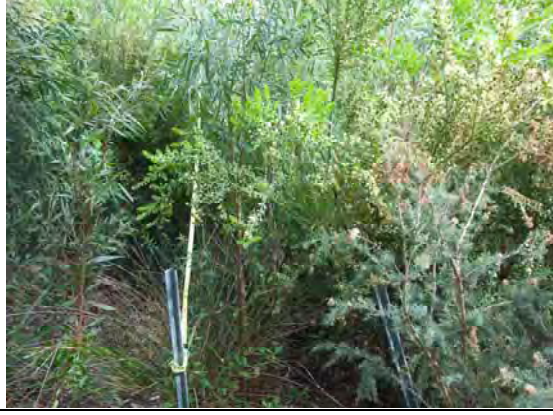
Transect 3 - 2014 Rehabilitation Block

October 2015 – 16 months	October 2016 – 28 months

October 2017 – 40 months	October 2018 – 52 months

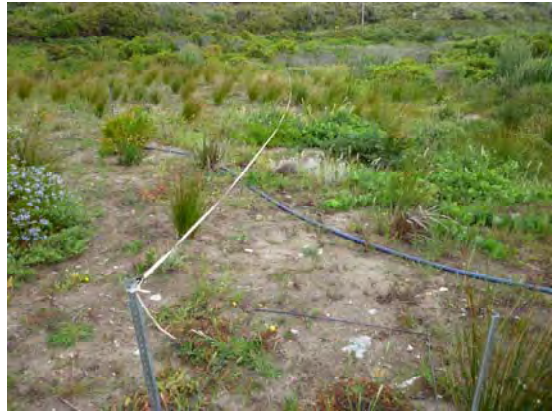
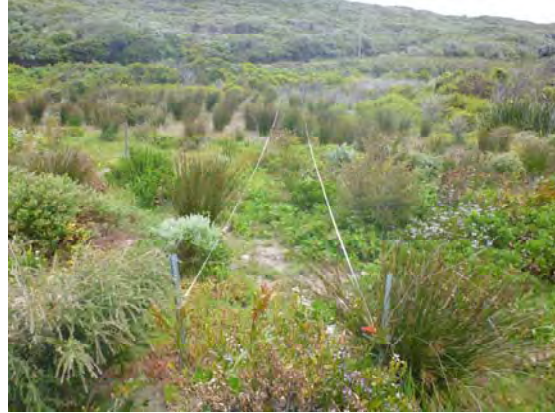
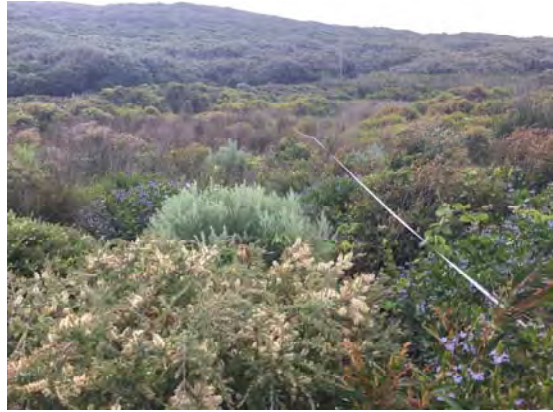
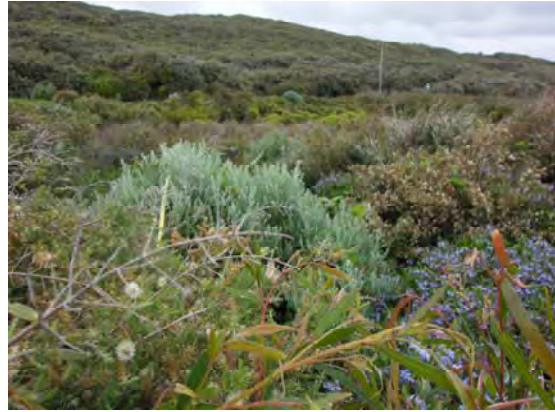
Transect 4 - 2014 Rehabilitation Block

October 2015 – 16 months	October 2016 – 28 months

October 2017 – 40 months	October 2018 – 52 months

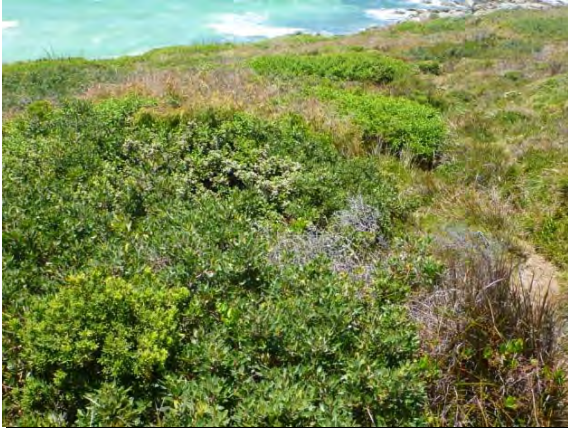
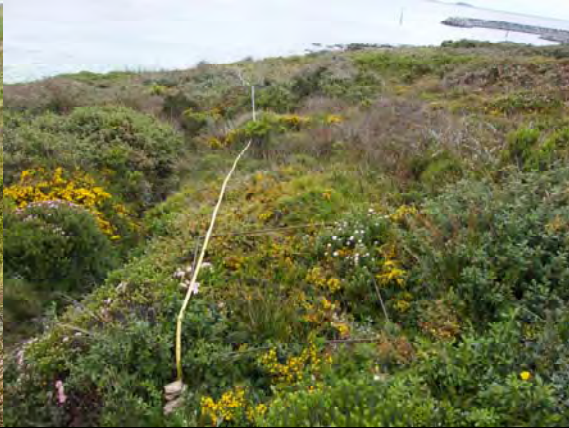
Analogue 1

November 2013	October 2018
Analogue 2

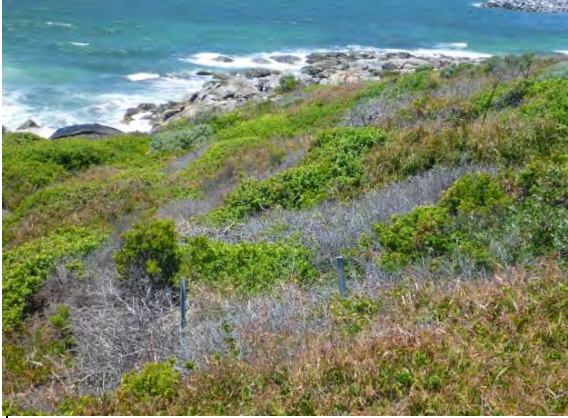
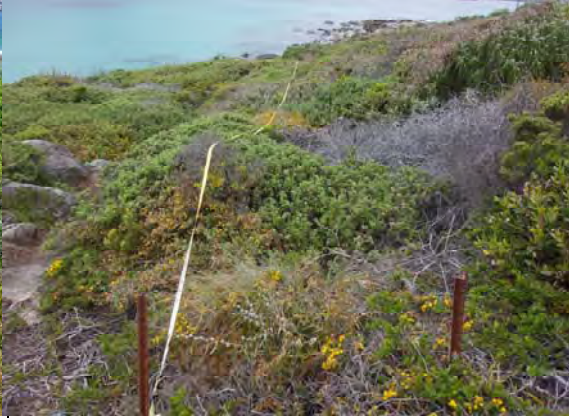
November 2013	October 2018
