Port Geographe Marina Monitoring Program (2016 - 2021)

Close-out Report

CLIENT: Department of Transport
STATUS: Rev 0 REPORT No.: R210044
ISSUE DATE: 3 November 2021

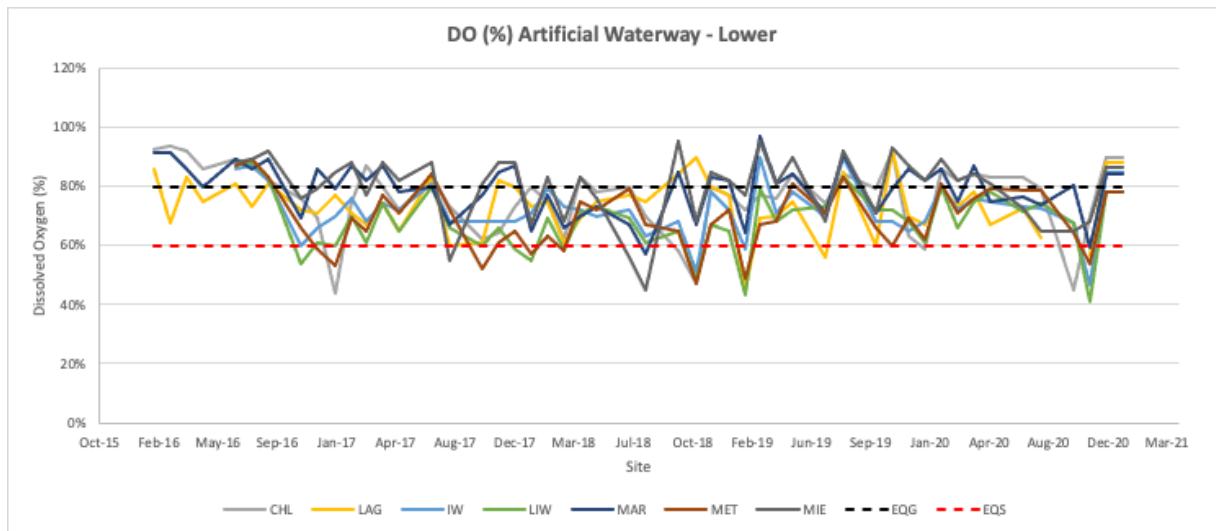
Figure 3 Dissolved Oxygen, Lower Artificial Waterway (February 2016 – January 2021).

The lowest DO concentrations were consistently recorded at five marina monitoring locations in close proximity to the marina entrance (MET, LIW, IW, LAG and CHL). Mean DO concentrations for these sites over the five-year monitoring period were 68.9%, 68.1%, 72%, 73.4% and 76.4% respectively. The likely cause of the reduced DO levels in these areas of the marina relates to the decomposition of organic material (seagrass) that builds up in the marina entrance. As described above, this decomposition process uses up oxygen levels in the water and sediment. Consistent low DO levels at these sites resulted in a regular breach of the EQG (refer Table 3 of O2 Marine 2017). These conditions have likely attributed to reduced aesthetic conditions (odour) in the area.

In addition to the frequent EQG exceedances, DO was also observed to decline below the EQS criteria of 60% for two or more consecutive surveys at CE, CHL, LIW, MET and MIE on at least one occasion per location. In these instances, it has been assumed that DO concentrations remained below the EQS for a period of more than one week, thus indicating an exceedance of the EQS. This assumption is supported by results recorded during reactive monitoring undertaken at CE during October/November 2018, where a telemetered DO sensor showed DO concentrations remained below 60% for a four-week period.

Throughout the five-year monitoring program, it was discussed with the DoT that the best management action in relation to addressing the low DO levels was maintenance dredging of the channel to remove the build-up of decomposing organic material and promote marina flushing. This activity was scheduled annually, and therefore no further management was required in addition to the regular monthly monitoring (physico-chemical parameters, water sampling, marine fauna observations etc). Timing of this activity was considered to be crucial to ensure that this risk was effectively mitigated before waters begin warming during spring.
