Timber Sorting Matrix*

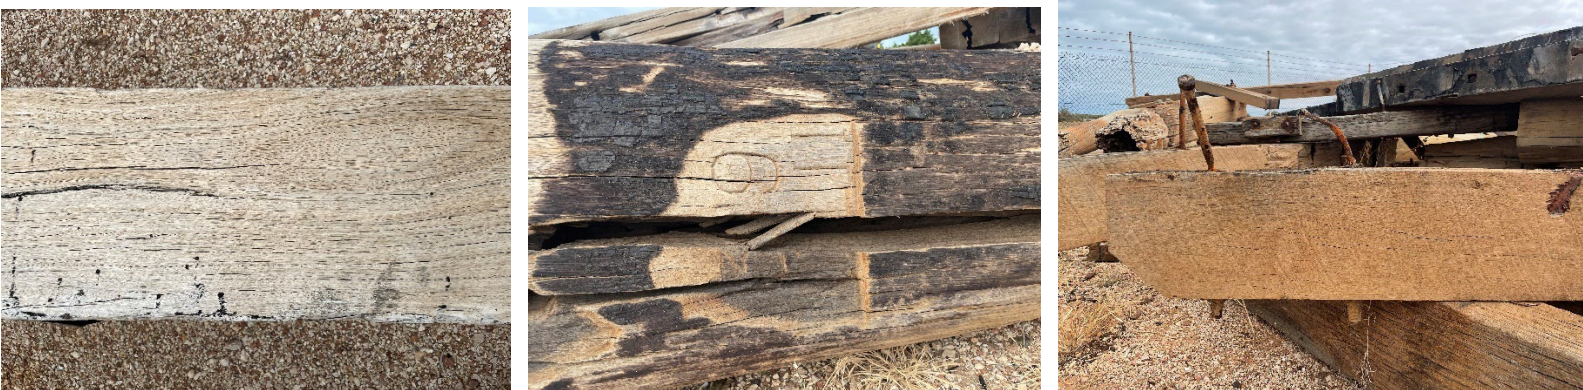
Grade	Extent of Visual Defects	Nature of Defects	Integrity & Authenticity	Future applications	Value	Example Photographs
1	≤10%	Weathering consistent with age. Localised deterioration around fixings and cut ends only. Timber in good, sound condition	Original or early fabric in intact lengths; original intact assemblies; fabric with desirable historic markings (typically 1898-1960s – numerals date pile, roman numerals mark bent location);	Recycled timber market; Re-use in Replacement Jetty design elements; Other construction projects	Commercial – high grade

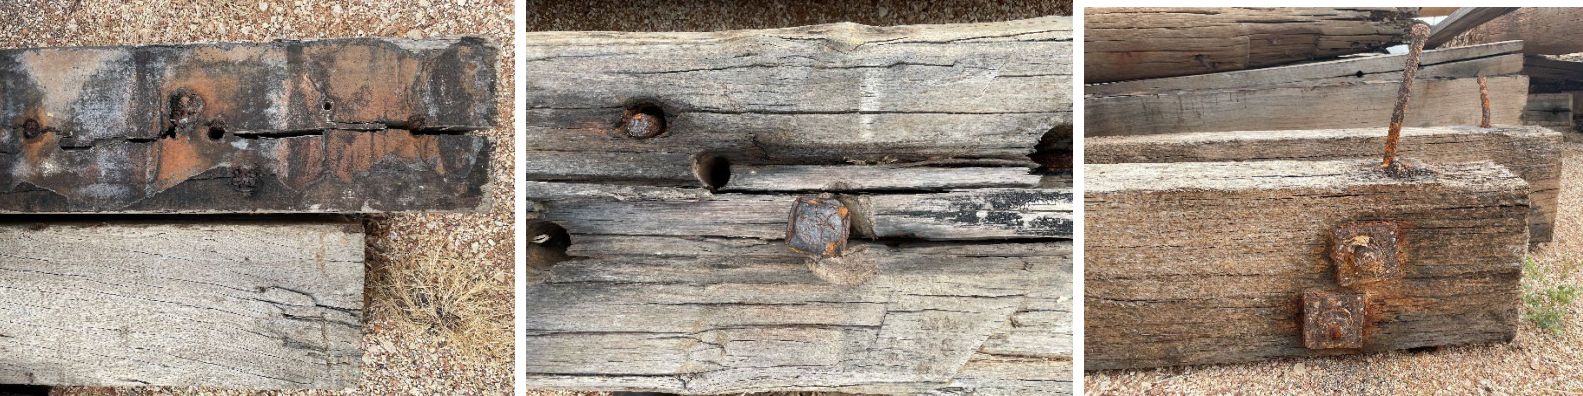
2	≤25%	Weathering consistent with age. Localised deterioration around fixings and cut ends, as well as other wear and tear/ general surface damage; timber generally in good to fair condition	Original or early fabric in intact or slightly modified lengths; timber in sound condition	Other construction or sculptural projects; timber trader market	Commercial – second grade

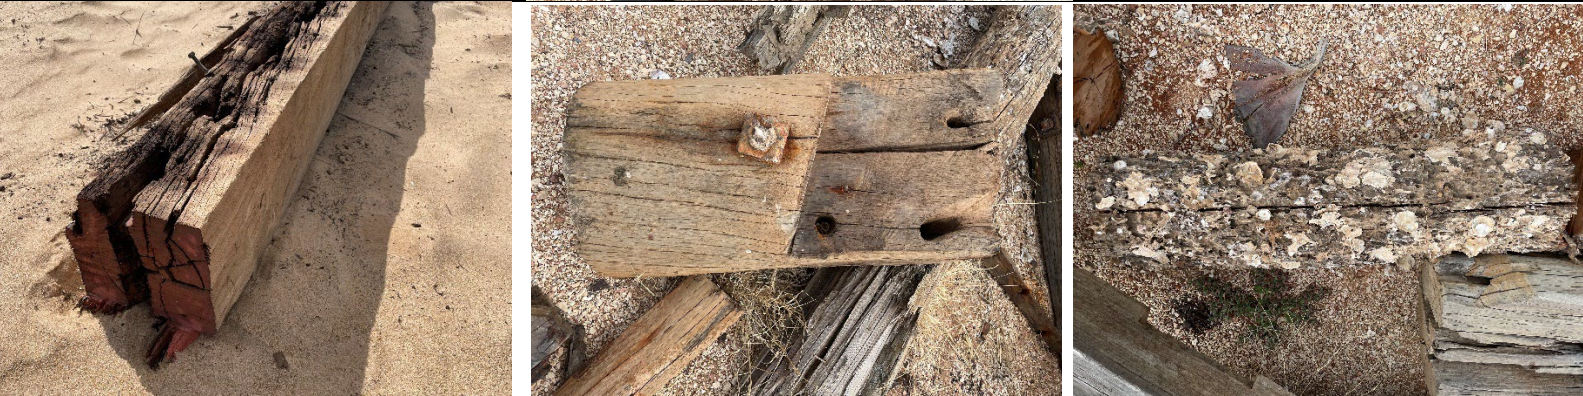
3	>25%	Considerable weathering; enlarged recesses and deterioration to exposed surfaces and around fixings and cut ends; timber generally in fair to poor condition	Cut-down or damaged lengths of early fabric; non-original replacement fabric	Small scale domestic and community use; opportunistic salvage. Some of this material may be short lengths suitable for firewood	Community

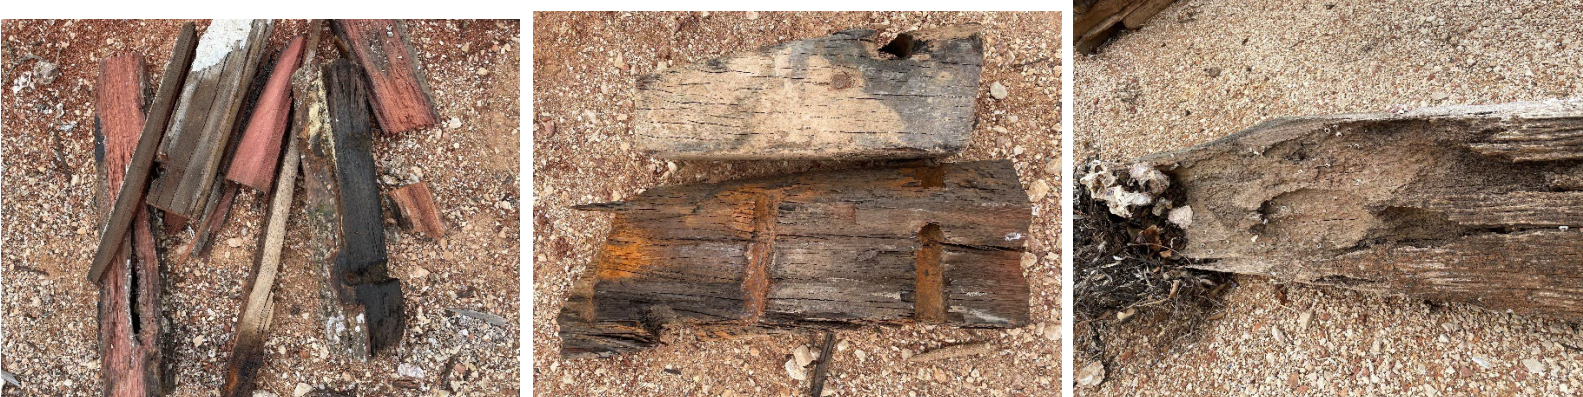
4	Defective	Excessive weathering and deterioration. Broken, rotted, splintered timber with structural failure; timber with contamination; timber generally in poor condition	Broken lengths; non-original replacement fabric; contaminated material; material covered in barnacles or which is hollowed out (by termites or teredo worm)	Opportunistic salvage; landfill	Minimal
