## Safe Active Streets Program:

# STIRLING

Interim Evaluation Report - 2023

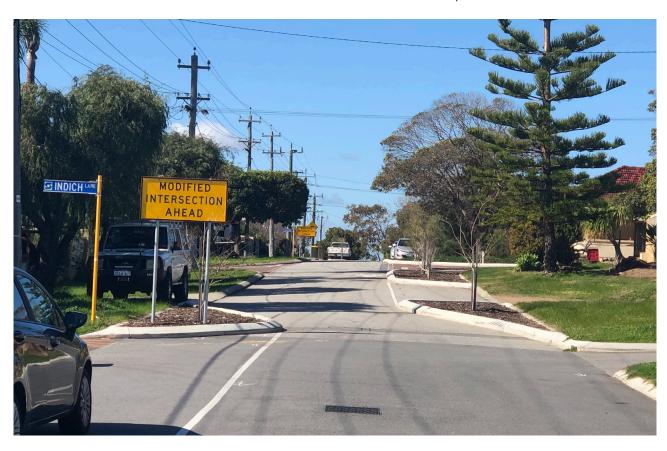
Video surveys involve placing video cameras at strategic locations to detect the movements of bike riders and pedestrians. Survey footage is then analysed to extract pedestrian and bike rider activity.

These surveys were conducted on the safe active street route and on adjacent intersections off-route to detect area wide trends. There are four comparable pre and post construction sites along the route shown in this report.

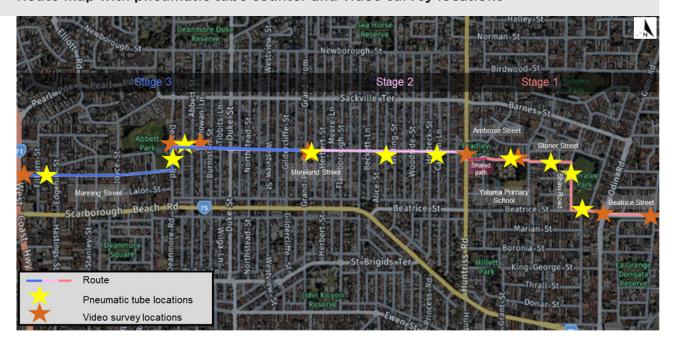
#### Route map with pneumatic tube counter and video survey locations

Tube counters were in place over a specified period to capture the pre and post construction counts. In this report, four comparable pre and post construction sites along Stage 1 have been shown, three sites along Stage 2 and three comparable sites along Stage 3.

- → Stage 1: August 2018 (pre-construction) and October 2021 and May 2022 (post-construction)
- → Stage 2: February 2018 (pre-construction) and February 2021 (post-construction)
- → Stage 3: February 2018 (pre-construction) and February 2021 and June 2022 (post-construction)

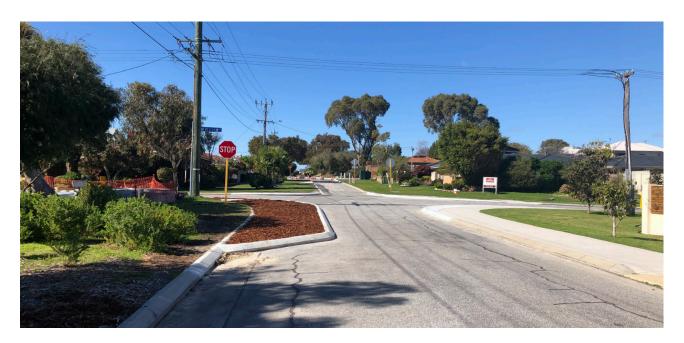
#### Walking activity (raw counts)

The largest increase in the number of people walking was observed in Stage 1 around Yuluma Primary School during the week.

- The largest increase was observed over the weekdays at the Ambrose Street site which indicates use of the route to access Yuluma Primary School.
- → Walking activity saw increases at each end of Moorland Street over the weekend, possibly due to Abbett Park located on the west end and Bradley Reserve on the east end of the route.
- → The largest decreases in walking activity were observed in Stage 3, particularly over the weekend.

Bicycle riding observed increases at seven (out of eight) sites over the weekend along the route.

- → Increases in bike riding were seen across all Stages (1-3) over the weekend, with the exception of the site located in Stage 3 at Moorland and Abbett Street, which remained somewhat unchanged.
- → An increase in bike riding activity was also seen at five (out of eight) sites during the week.

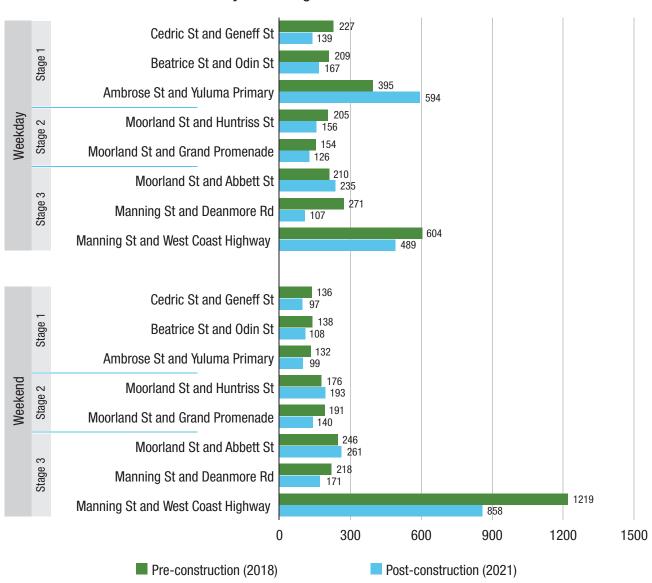
#### Chart 1

## Average weekday and weekend walking activity Pre and post construction (raw counts)

#### City of Stirling Safe Active Street

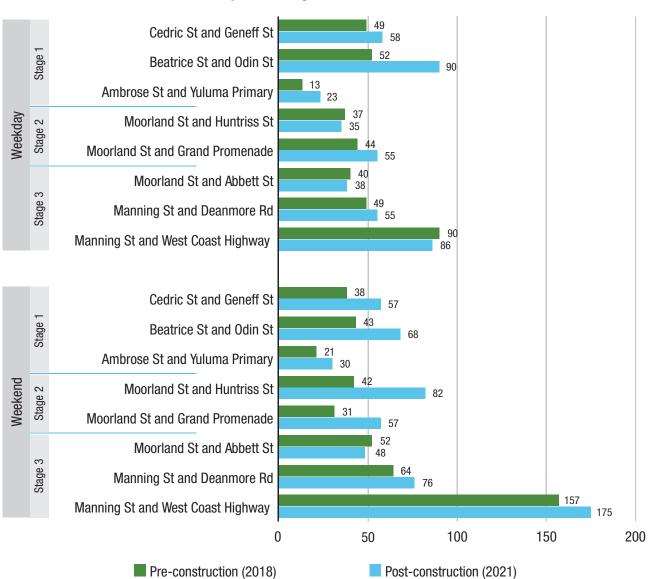
Chart 2

## Average weekday and weekend bike riding activity Pre and post construction (raw counts)

#### City of Stirling Safe Active Street
