# WA Coastal Erosion Hotspots

## Review of Coastal Management History - 12 Sites

Document no. Rev 1: 311012-02081-CS-REP-001

12 June 2025

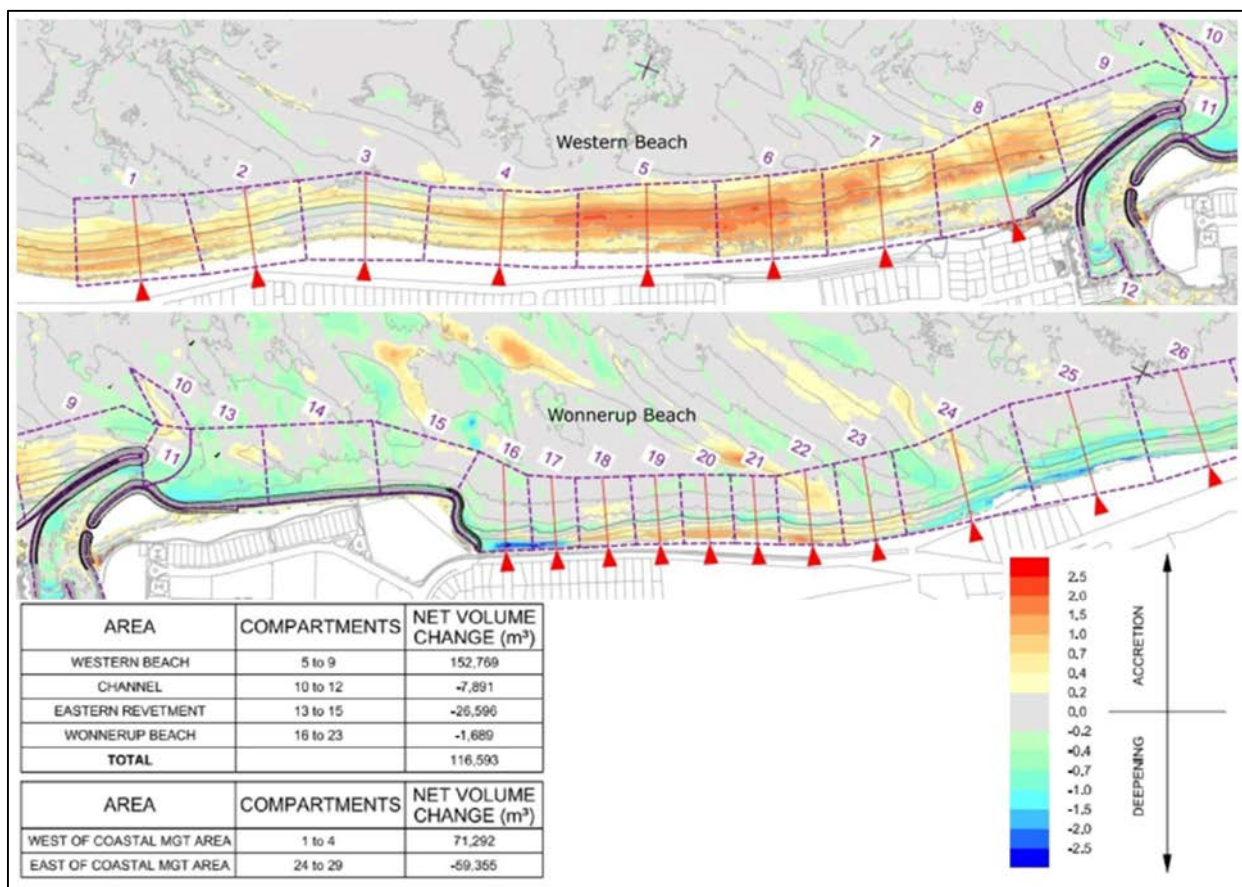
At Port Geographe (Wonnerup), the availability of shore-accessed sand has decreased since the sand trap and western groyne were reconfigured (2014). This has likely contributed to the significant reduction of bypassing practices at this site, with wide-spread accretion no longer 'easy' to win from a localised area (refer to Figure 2-1). Although natural bypassing of sand has likely improved at the site (since reconfiguration), investigation of the Wonnerup hotspots indicates not enough sand was transported to Wonnerup eastern beaches to prevent erosion. Additionally, the impact that bypassing has on wrack accretion updrift of Port Geographe is a key consideration that has limited bypassing since reconfiguration.

Figure 2-1: Survey changes along the Western and Wonnerup beaches since reconfiguration of the Port Geographe Marina (Department of Transport, 2020); changes from Nov 2014 to Dec 2019

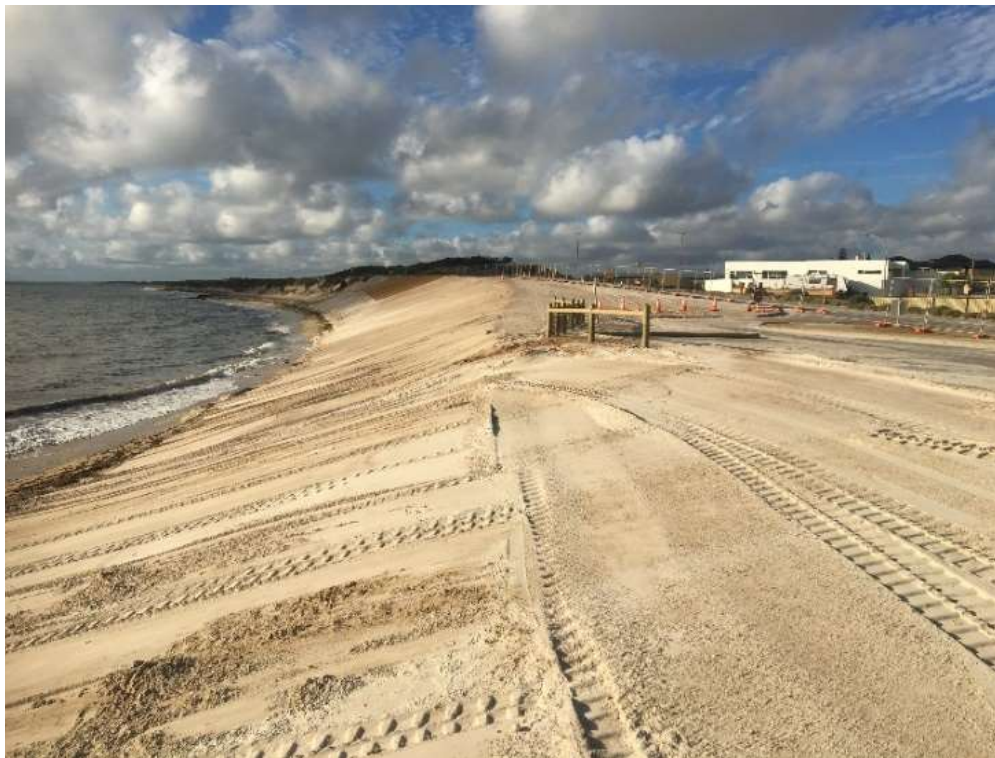
*Figure 1-2: Photo taken of Surf beach dune/beach profile, post stage 2 stabilisation works, 10 March 2021*

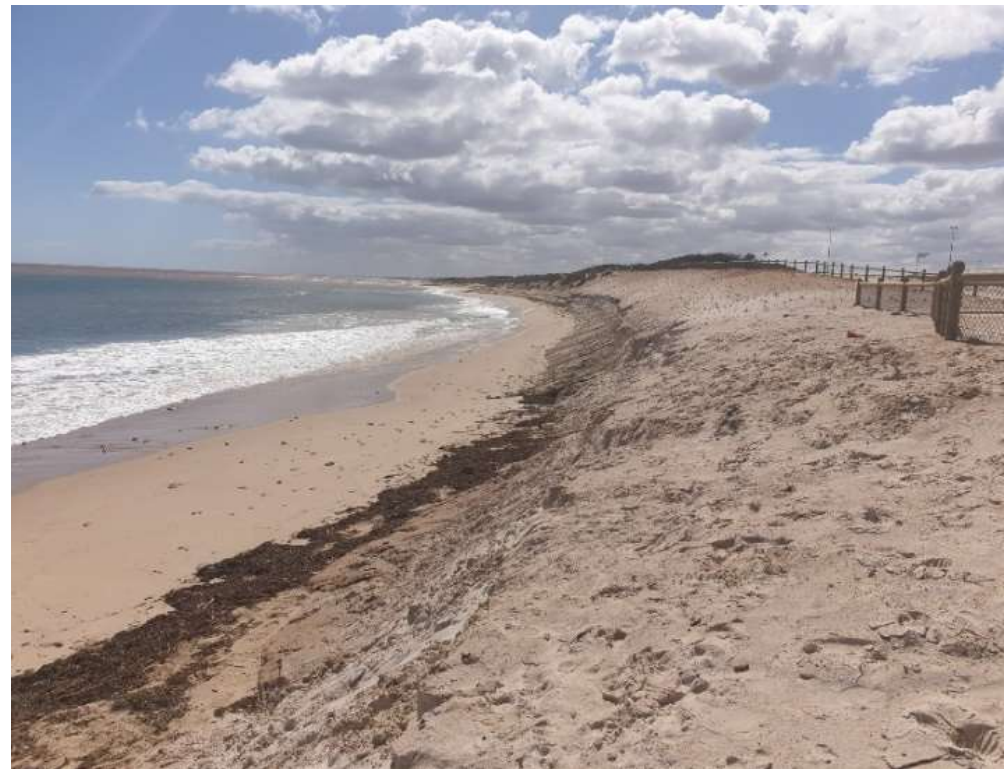
*Figure 1-3: Photo taken of Surf Beach dune/beach profile, post storm event, scarp and exposed concrete face apparent 11 April 2021*

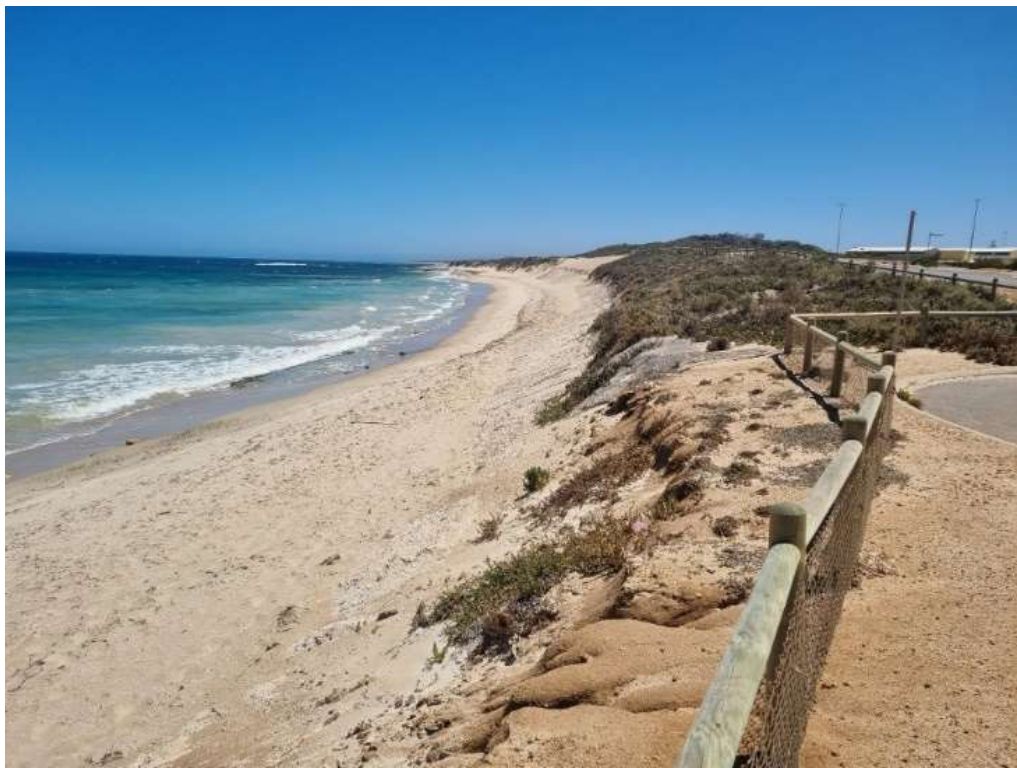
*Figure 1-4: Photo taken of Surf beach dune/beach profile during site visit 29 January 2024*

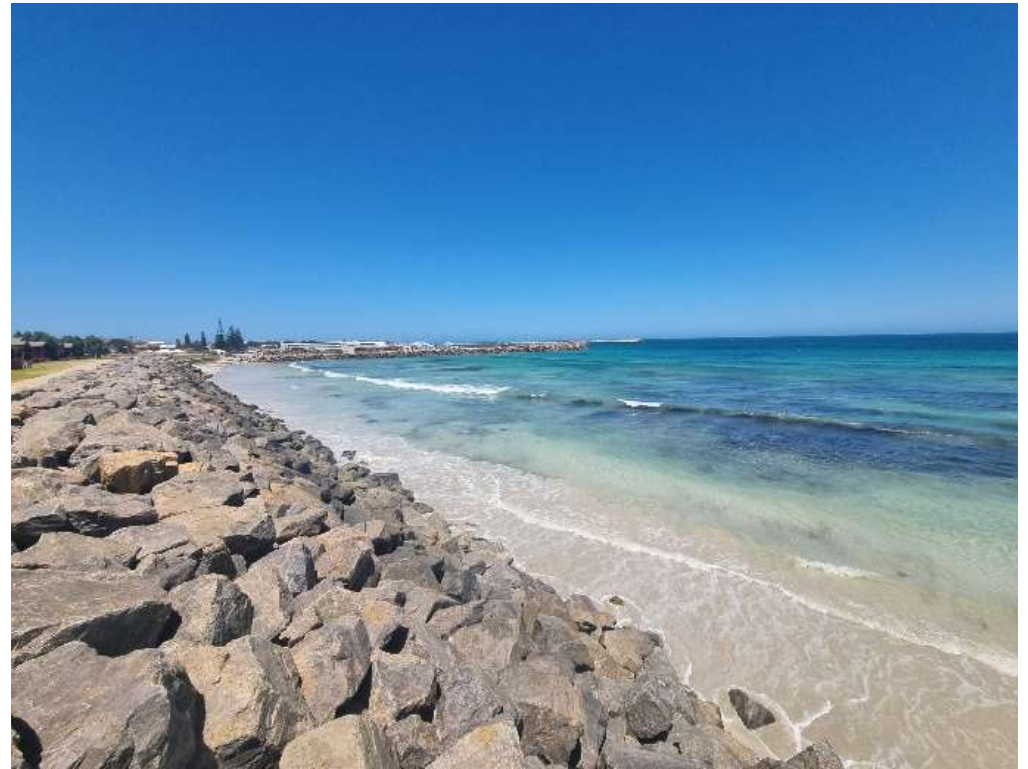
*Figure 1-7: Seawall looking southwest (taken during site visit 29 January 2024)*

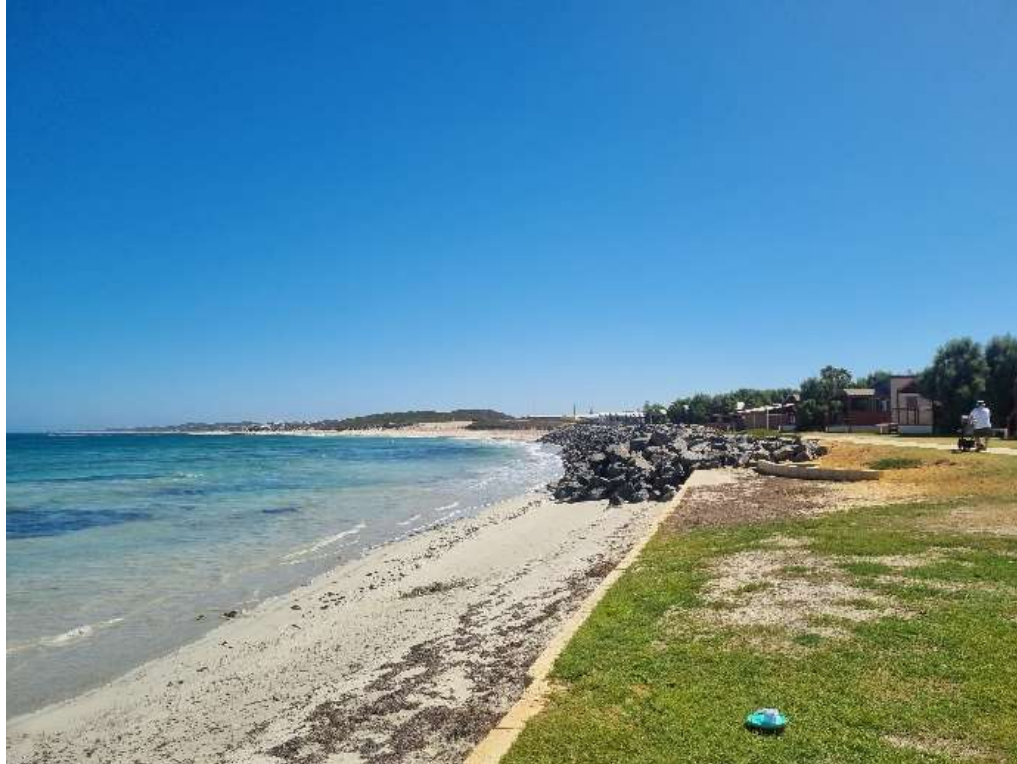
*Figure 1-8: Seawall and retaining wall looking north (taken during site visit 29 January 2024)*

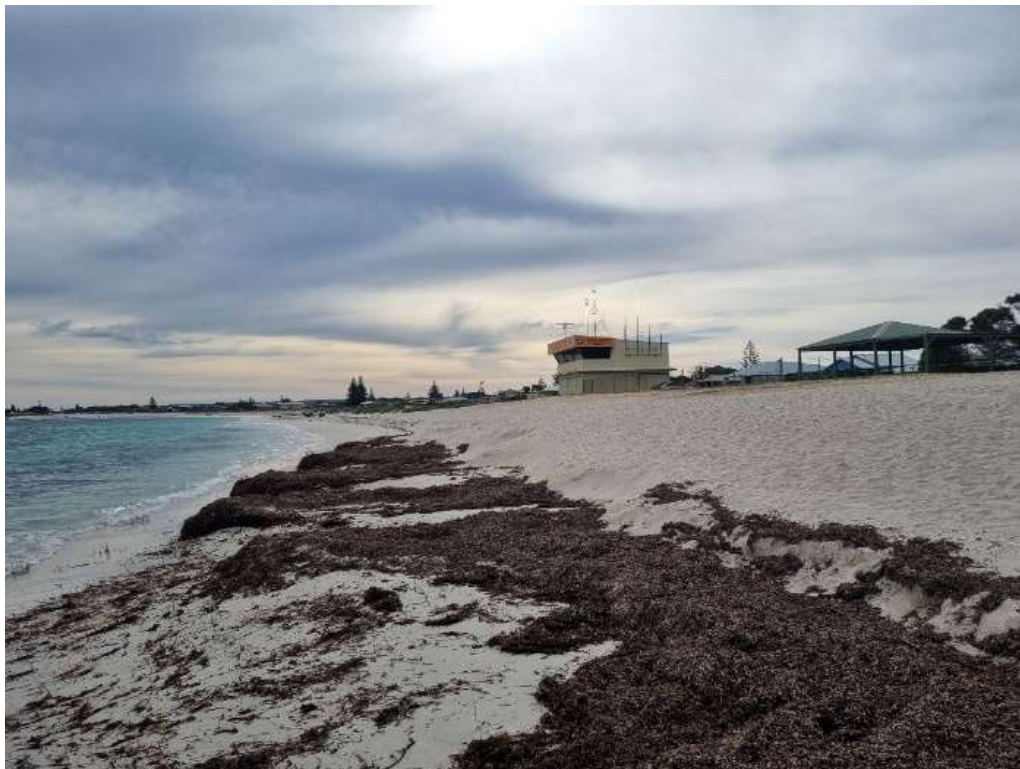
*Figure 2-2: Photo taken of Grace Darling Park, looking south, adjacent to car park. Taken during site visit 20/05/2024 (5 months after latest nourishment campaign).*

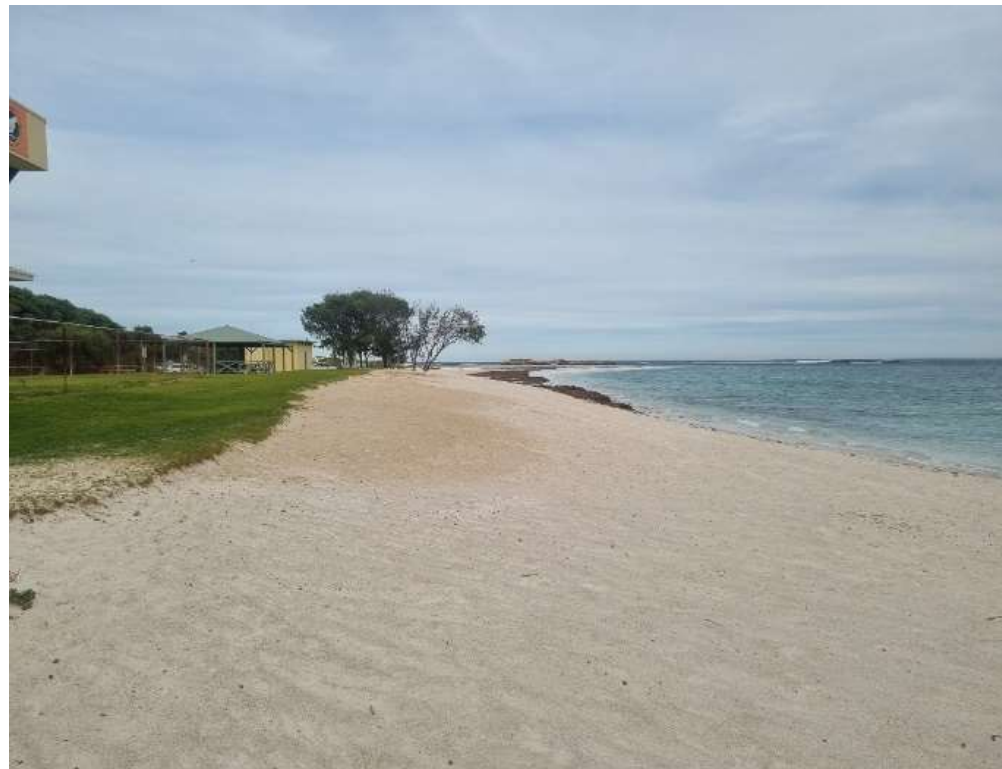
*Figure 2-3: Photo taken of Grace Darling Park, looking south, adjacent to Volunteer Marine Sea Rescue building. Taken during site visit 20/05/2024 (5 months after latest nourishment campaign).*

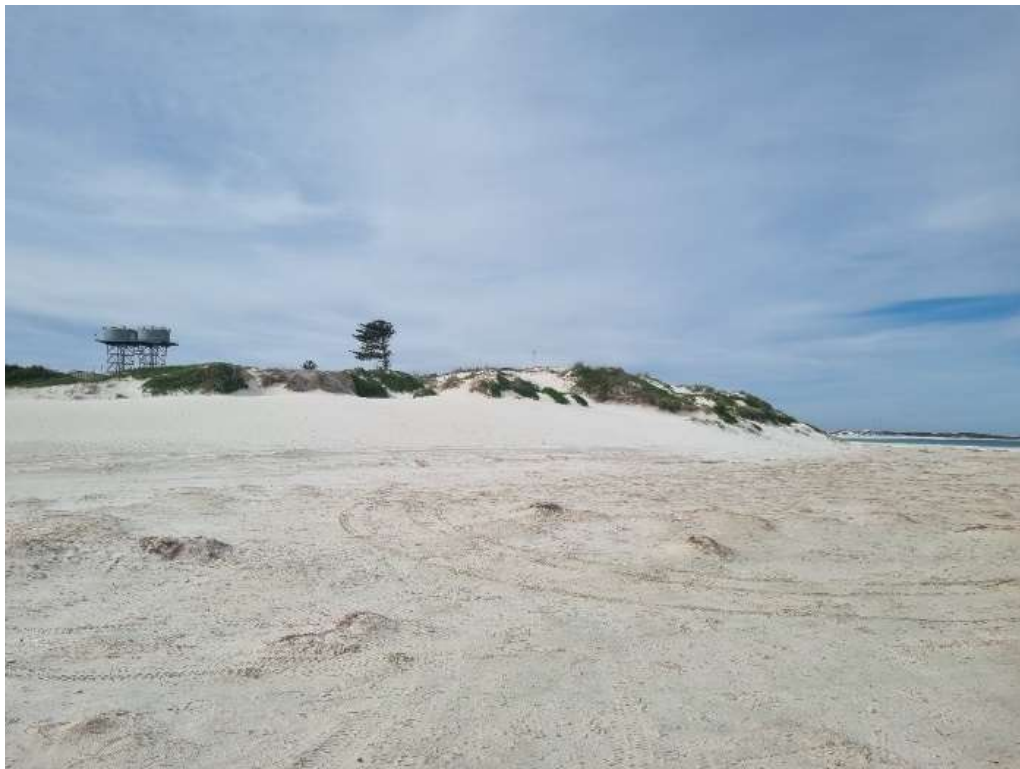
| ID | Category | Content |
|---|---|---|
| | | <ul style="list-style-type: none"> <li>Four-wheel-drive access to the south of Grace Darling is impacting the coastal vegetation, and their ability to stabilise the sand dune bordering the cusplate foreland. Restricting access here year-round will assist the dune to establish itself.</li> <li>Stockpiling disposed dredge material at the cusplate spit should be continued during future maintenance dredging campaigns (in addition to nourishing Grace Darling during the same campaigns). Keeping reserve of sand within the system will assist the sand dunes rebuild here but will also give the SoG access to sand to use for nourishment at their discretion.</li> </ul> <p><b>Community engagement/education</b></p> <ul style="list-style-type: none"> <li>Lancelin is likely to face some strong opposition regarding the proposed action, and findings from the integrated CHRMAP study. To execute the proposed path forward, public support and education is required, to inform the community of the implications if action is not taken.</li> </ul> |

*Figure 2-4: Dune adjacent to Edward Island cusplate foreland, showing vehicle proximity to foot of dune system. Taken during site visit 20/05/2024.*

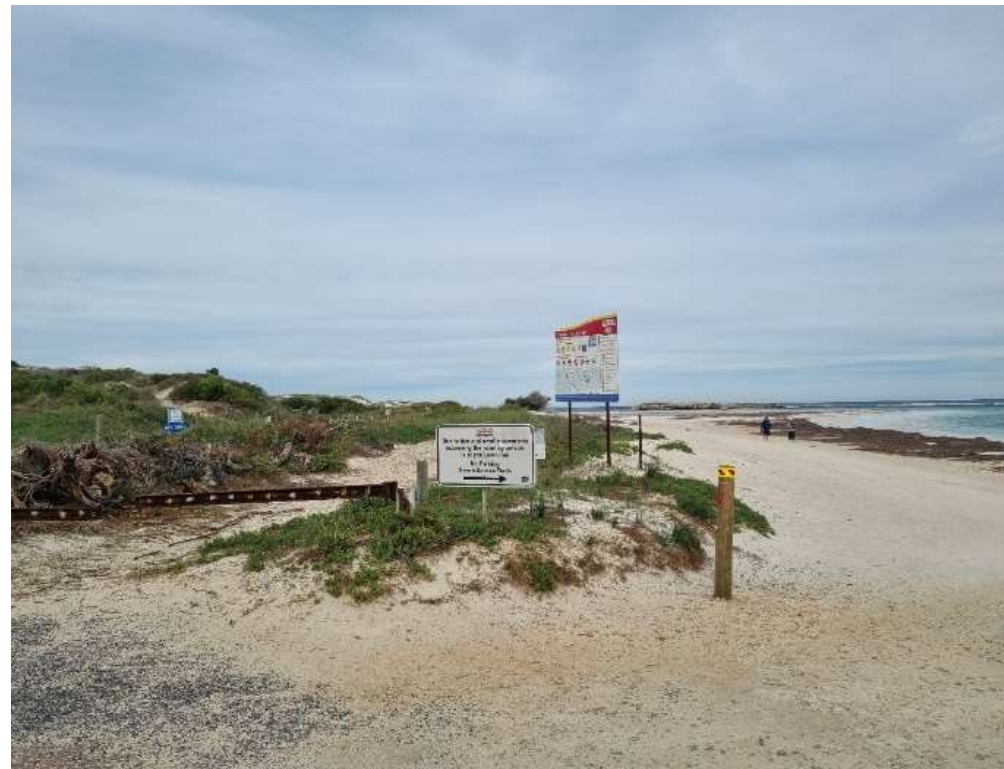
*Figure 2-5: Photo taken of Edward Island four-wheel-drive access south of Grace Darling car park. Taken during site visit 20 May 2024.*

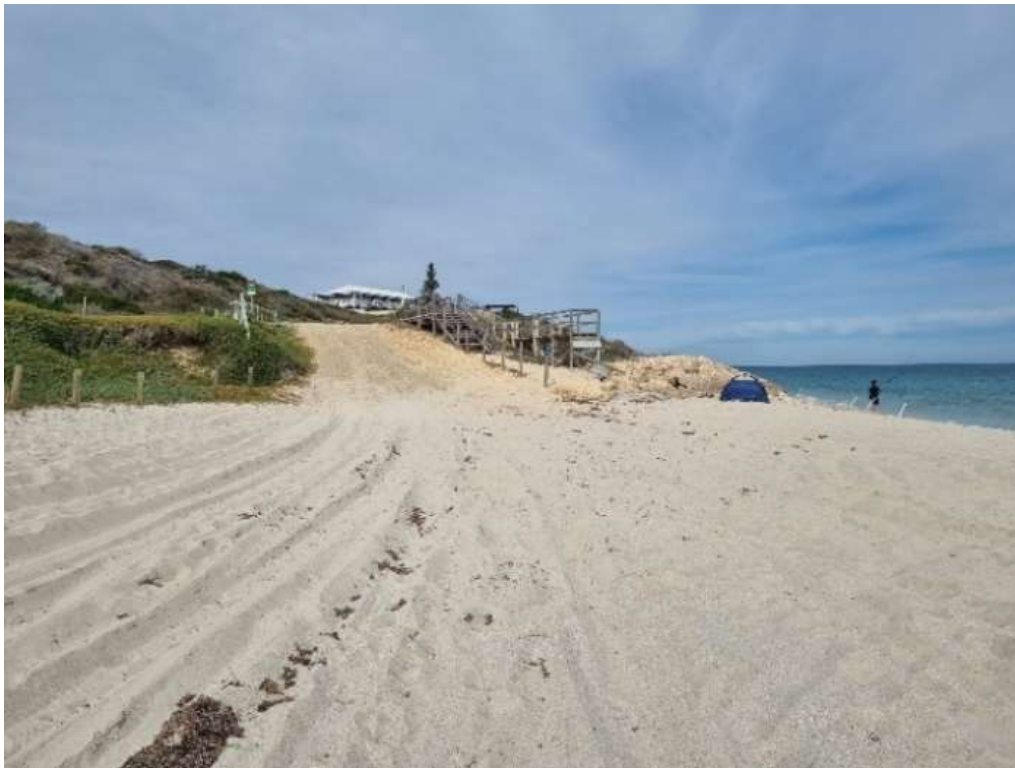
*Figure 3-2: Photo taken of 4x4 access onto beach, immediately north of Seabird rock revetment, facing south during site visit 20 May 2024*

| ID | Category | Content |
|---|---|---|
| | | <ul style="list-style-type: none"> <li>Four-wheel-drive access to the beach should be transferred to an alternate location north of the existing Edwards Street carpark. The existing location faces multiple erosional pressures including the downdrift impacts associated with the Seawall. It is recommended that the carpark is modified to minimise the encroachment into the coastal dune system.</li> </ul> |

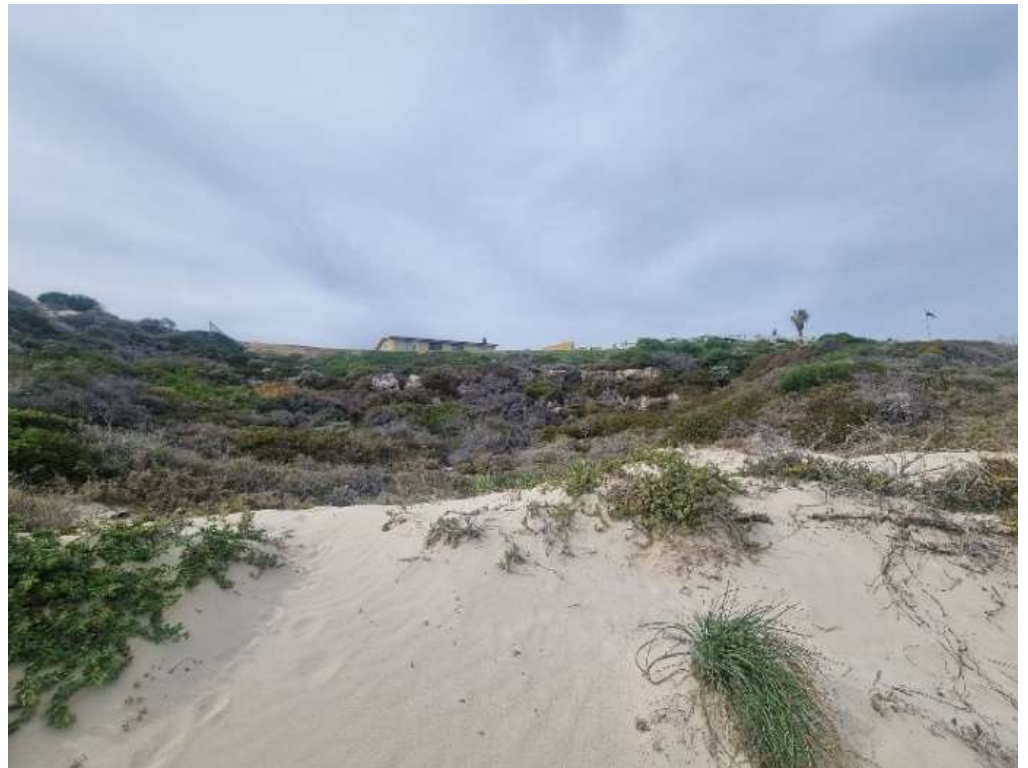
*Figure 3-3: Photo taken of coastal rock protruding from dune surface (facing east) adjacent to Seabird Tavern, during site visit 20 May 2024.*

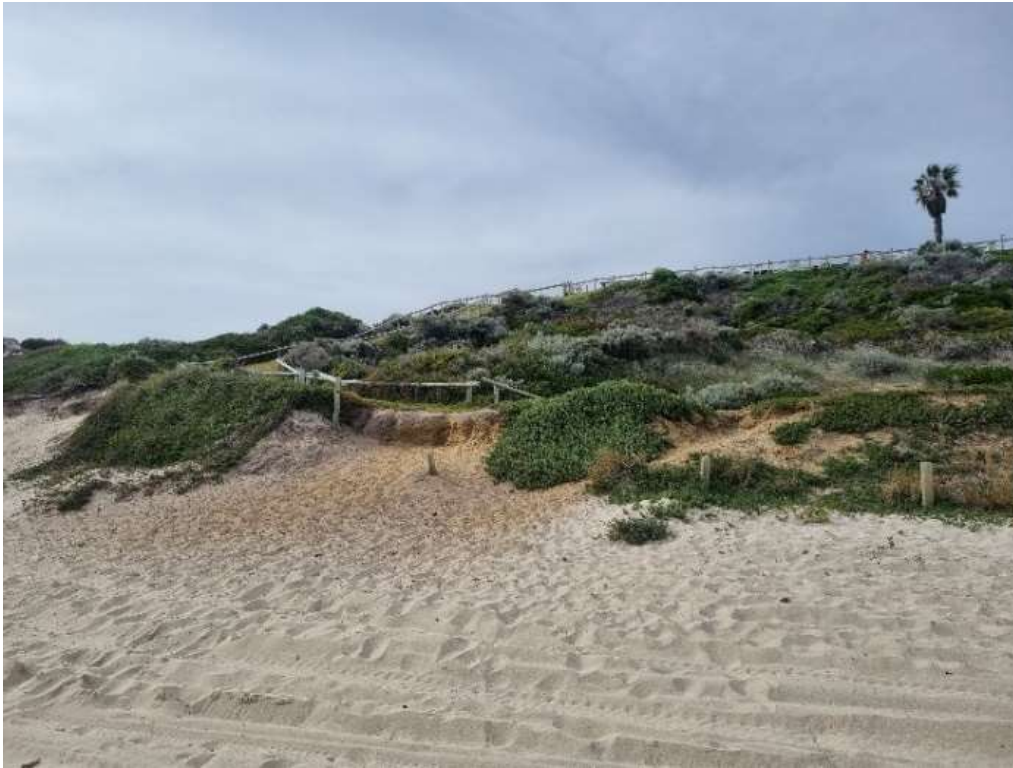
*Figure 3-4: Private pedestrian access down from Seabird Tavern onto beach. Erosion apparent at base of access path. Taken facing east during site visit 20 May 2024.*

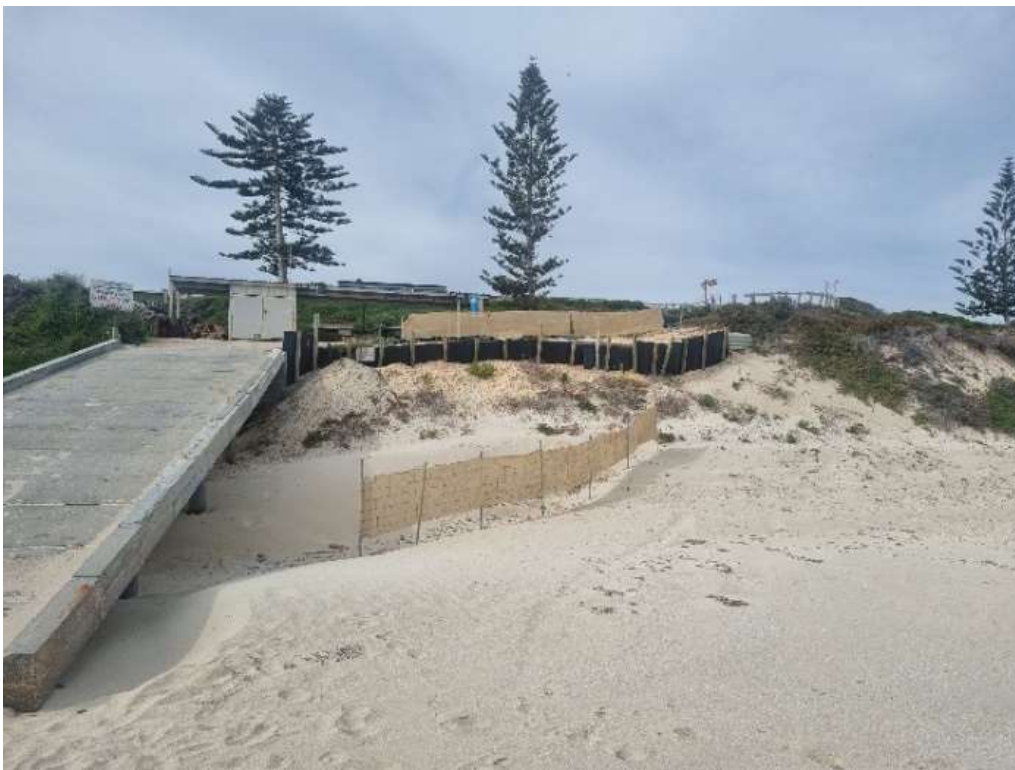
*Figure 3-6: Seabird Private Caravan Park, private access vehicle ramp. Light retaining structure and wind fencing in place to protect road access. Facing east, taken during site visit 20 May 2024.*

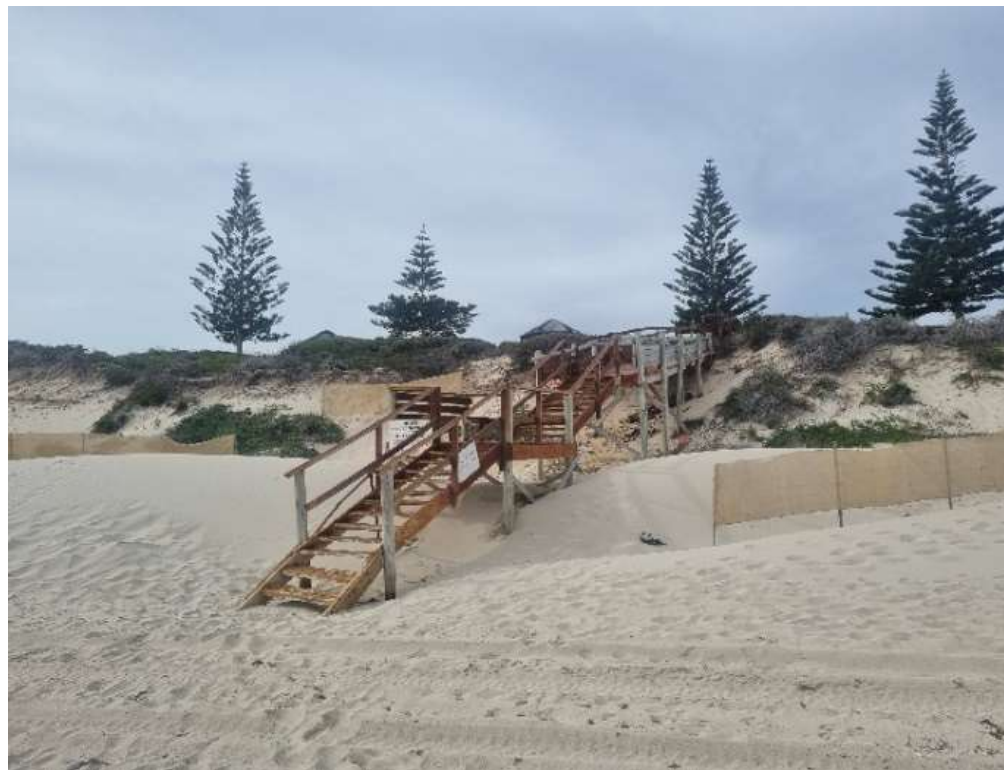
*Figure 3-7: Seabird Private Caravan Park, pedestrian access stairs. Facing northeast, taken during site visit 20 May 2024.*

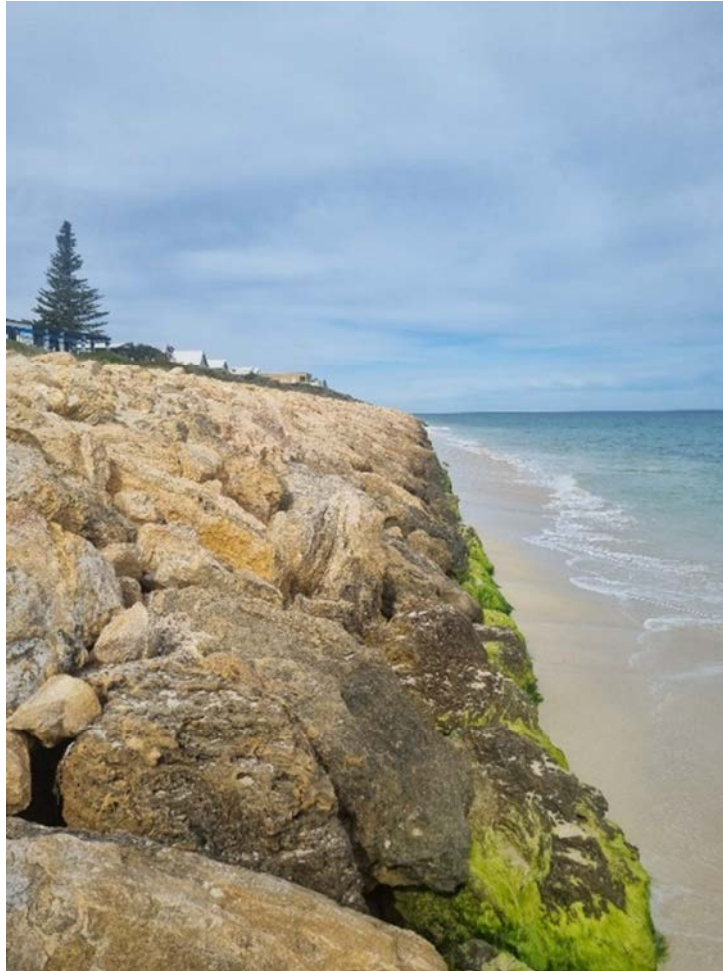
*Figure 3-8: Seawall photo taken facing south, at chainage ~+1000m*

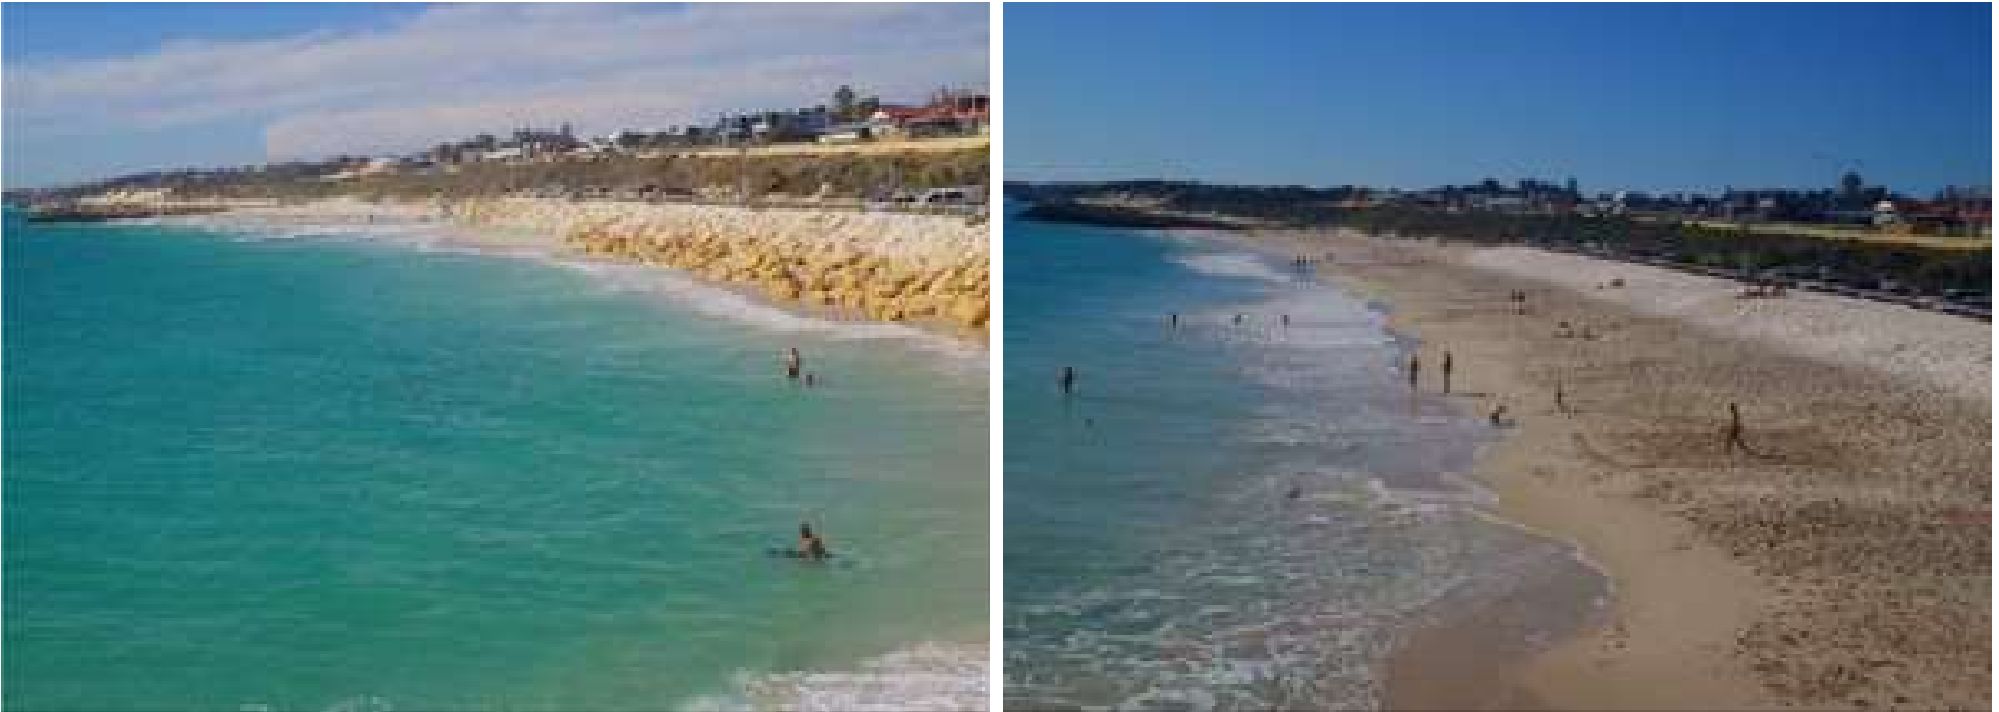
*Figure 4-2: Photos taken from Groyne 1 fixed monitoring camera, looking north towards Section 3 (left) 30 January 2023 (right) 26 August 2023. Images show the extremes of seasonal morphological changes adjacent to the carpark.*

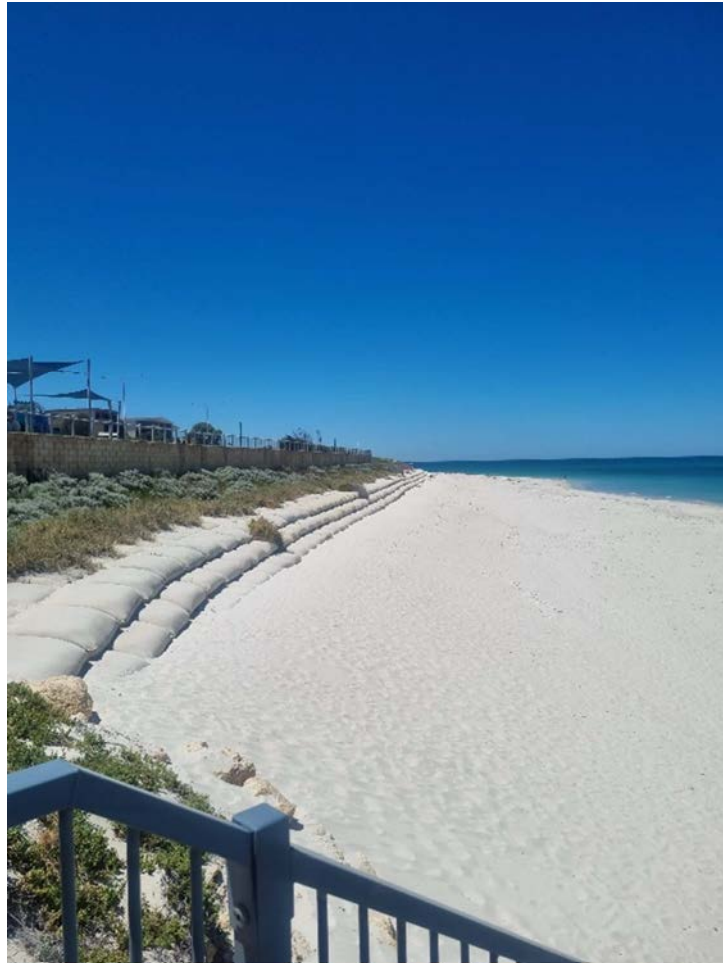
*Figure 4-3: Photo taken south from access stairs at north end of section 2. GSC seawall, with lower tier containers buried, ~50m wide beach buffer (taken 11 December 2023)*

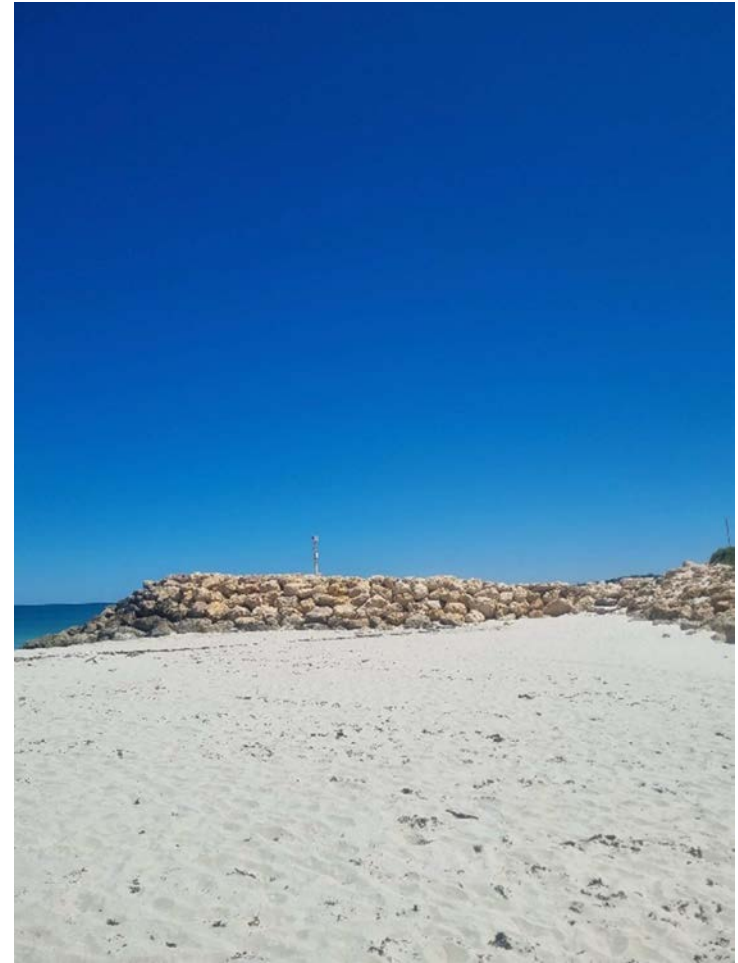
*Figure 4-4: Photo taken north from access stairs, north end of section 2. Groyne 1 shown with ~50m beach width (taken 11 December 2023)*

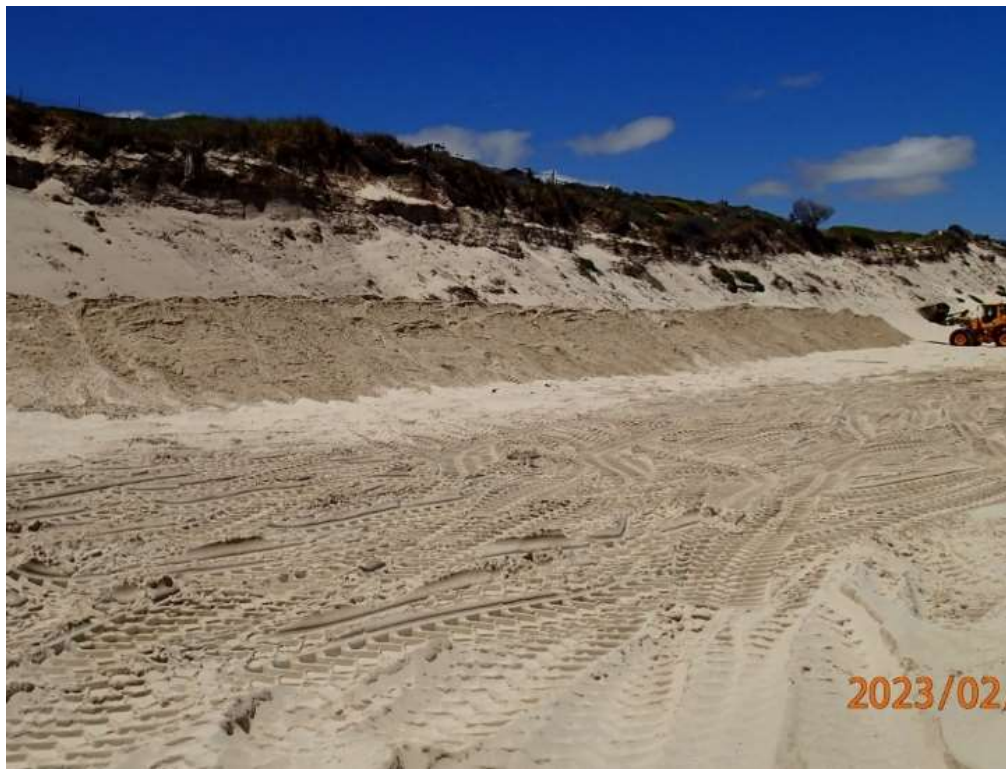
Figure 4-5: Placement of 'scraped' beach sand at base of eroding dune, taken from Groyne 4, facing south (Ellyard, 2023).

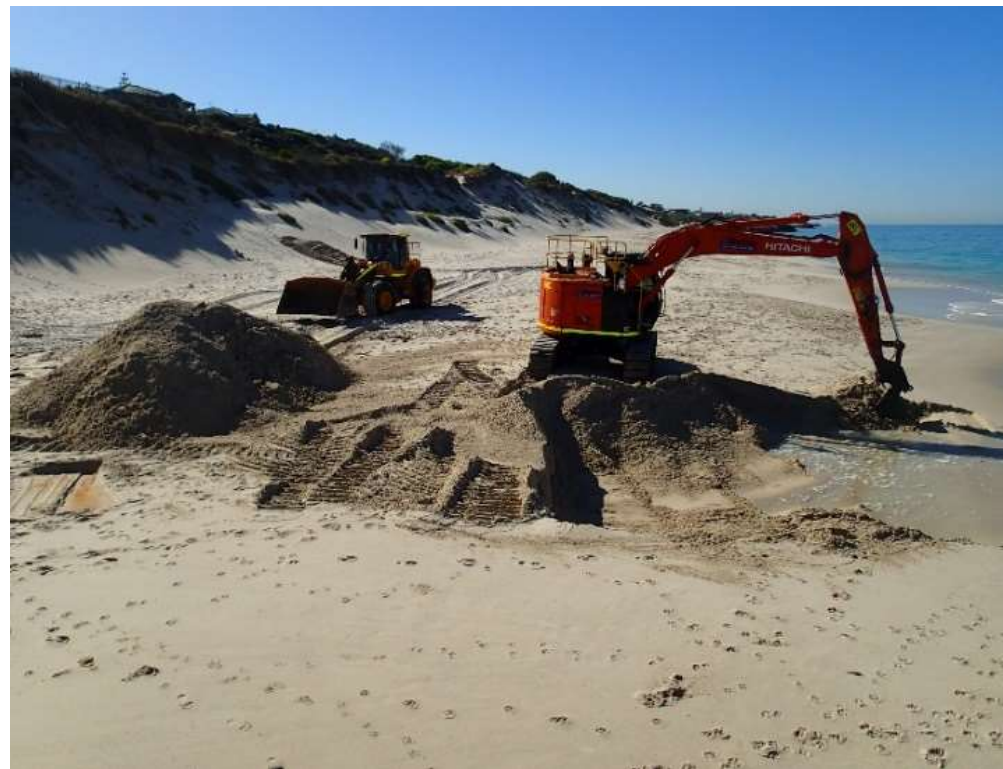
Figure 4-6: 'Scraping' sand from swash zone adjacent to Groyne 4, north end of Section 5, facing south (Ellyard, 2023)

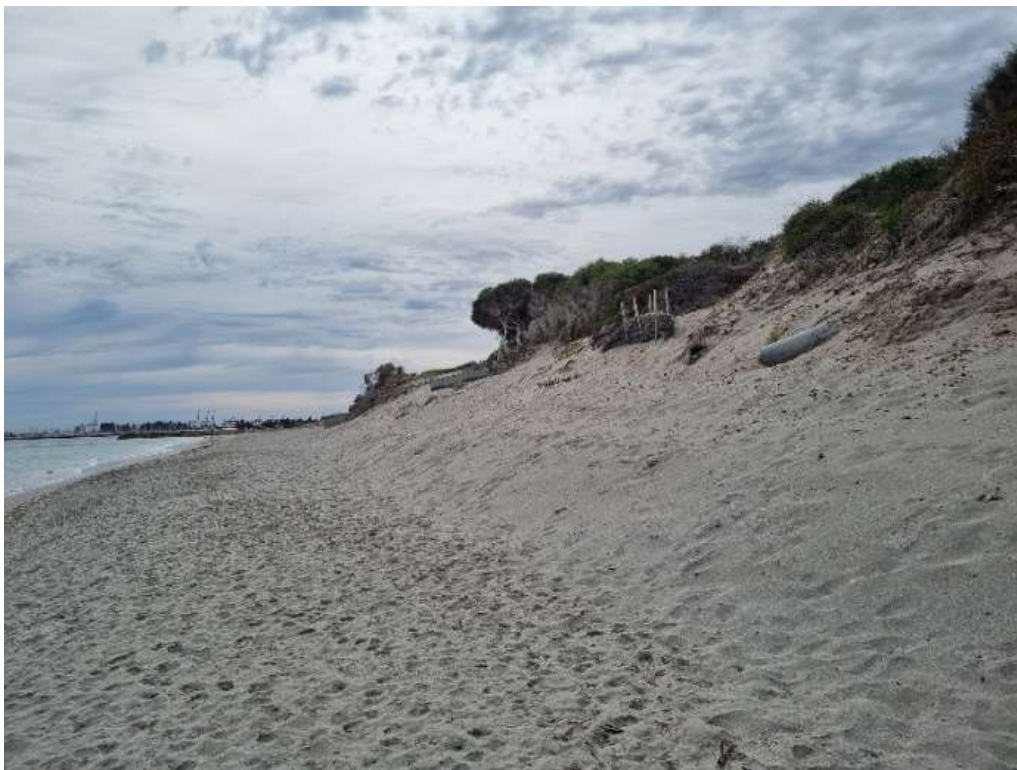
*Figure 5-3: Photo taken of C.Y. O'Connor beach dune/beach profile (north of Catherine Point Groyne), during site visit 9 May 2024*

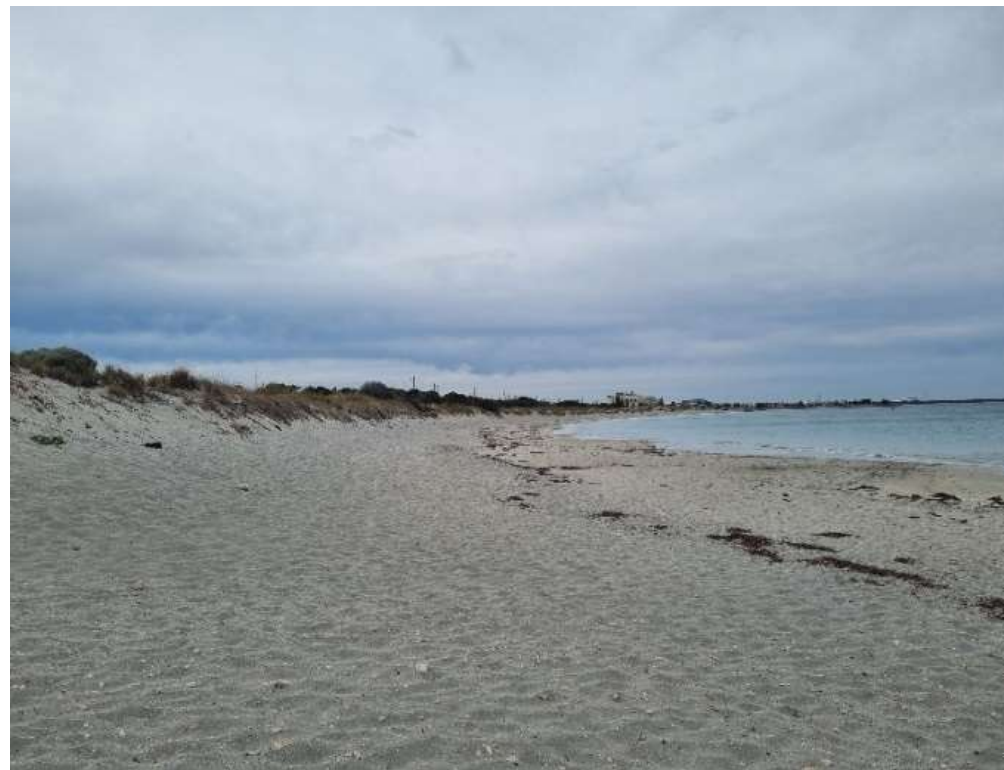
*Figure 5-4: Photo taken of C.Y. O'Connor beach dune/beach profile (south of Catherine Point Groyne), during site visit 9 May 2024*

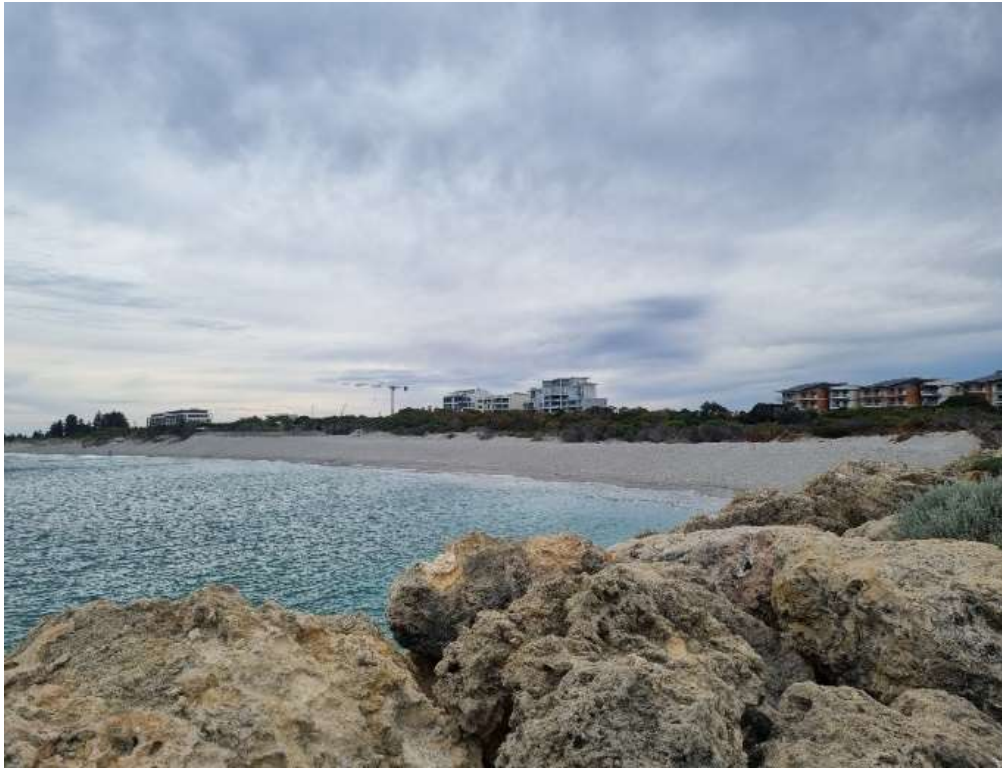
*Figure 5-5: Photo taken of C.Y. O'Connor beach dune/beach profile, looking south from Catherine Point Groyne during site visit 9 May 2024*

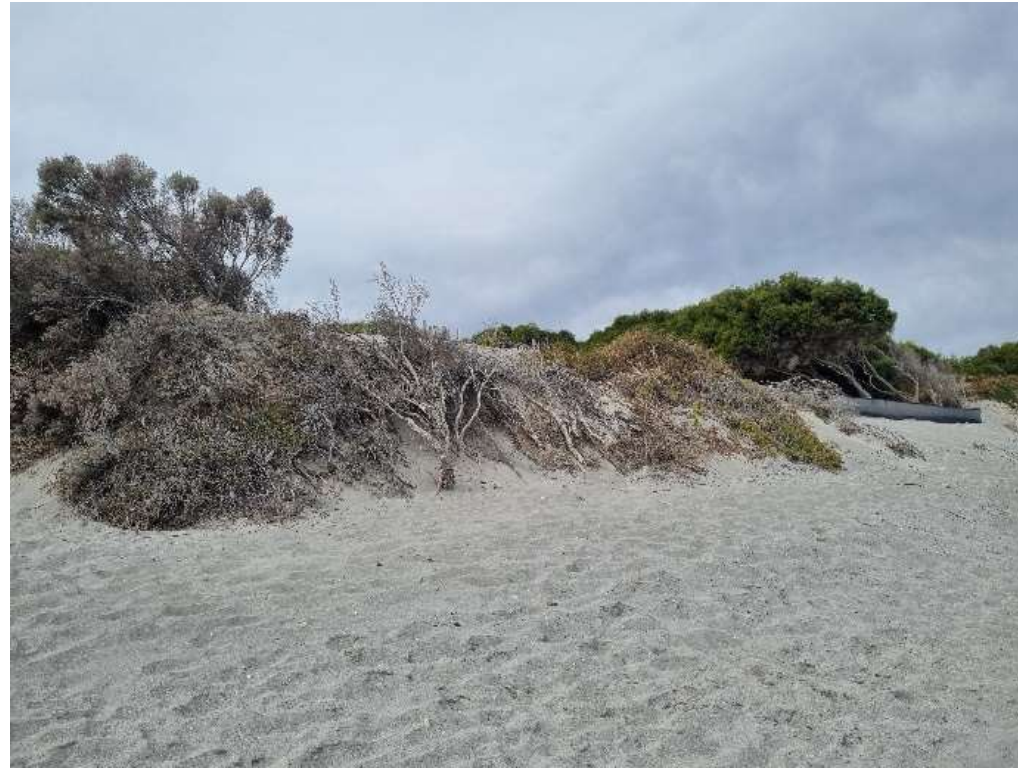
*Figure 5-6: Vegetation on top dunes at C.Y. O'Connor beach (taken during site visit 9 May 2024)*

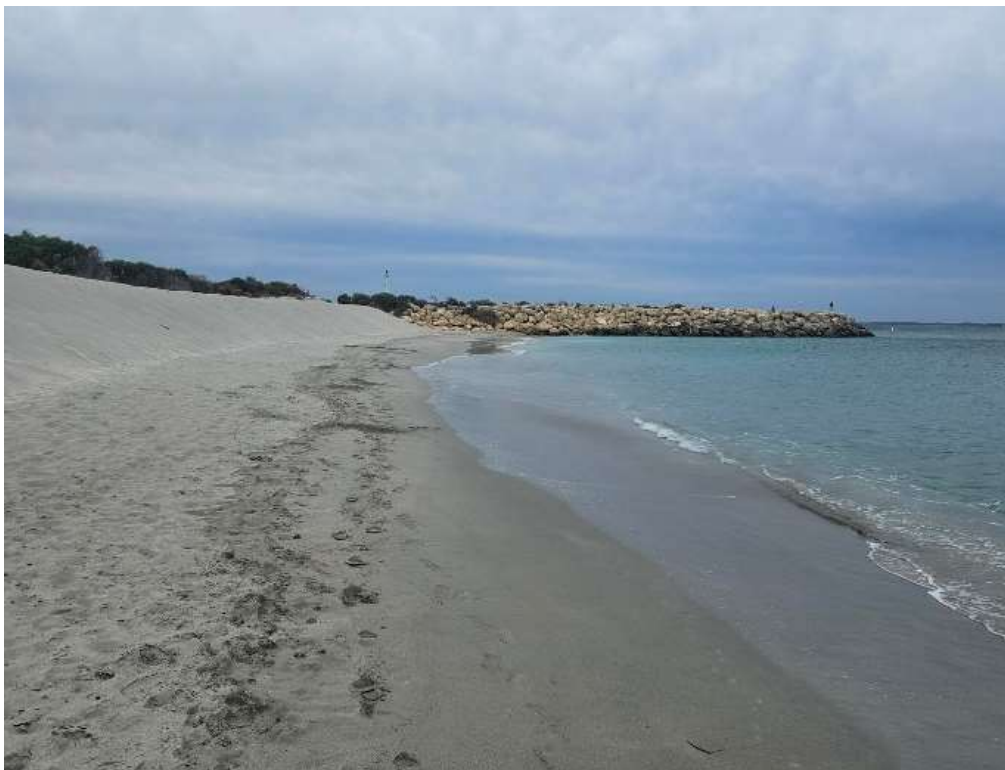
*Figure 5-7: Catherine Point Groyne and beach dune/beach profile, looking south  
(taken during site visit 9 May 2024)*
