# WA Coastal Erosion Hotspots

## Review of Coastal Management History - 12 Sites

Document no. Rev 1: 311012-02081-CS-REP-001

12 June 2025

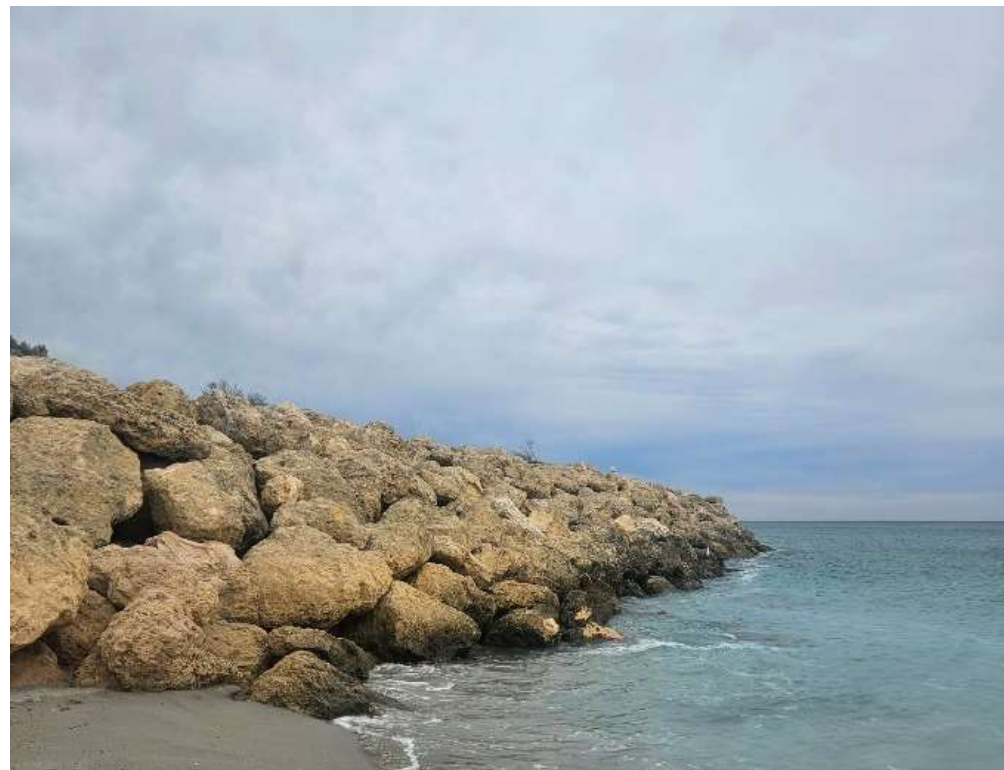
*Figure 5-8: North side of Catherine Point Groyne (taken during site visit 9 May  
2024)*

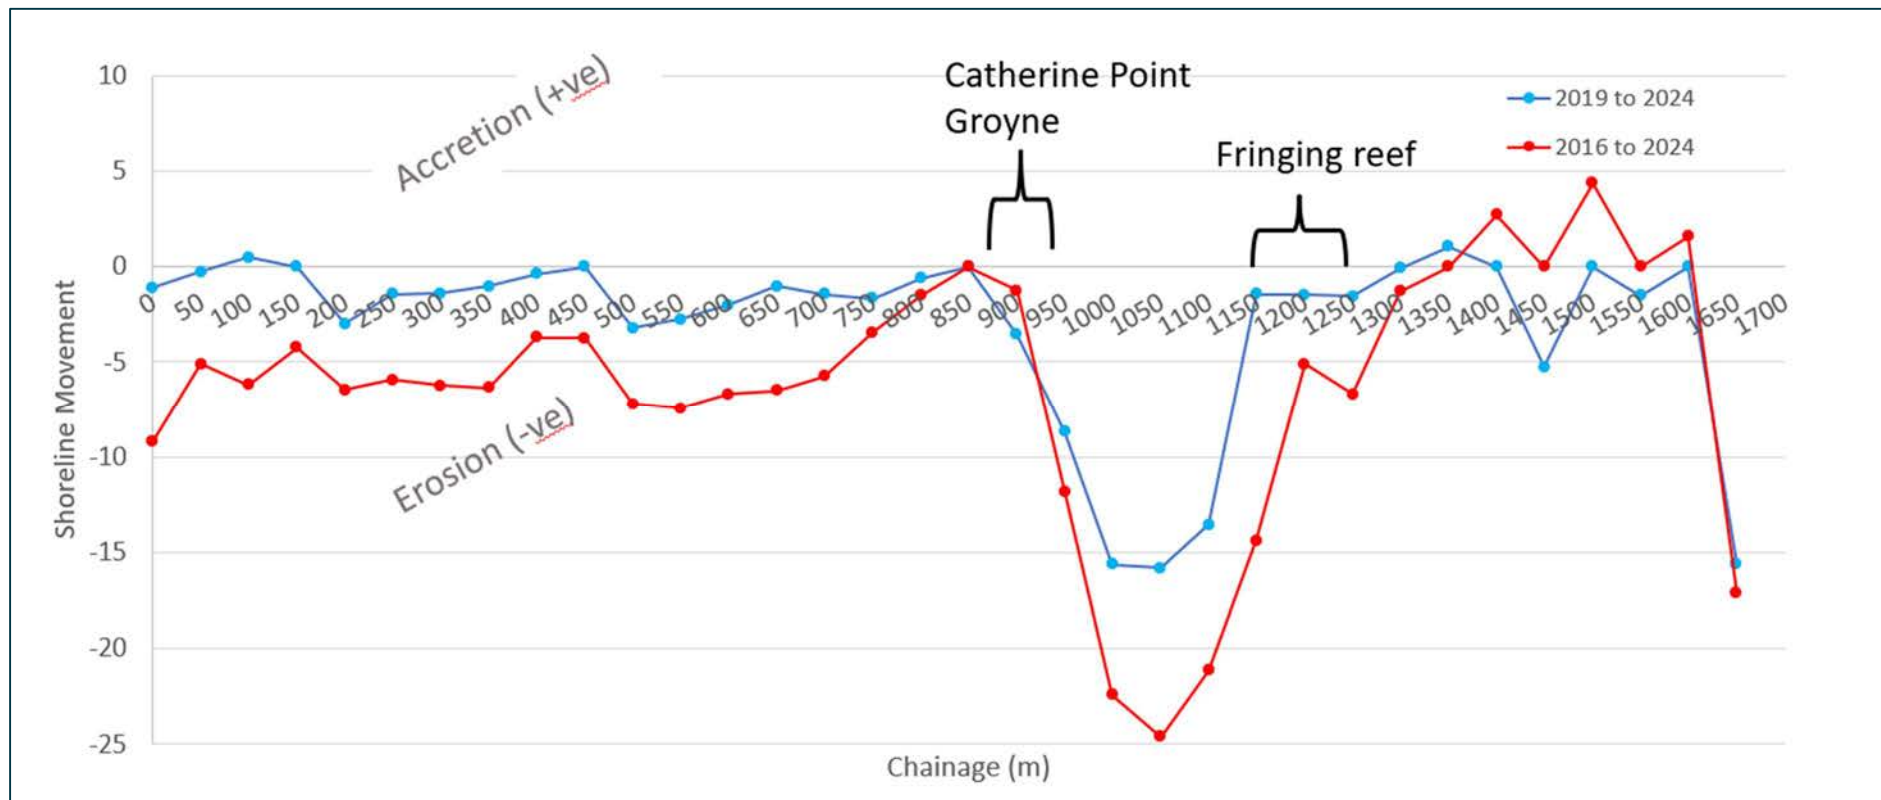
| ID | Category | Content |
|---|---|---|
| 8. | <b>Performance / Effectiveness of coastal management measure/s</b> | <p>Short and mid-term vegetation line mapping has been undertaken using satellite imagery, and beach changes in 50m increments are presented in Figure 5-9.</p> <p><b>South of Catherine Point (+0m to +900m)</b></p> <p>Milder erosion has been observed south of the Catherine Point Groyne. Minor vegetation retreat (up to eight metres) between 2016 to 2024 and (up to three metres) between 2019 to 2024.</p> <p>Milder erosion in the shorter-term analysis suggests that the nourishment being</p> |

| ID | Category | Content |
|---|---|---|
| | | <p>undertaken here is nearly sufficient to keep up with sediment loss from the system here.</p> <p><b>North of Catherine Point (+900m to +1600m)</b></p> <p>Mapping has confirmed that the coastline north of the Catherine Point Groyne has been undergoing erosion (up to 25 m) between 2016 and 2024, with up to 15 m of this erosion occurring between 2019 and 2024. On an annualised rate, the coastline has been receding at similar rates across both periods, up to 3m per year.</p> <p>The most significant erosion has been observed within the 300 m of beach immediately north of the Catherine Point Groyne.</p> <p>Despite the regular nourishment of this beach, erosion is still being observed, with hard structures now being incorporated to reduce direct impacts on adjacent CoC assets.</p> <p>In addition to the analysis above, monitoring undertaken of the beach response to the AFR (UWA, 2024) concluded that the beach response (in the last 2 years) is in a more eroded state than its typical, seasonally averaged position. The report suggested that results at this stage are inconclusive, and longer-term monitoring of the impact of the AFR is required.</p> |

Figure 5-9: Results of C Y O'Connor beach shoreline changes, showing short and mid-term changes, for chainage reference refer to Figure 5-1

| ID | Category | Content |
|---|---|---|
| 9. | Recommendations & lessons learnt | <p><b>Coastal monitoring</b></p> <ul style="list-style-type: none"> <li>It is recommended that shoreline monitoring continues adjacent to the AFR and the GSC seawalls to understand the impacts that the reef is having on adjacent beach. Surveyed transects and laser scanning (undertaken on a three-to-six-month basis) will assist to determine volume of sand being retained within the sub-aerial beach and ascertain long-term trends in net longshore sediment transport rates and directions.</li> <li>Cockburn Cement have been undertaking coastal monitoring of wave conditions, and shoreline monitoring associated with their approval to dredge offshore of this site. It is recommended that access to this data is requested by DoT/CoC in order to avoid duplication of coastal monitoring efforts.</li> </ul> <p><b>Coastal management actions</b></p> <ul style="list-style-type: none"> <li>Back-passing activities are recommended to continue (both north and south of Catherine Point) although sand available will continue to decline in years to come. Significant consideration should be given to impacts on downstream beaches, (north of Island Road groyne, and south of Port Coogee marina) prior to removing sand. Increased nourishment (from external sources) is recommended in the short term to avoid recession of the shoreline indicated by vegetation line mapping.</li> <li>Infrastructure development has put pressure on the buffer of dune between the beach and footpath north of Catherine point. CoC should consider relocating the path to eastern side of the recreational area to increase coastal buffer.</li> </ul> <p><b>Coastal investigation</b></p> <ul style="list-style-type: none"> <li>Recommend investigation into offshore sand supply options to supplement the diminishing feed of sand onshore from Success Bank. This could use indirect methods (placing dredge spoil offshore in future dredging campaigns in the region) or directly placing material into the nearshore zone using rainbowing methods similar those recently trialled in March 2023 at Port Beach in North Fremantle.</li> <li>Alternative nourishment sources from outside of the sediment cell should be investigated to supplement the diminishing feed of sand from Success Bank.</li> <li>Any modifications to Catherine Point Groyne should be investigated in detailed studies. Coastal realignment following modifications to it could lead to significant loss of dune, and infrastructure located within the Rollinson Road recreational area.</li> </ul> <p><b>Coastal adaptation design</b></p> <ul style="list-style-type: none"> <li>Infrastructure development has put pressure on the buffer of dune between the beach and footpath north of Catherine point. CoC should consider relocating the path to eastern side of the recreational area to increase coastal buffer.</li> </ul> |

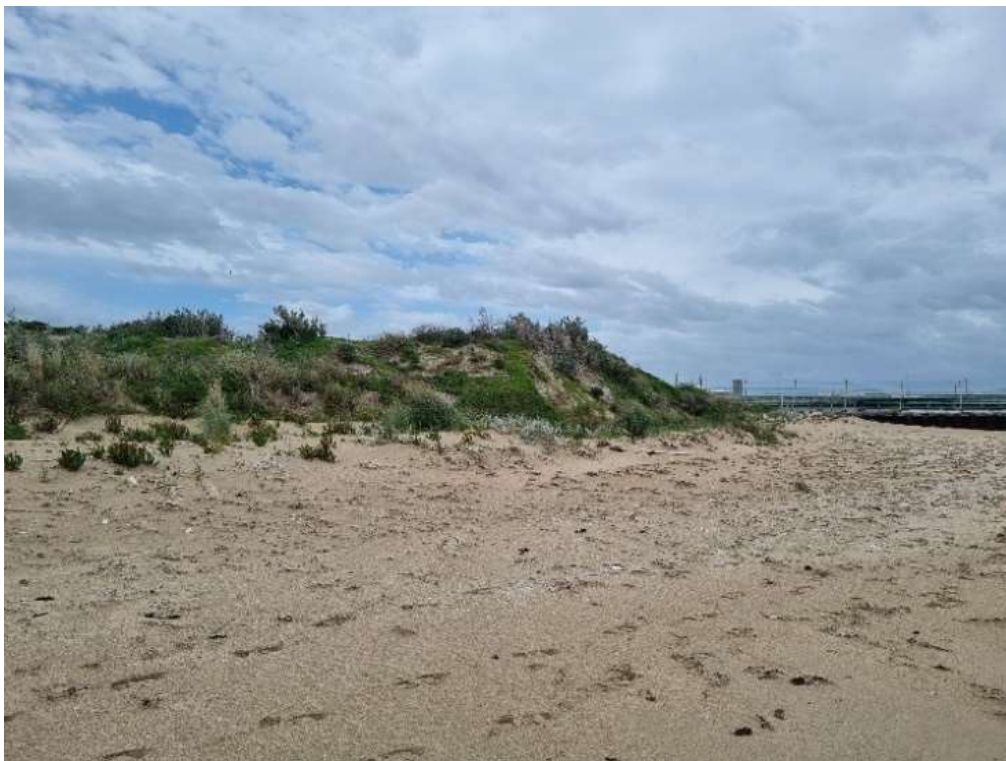
*Figure 6-1: Photo taken of dune immediately north of BP flume (+2300m) taken during site visit 20 May 2024.*

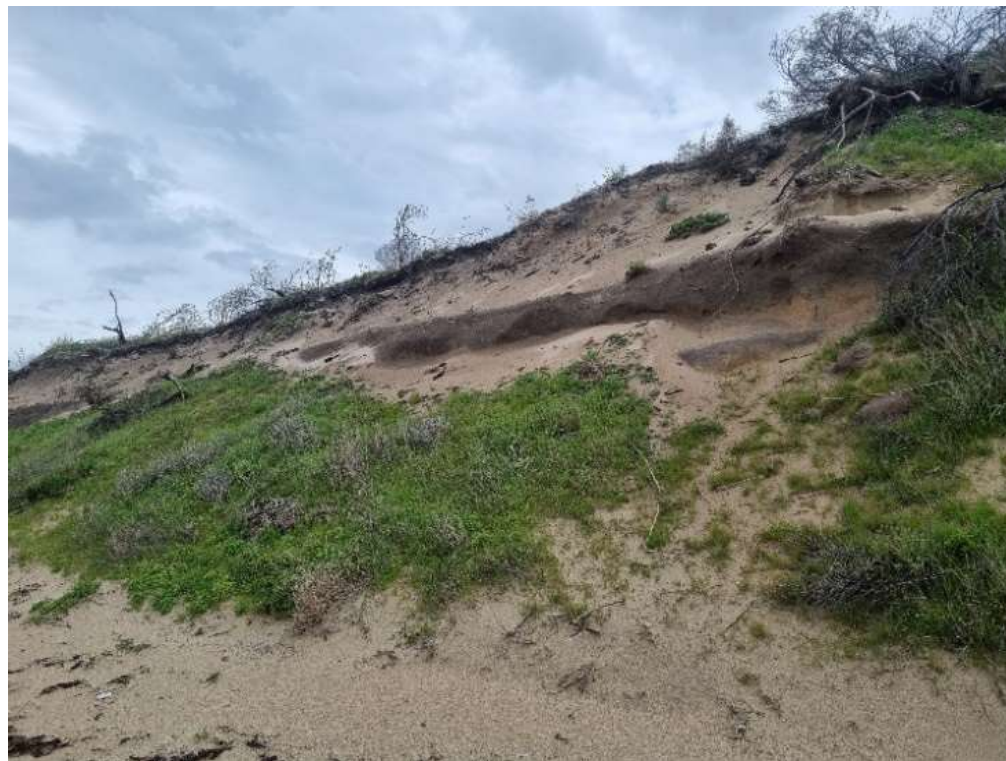
*Figure 6-2 :Coastal scarping and natural revegetation (+2600m) along the BP coastline, taken during site visit 14 August 2024*

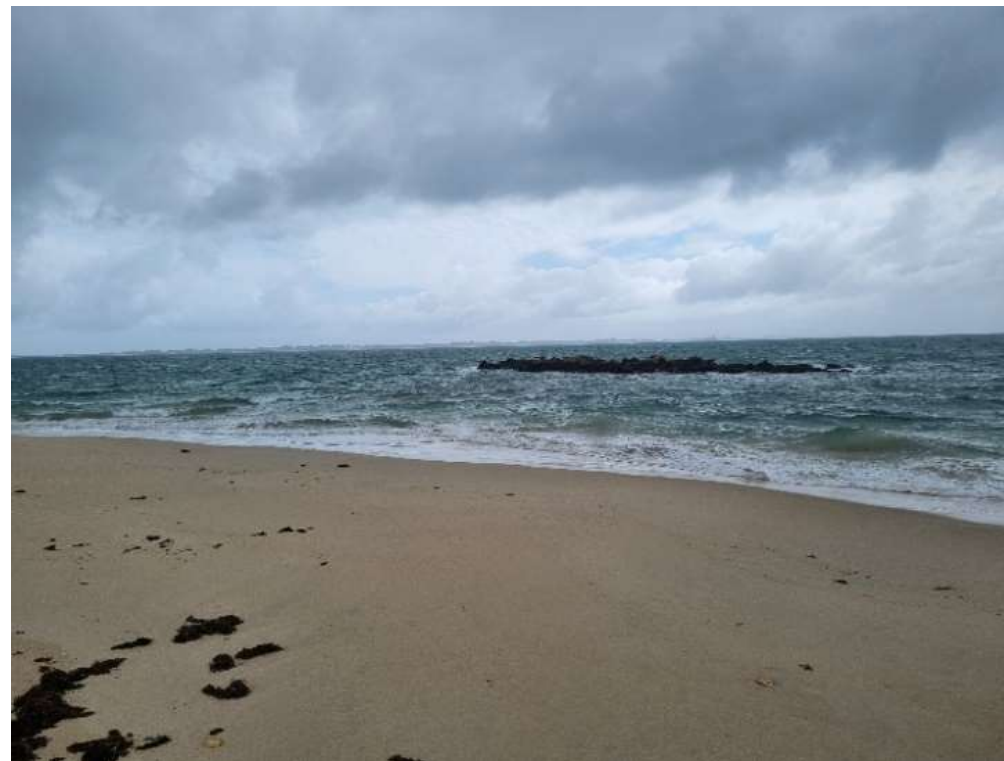
*Figure 6-6: Artificial headland five (chainage +3075m) with submerged salient, taken during site visit 14 August 2024.*

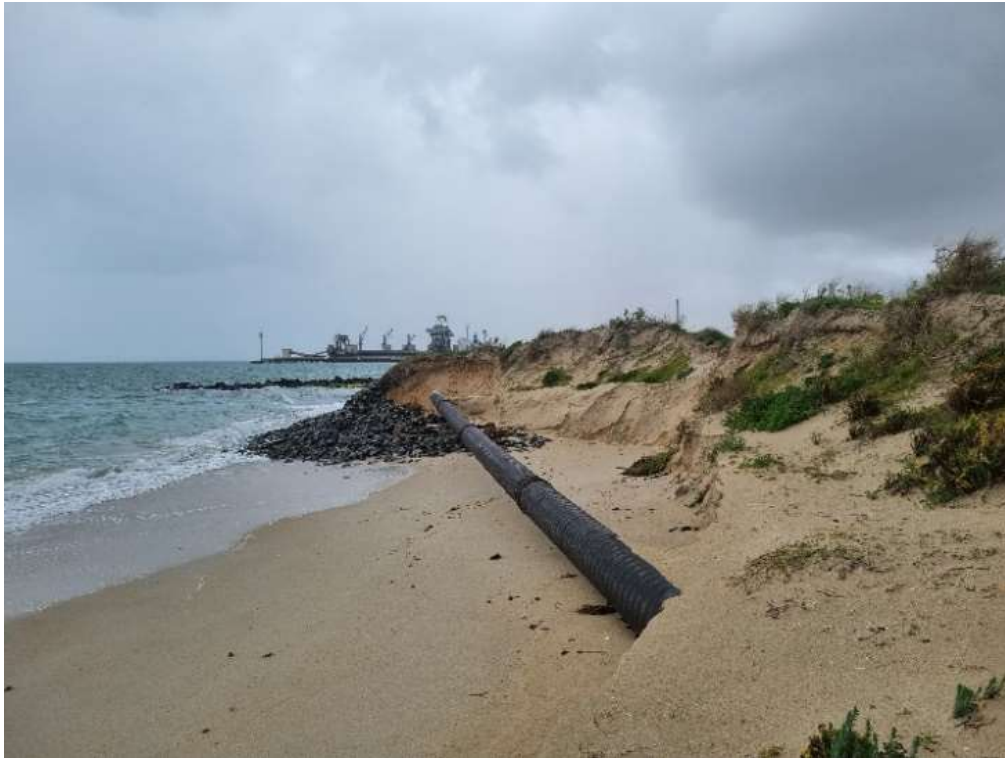
*Figure 6-7: BP refinery storm water outfall, and informal armouring (chainage +3200) taken facing north during site visit 14 August 2024.*

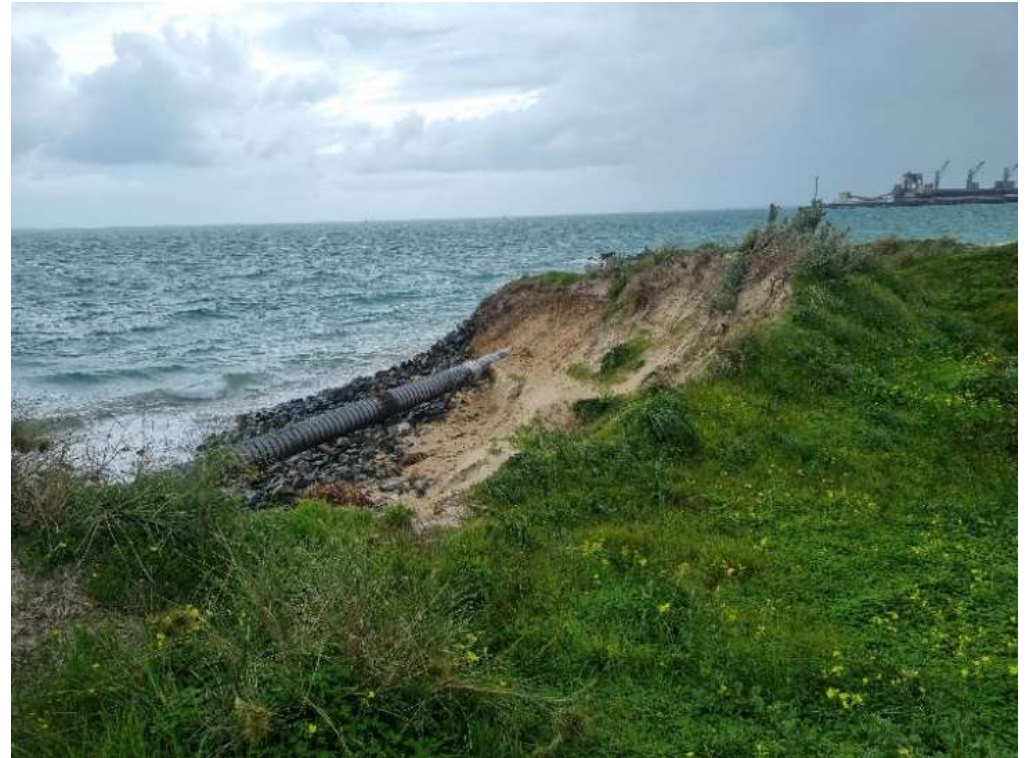
*Figure 6-8: BP refinery storm water outfall, and scarping above (chainage +3250) taken facing northwest during site visit 14 August 2024.*

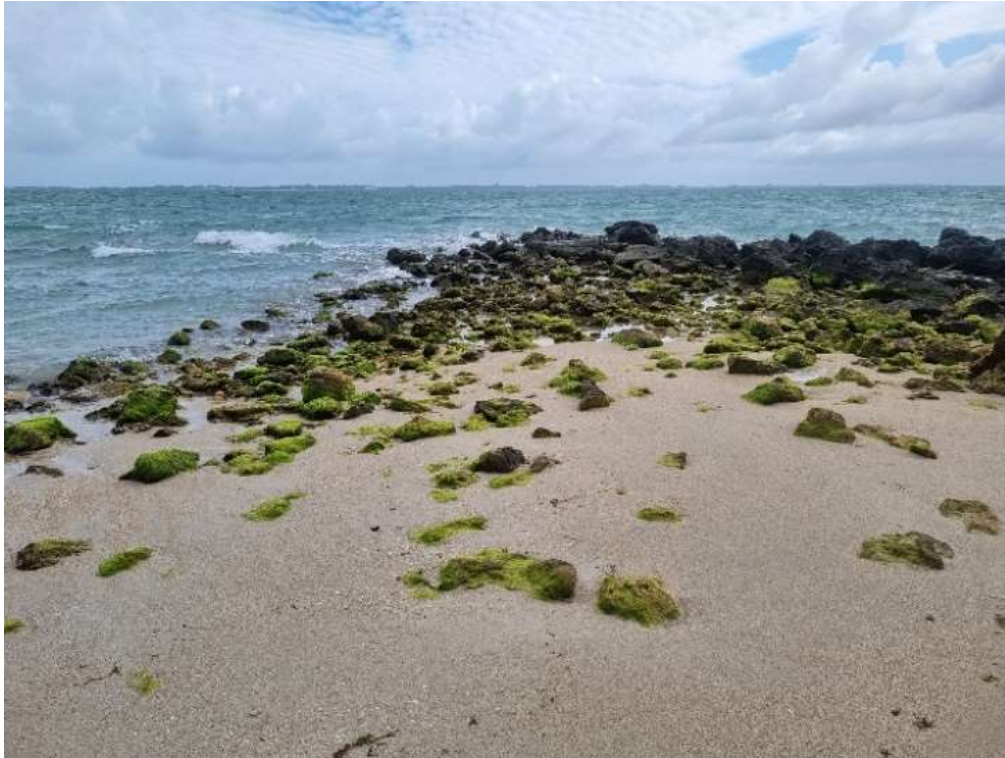
*Figure 6-9: Artificial headland six (+3275m) with scattered armour, taken facing west during site visit 14 August 2024.*

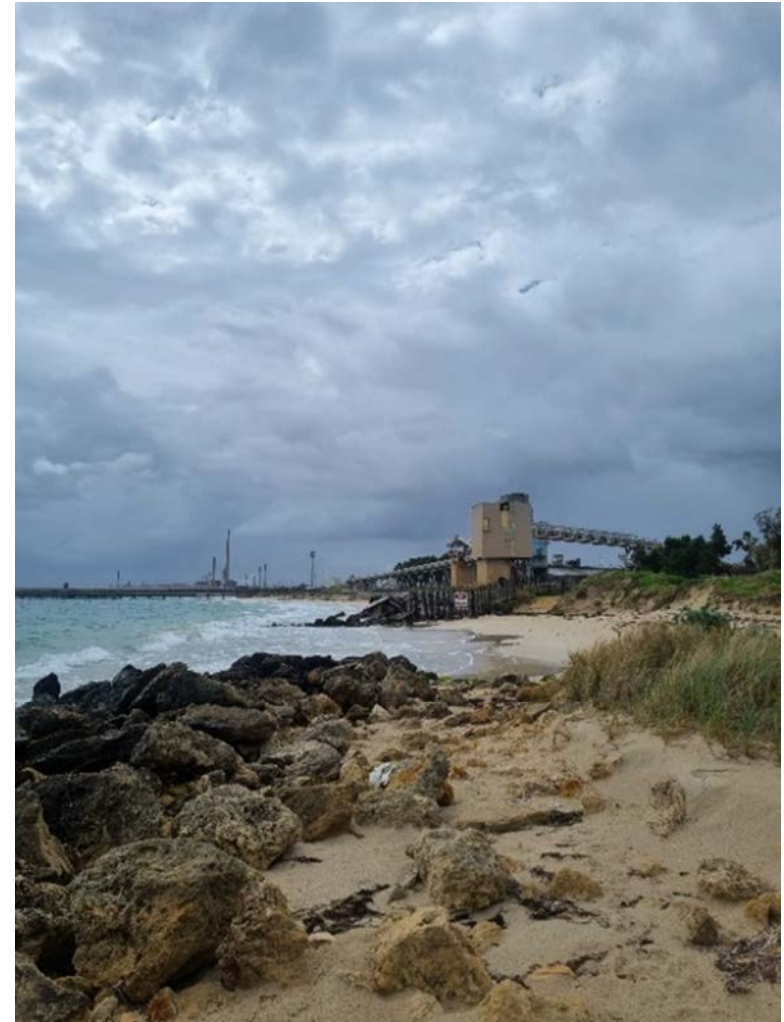
*Figure 6-10: Artificial headland seven (+3400m) taken facing north during site visit 14 August 2024.*

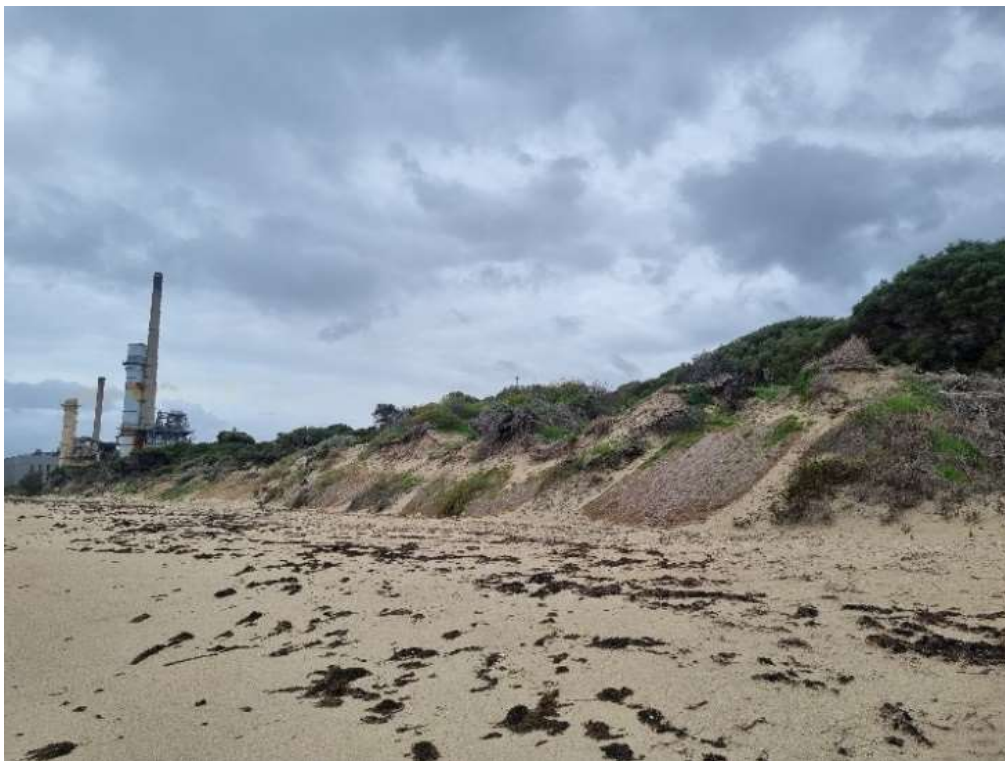
*Figure 6-11: Jute matting stabilisation installed adjacent to WaterCorp desalination site (Barter Rd), taken during site visit 14 August 2024.*

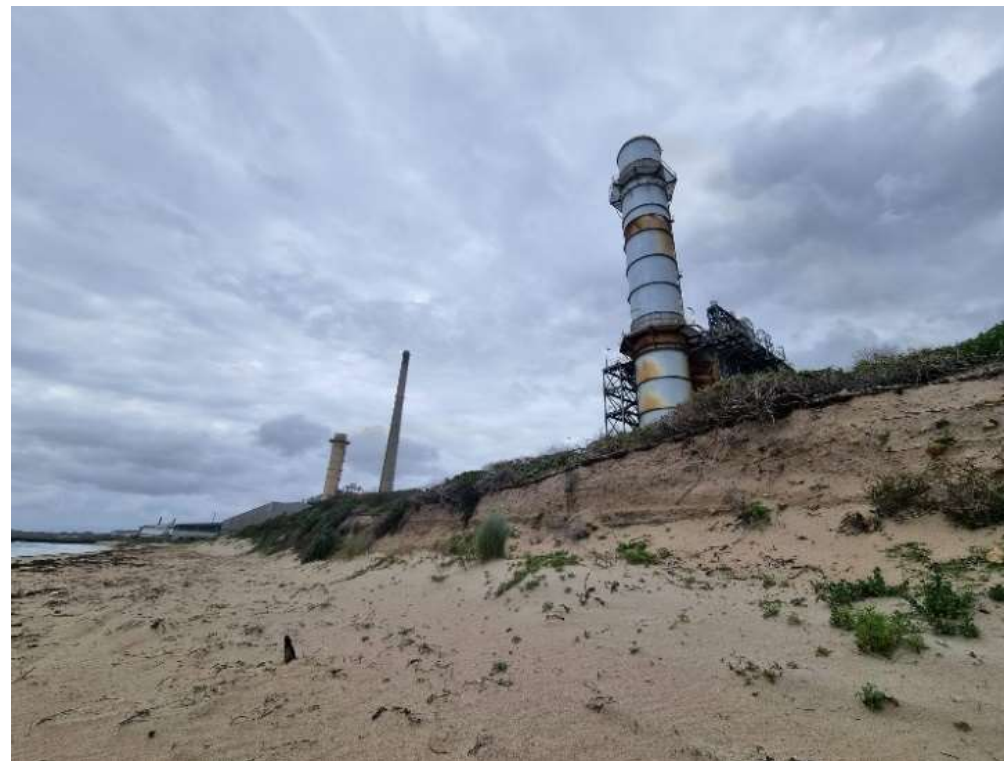
*Figure 6-12: Scarping along dune face adjacent to NewGen power station (chainage +taken during site visit 14 August 2024.*

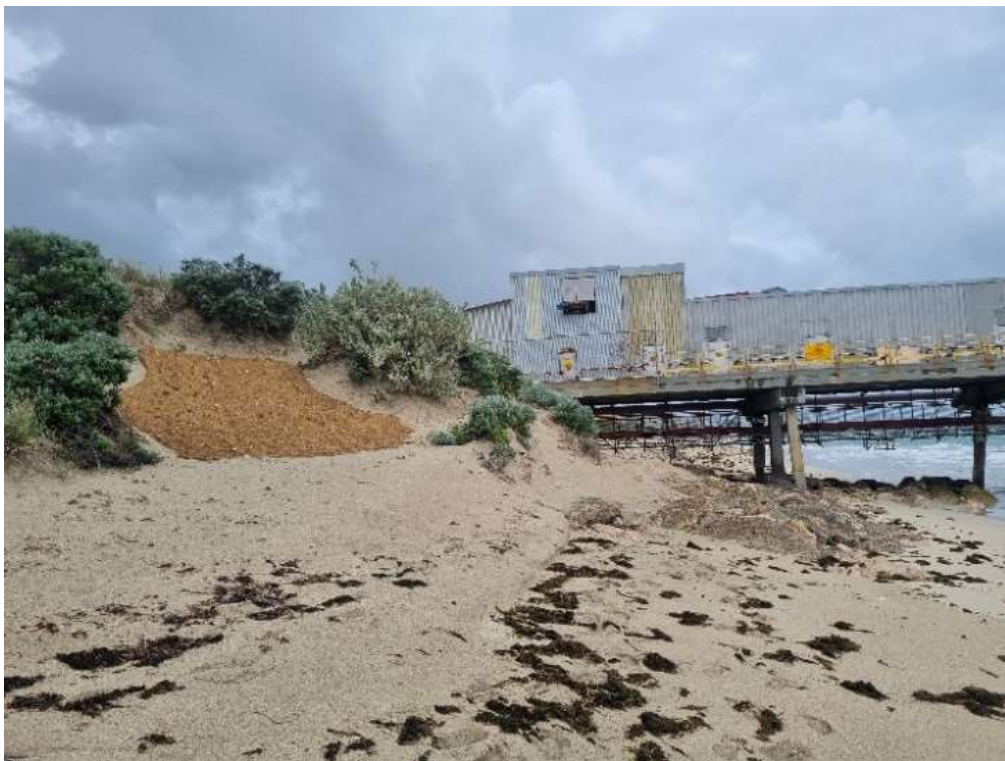
*Figure 6-13: Jute matting stabilisation installed directly north of Alcoa Jetty, taken during site visit 14 August 2024.*

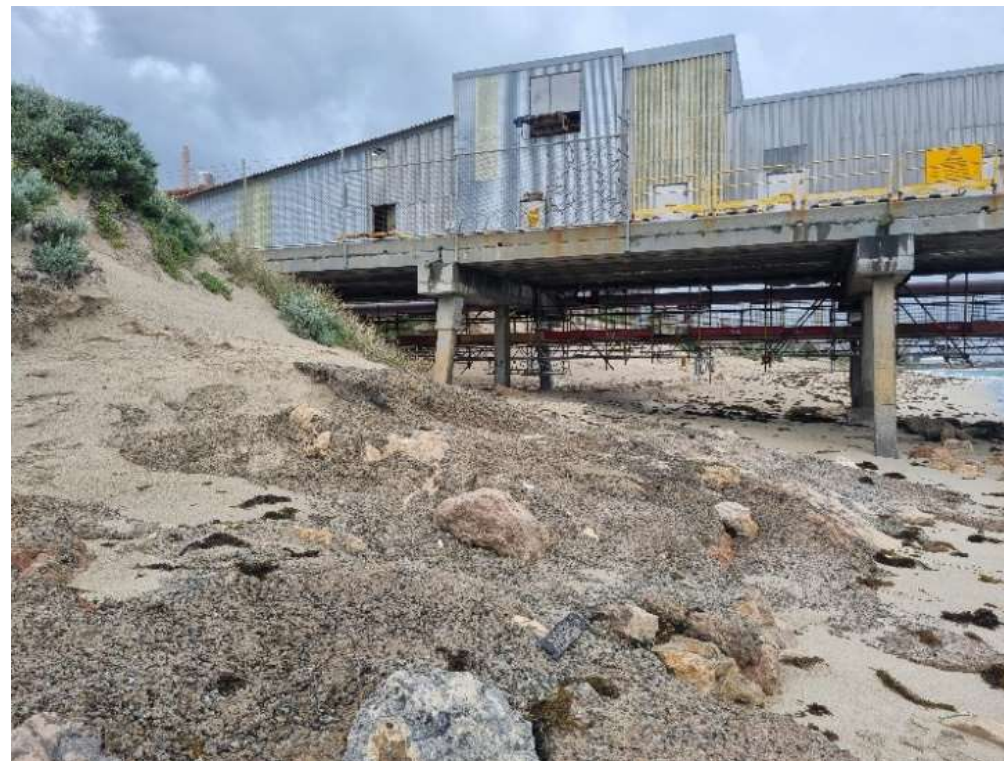
*Figure 6-14: Cement stabilisation of beach directly north of Alcoa Jetty, taken during site visit 14 August 2024.*

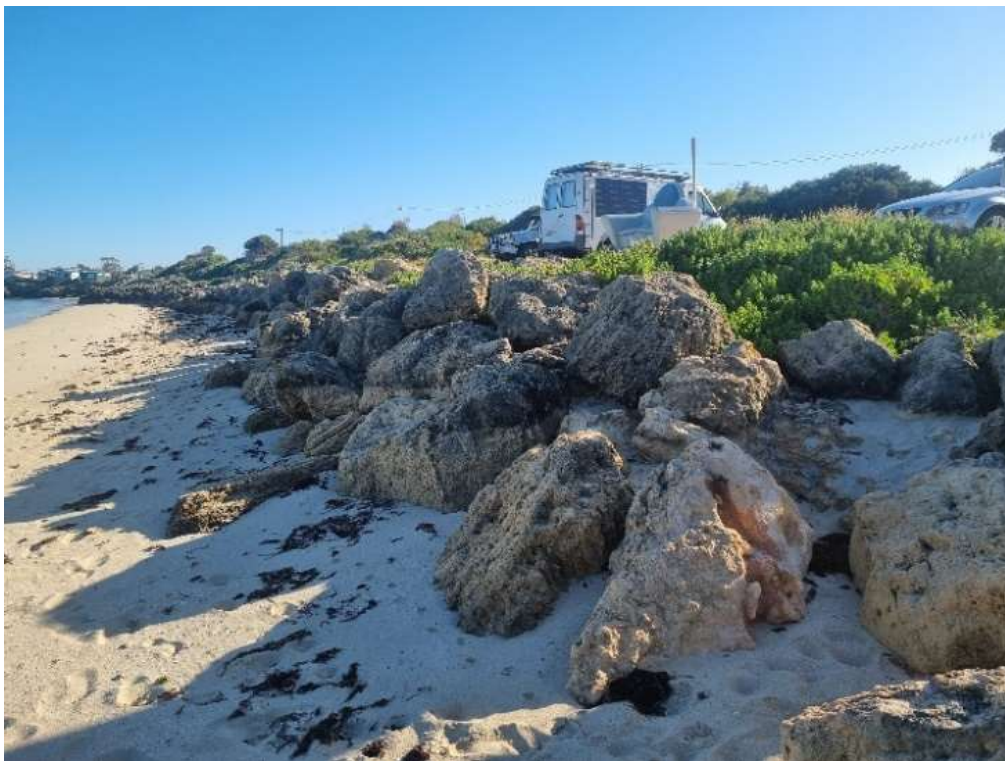
*Figure 6-15: Southern end of Navy shacks rubble mound revetment, taken facing north during site visit 25 October 2024.*

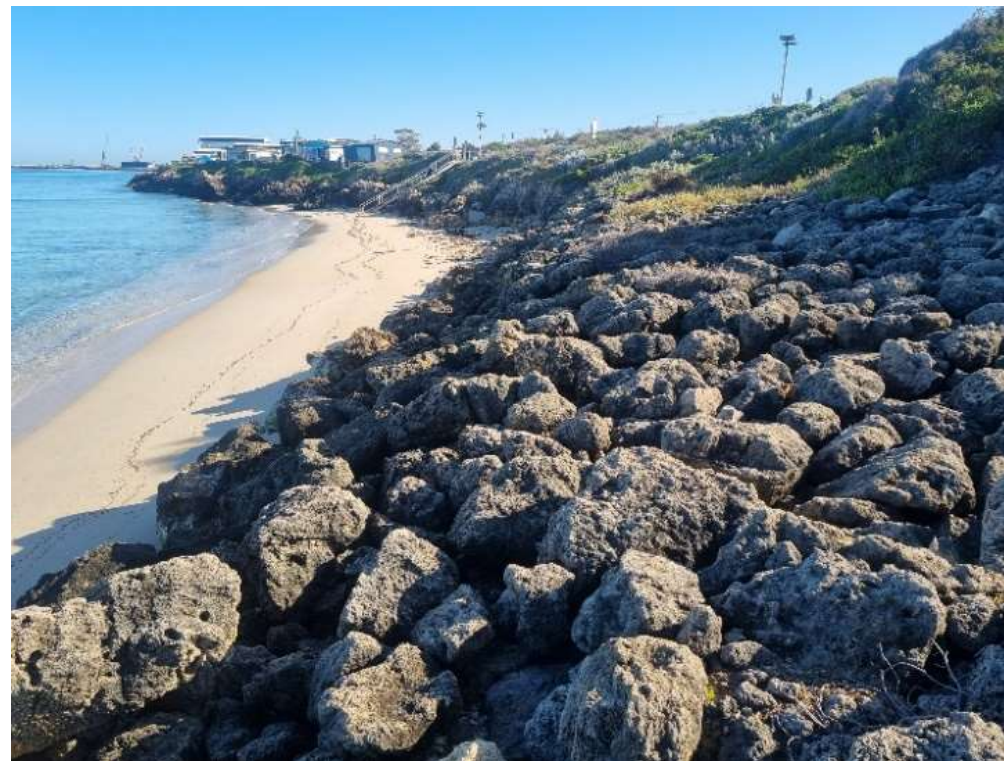
*Figure 6-16: Northern end of Navy shacks rubble mound revetment, taken facing north during site visit 25 October 2024.*

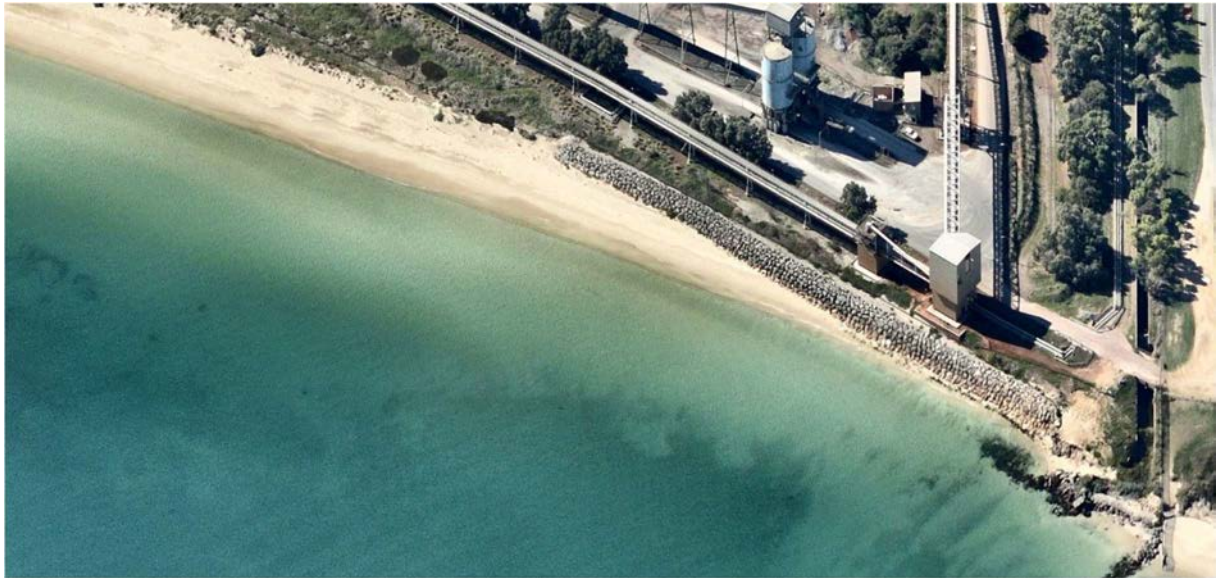
*Figure 6-17: Oblique imagery of seawall adjacent to KBT conveyors. Nearmap imagery captured 29 April 2023.*

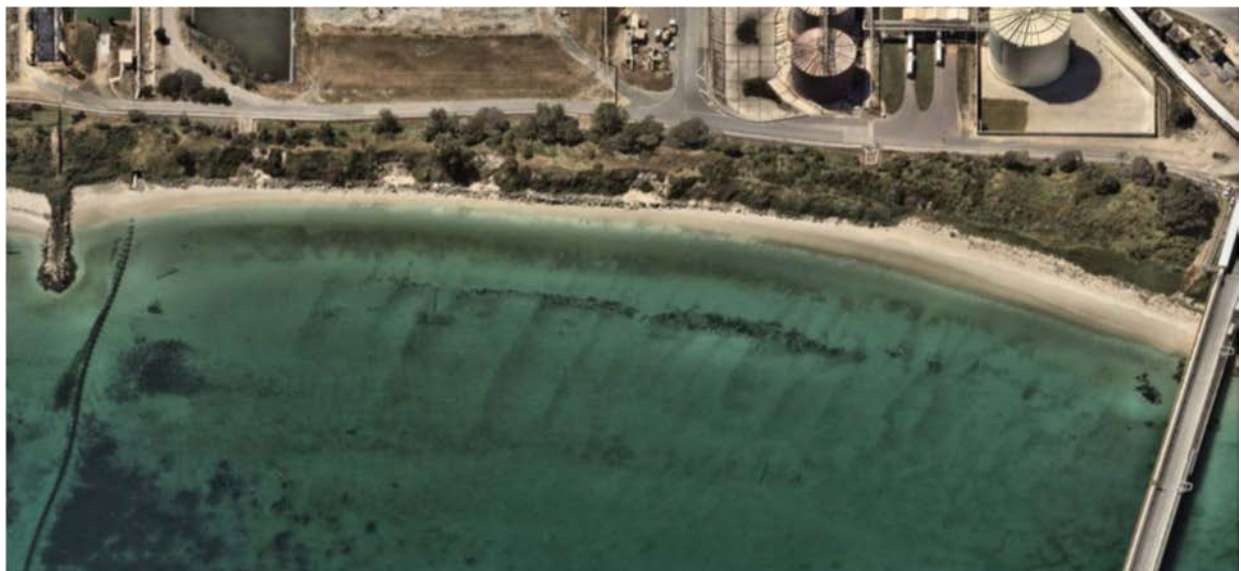
*Figure 6-18: Oblique imagery of seawall adjacent to CSBP export/import pipelines to KBJ. Nearmap imagery captured 14 September 2024*

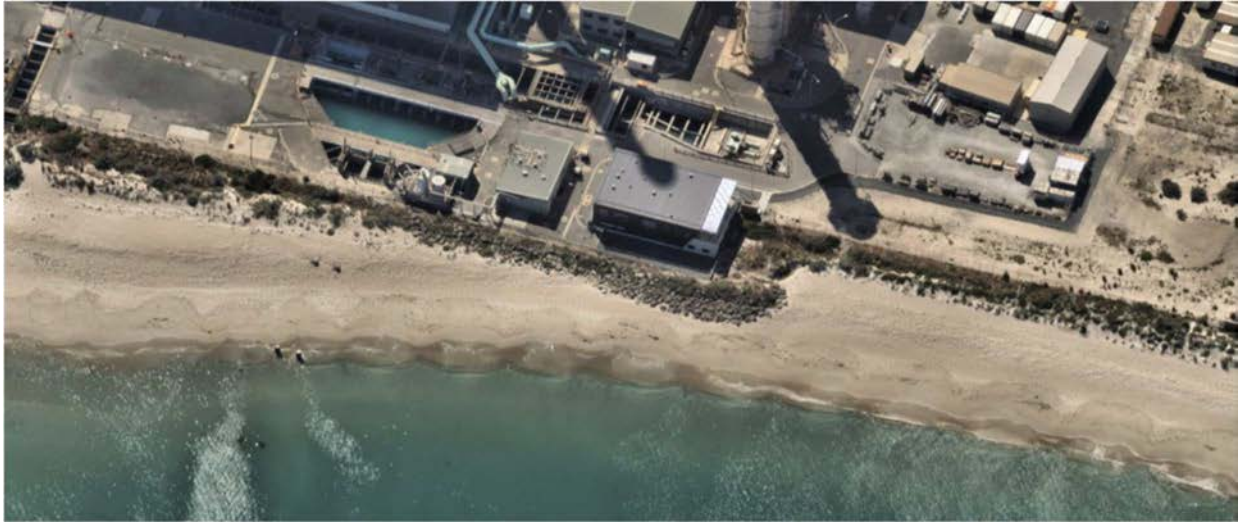
*Figure 6-19: Oblique imagery of seawall adjacent to Synergy office and Kwinana Power Station.  
Nearmap imagery captured 15 October 2023.*

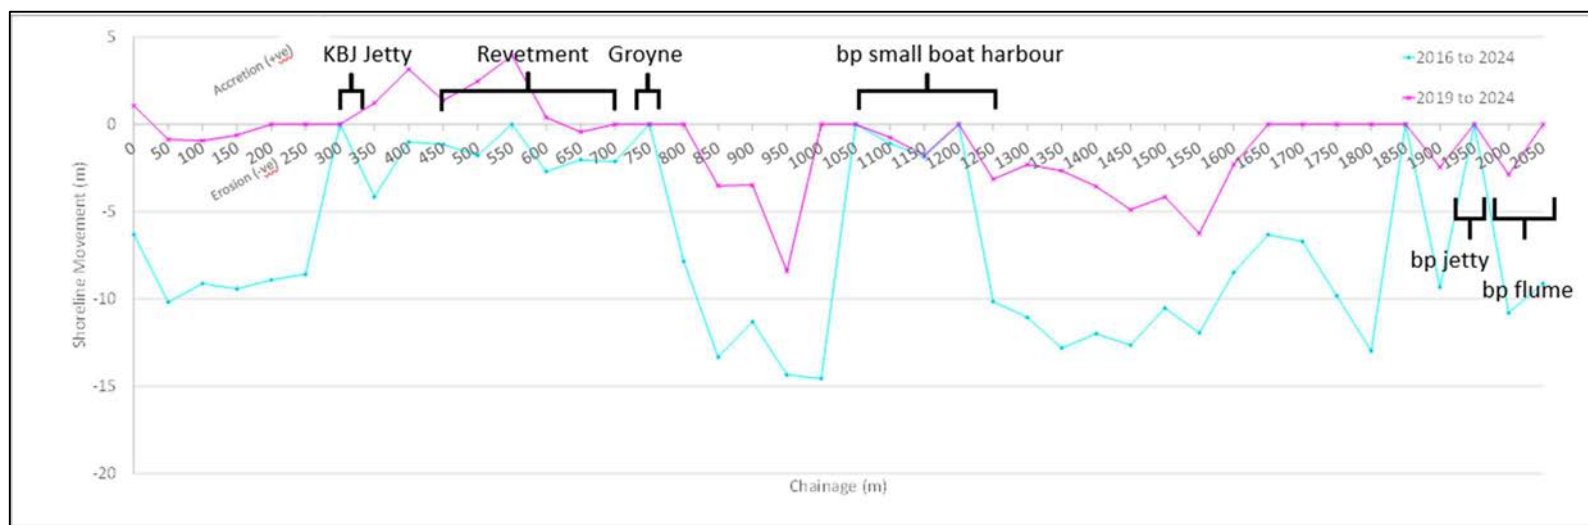
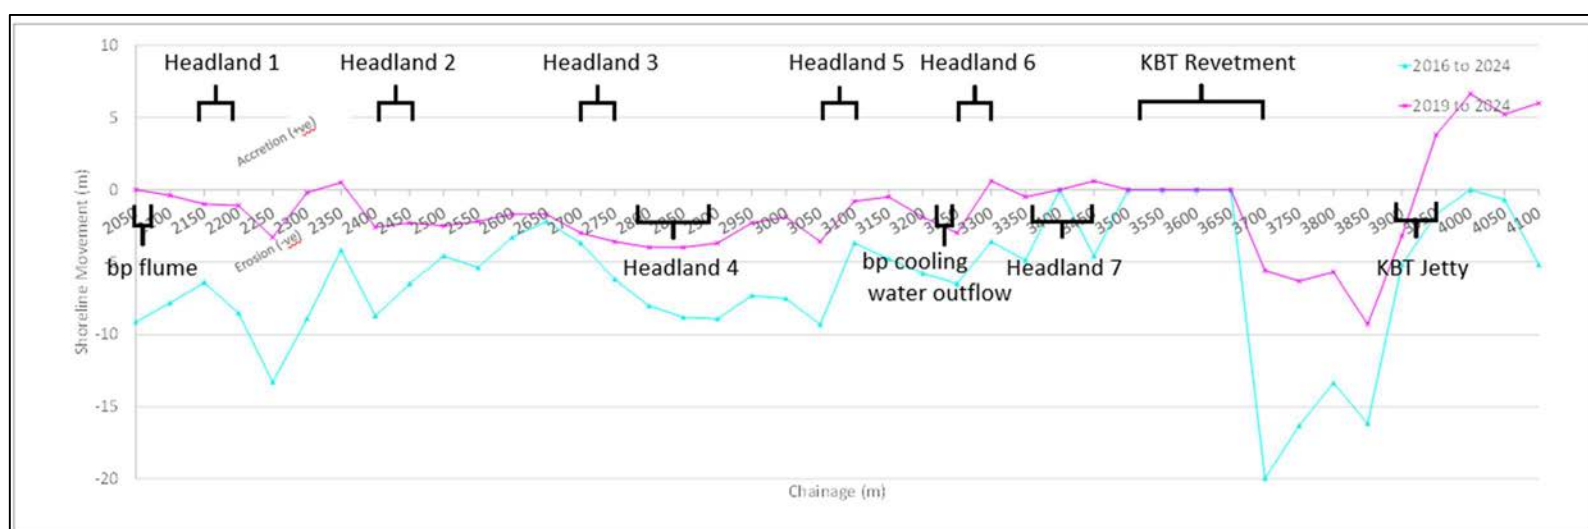
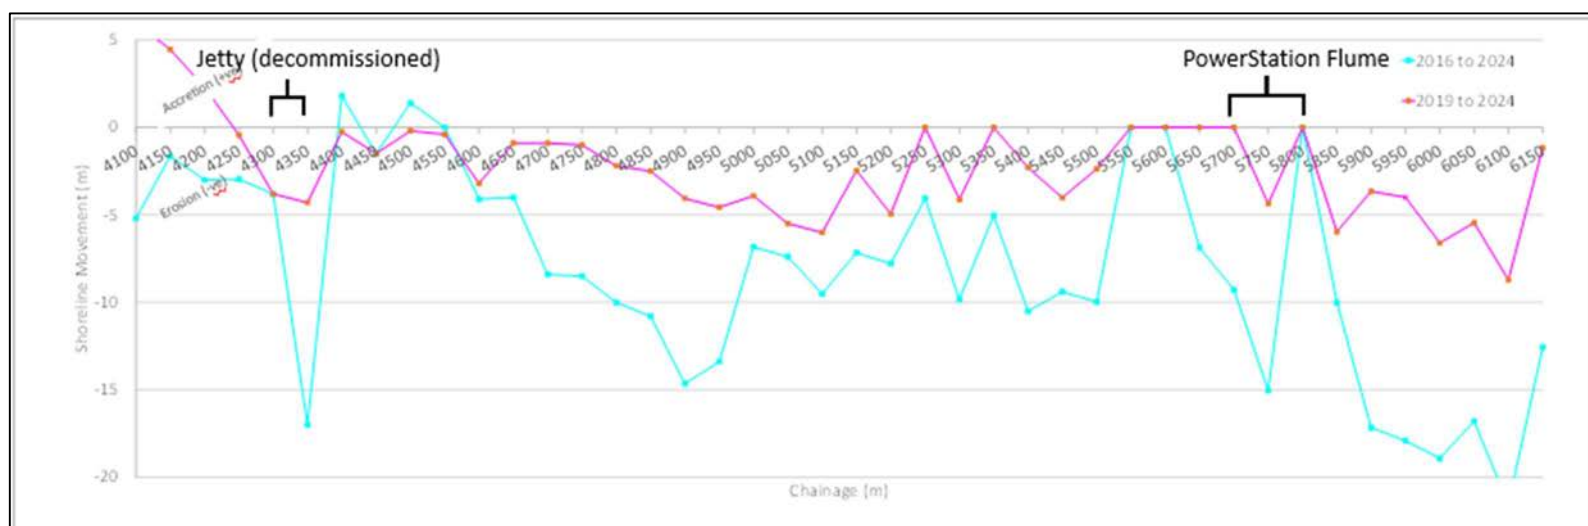
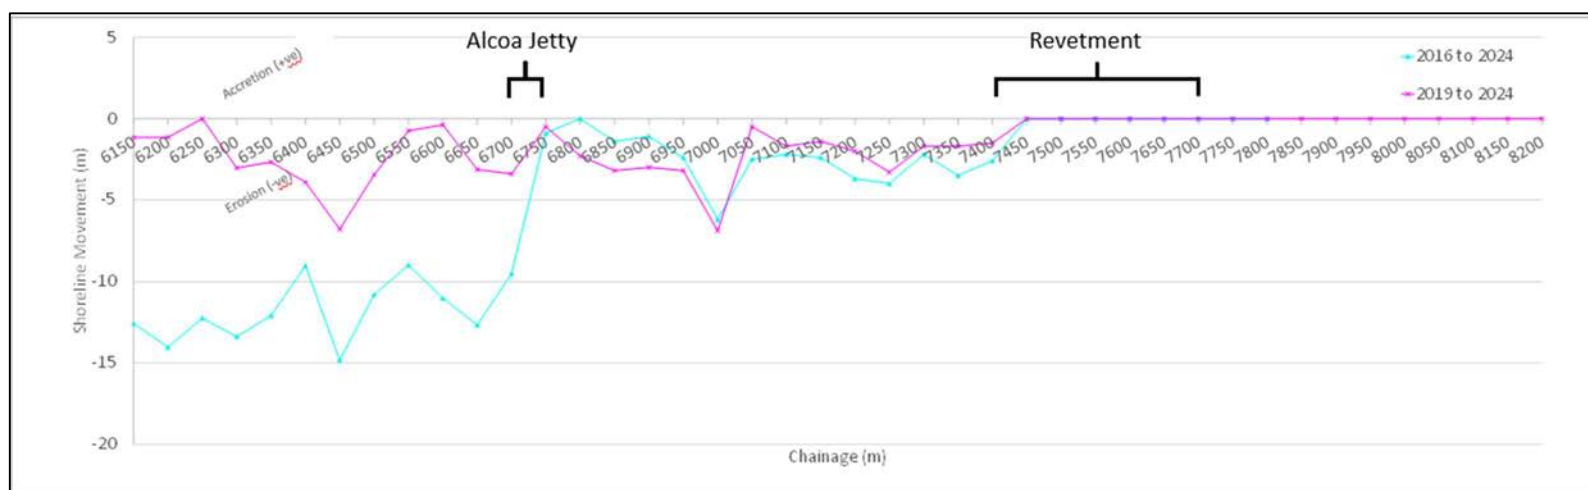
| ID | Category | Content |
|---|---|---|
| 8. | <b>Performance/<br/>Effectiveness of<br/>coastal management<br/>measure/s</b> | <p>Mid and short-term shoreline mapping has been undertaken using satellite imagery, and beach changes in 50 m increments are presented in Figure 6-23.</p> <p><b>North Wells Park to bp small boat harbour (+0m to +1000m)</b></p> <p>Mid-term shoreline mapping indicates that this stretch of coastline has been undergoing erosion (up to 15 m) between 2016 and 2024. The most significant erosion occurs within the 300 m immediately south of the bp small boat harbour. This is equivalent to two metres per year.</p> <p>Short-term shoreline mapping between 2019 and 2024, indicates that the overall erosion trend has slowed in more recent years, with widespread minor erosion up to one metre per year.</p> <p>Aerial imagery analysis has indicated scarping immediately behind the KBJ revetment, suggesting this structure has either been overtopped or run-off drainage has led to slope failure behind the structure. This is of particular concern, as it appears to be protecting pipeline infrastructure less than five to ten metres adjacent. This revetment was not inspected during the site visit.</p> <p><b>bp Waterfront (+1000m to +3500m)</b></p> <p>Mid-term shoreline mapping indicates that this stretch of coastline has been undergoing erosion (up to 13 m) between 2016 and 2024. The most significant erosion occurs within the 500 m immediately north of the redundant bp flume. This is equivalent to two metres per year.</p> <p>Short-term shoreline mapping between 2019 and 2024, indicates a slightly reduced trend of erosion equivalent to one metre per year along the same stretch of coastline.</p> <p>The seven artificial headlands appear to influence the variability of the historical shoreline adjacent. Specifically, immediately north of headlands five and six, and south of headland three indicate signs of stability. All seven headlands continue to support the tombolo/salient morphology in their lee, and hence are considered functional despite poor structural assessments (collapsed slopes, and lack of any interlocking) during the site visit (14/08/2024).</p> <p>Salt water discharge at the bp cooling water outflow (+3225m) ceased in September 2021. Analysis of aerial imagery indicates turbidity and plume generated from when this was operational appears to have mobilised sediments offshore and simulated a bypassing process assisting accretion along beaches north of artificial headland six.</p> <p><b>Kwinana Bulk Terminal (+3500m to +4400m)</b></p> <p>Mid-term shoreline mapping indicates that this stretch of coastline has been undergoing erosion (up to 20 m) between 2016 and 2024, equivalent to 2.5 metres per year. The most significant erosion occurs within the 300 m immediately north of the KBT revetment.</p> <p>Short-term shoreline mapping between 2019 and 2024, indicates a continued erosion trend south of the KBT jetty (up to two metres per year). North of the jetty there has been minor accretion (up to one metre per year), extending until the BHP jetty.</p> <p>The partial demolition of the BHP jetty (+4325m) appears to have impacted the vegetation immediately adjacent to the structure, appearing as a significant erosion spike (up to 17 m) in the mid-term.</p> <p>Aerial imagery shows a neat, 2013 constructed and 2021 upgraded revetment protecting conveyor infrastructure at the southern end of the KBT lease. This revetment was not accessed during the site visit.</p> <p><b>Water Corp to Synergy (+4400m to +5950m)</b></p> <p>Mid-term shoreline mapping indicates that this stretch of coastline has been undergoing erosion (up to 20 m) between 2016 and 2024, equivalent to 2.5 m per year. The most significant erosion occurs in the 200 m stretching north of the</p> |

| ID | Category | Content |
|---|---|---|
| | | <p>Synergy cooling water flume. (Cardno, 2013).</p> <p>Another significant erosion area occurs 200 m immediately south of the Barter Road road access to the Naval Base Horse Beach equivalent to two metres per year.</p> <p>The remaining stretch of beach is limited to uniform minor erosion (less than one metre per year). Short-term shoreline mapping between 2019 and 2024, indicates minor erosion along the entire stretch (less than one metre).</p> <p>The 'NewGen' power station and Synergy offices appear to be located immediately south of the Synergy revetment, where approximately five metres of erosion has been experienced across the mid-term. The revetment was not inspected during the site visit.</p> <p><b>Alcoa site to Alcoa jetty (+5950m to +6700m)</b></p> <p>Mid-term shoreline mapping indicates that this stretch of coastline has been undergoing erosion (up to 15 m) between 2016 and 2024, equivalent to two metres per year. The most significant erosion occurs uniformly across the southern 700m until the Alcoa jetty.</p> <p>Short-term analysis indicates a stable shoreline with negligible changes.</p> <p><b>Challenger Beach (+6700m to +8200m)</b></p> <p>Mid and short-term analysis indicates a stable shoreline north of the Alcoa jetty, extending until the Navy shacks revetment and boat ramp. The Navy shacks revetment appeared in good condition during site visit (24/10/24), with slopes appearing to be stable and good interlocking of armour rock.</p> |

Figure 6-23: Results of Kwinana Industrial shoreline mapping, showing short and mid-term changes, for chainage reference refer to Figure 6-20, Figure 6-21 and Figure 6-22

| ID | Category | Content |
|---|---|---|
| 9. | <b>Recommendations &amp; lessons learnt</b> | <p><b>Coastal monitoring</b></p> <ul style="list-style-type: none"> <li>It is recommended that shoreline monitoring using LIDAR equipped drones or equivalent survey alternatives are undertaken along this hotspot at a minimum, annual frequency subject to safety and necessary access approvals. Specific areas of concern include: <ul style="list-style-type: none"> <li>shoreline/dune adjacent to KBJ seawall</li> <li>shoreline/dune system protecting NewGen power station</li> <li>shoreline/dune foreshore along bp land</li> </ul> </li> <li>It is recommended that a detailed inspection of the revetment adjacent to the KBJ seawall is undertaken, and renewal/refurbishment considered based on the inspection outcome.</li> <li>Consideration should be given to monitoring and management requirements for Westport or other major projects.</li> </ul> <p><b>Coastal investigation</b></p> <ul style="list-style-type: none"> <li>It is recommended that a holistic revision of the CHRMAP is undertaken considering all possible future uses of the individual leases (including Westport).</li> <li>It is recommended that private leaseholders individually assess the risk of coastal erosion/inundation impacting their assets, and establish protect strategies best suited to their individual circumstance.</li> </ul> <p><b>Coastal management actions</b></p> <ul style="list-style-type: none"> <li>Revetments remain the preferred protect strategy for all industrial leases (GHD, 2016), and are recommended to be installed in a staged manner as individual leases reach risk thresholds requiring mitigation. Any protection concepts should consider a design life tailored to the individual lease expiry.</li> <li>Where suitable, staged protection outlined above will need to consider impact on neighbouring lease holders, and revetment concepts grouped to ensure that resources can be shared during the construction of such infrastructure.</li> </ul> |

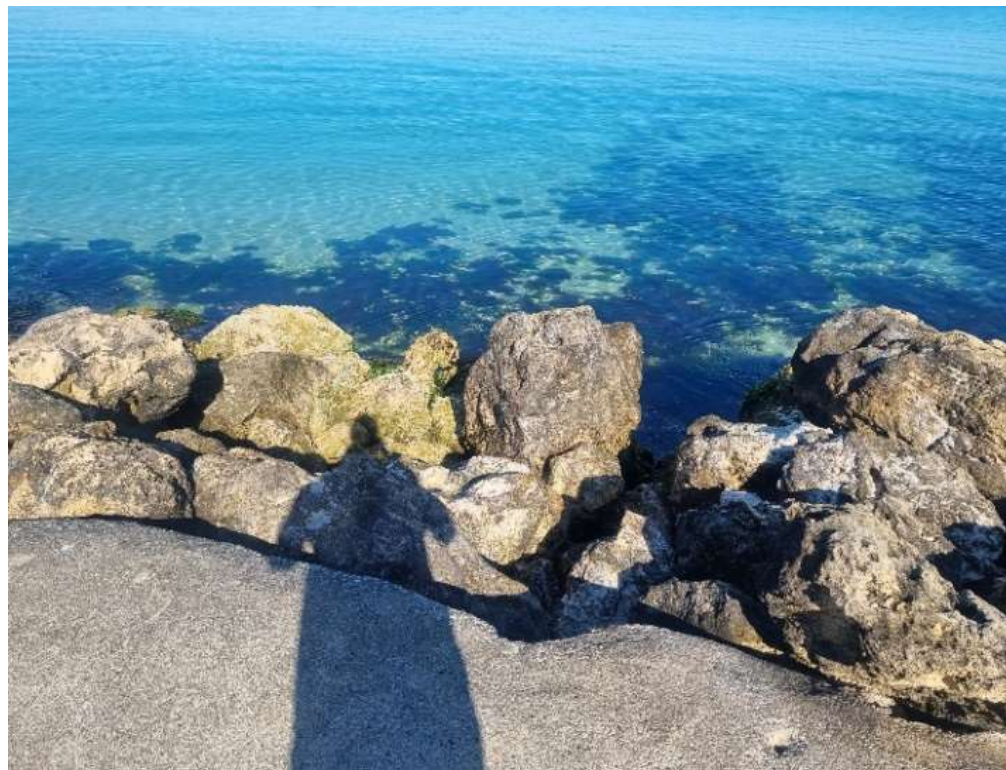
*Figure 7-2: Photo taken of Wells Park seawall (+1370m) showing poor interlocking, and gaps in armour during site visit 24/10/2024.*
