# WA Coastal Erosion Hotspots

## Review of Coastal Management History - 12 Sites

Document no. Rev 1: 311012-02081-CS-REP-001

12 June 2025

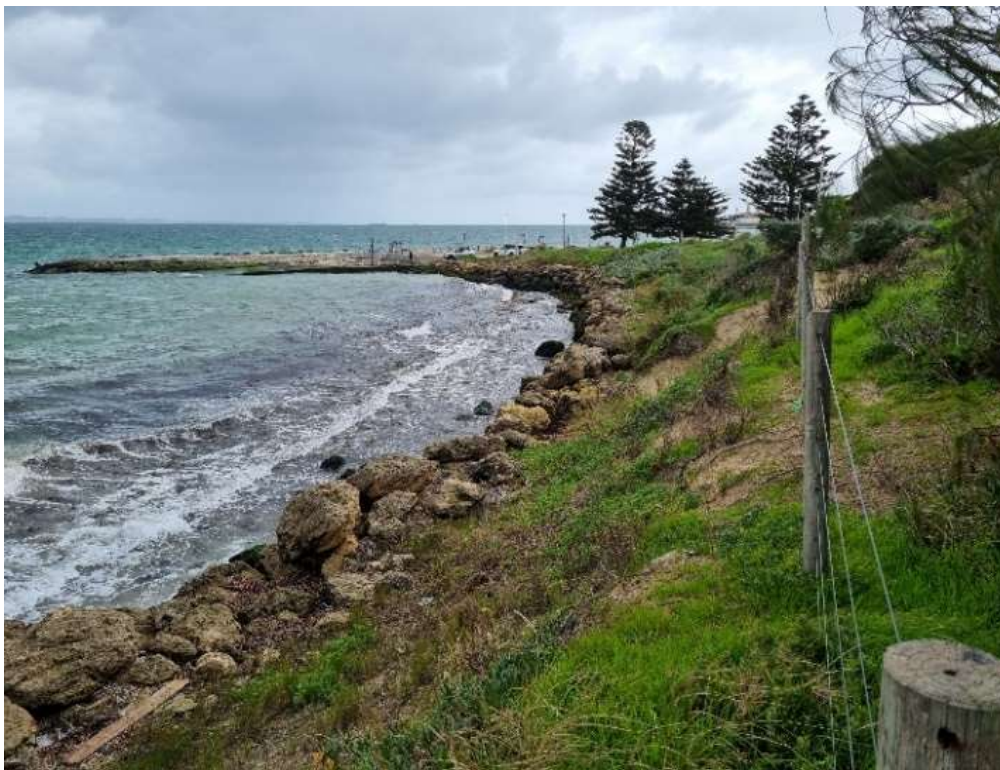
*Figure 7-7: Limestone seawall (+1100m) south of Wells Park, showing eroded dune face above, facing northwest during site visit 14/08/2024.*

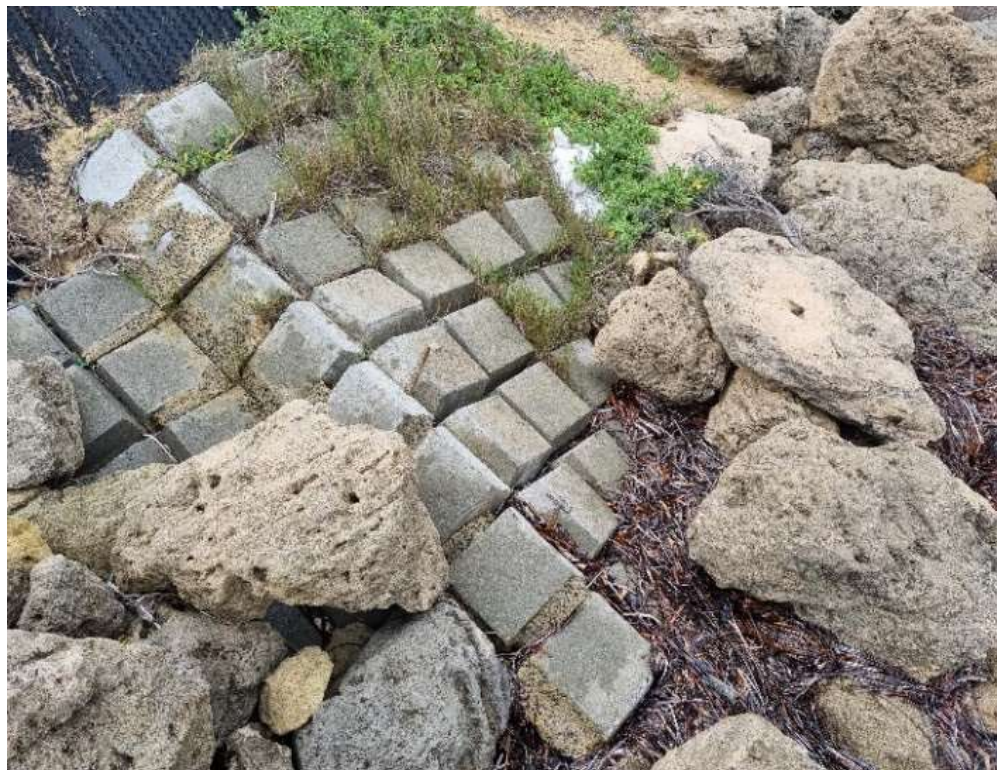
*Figure 7-8: Concrete flex-mat along seawall crest (+1100m), adjacent to old boat ramp, taken during site visit 14/08/2024.*

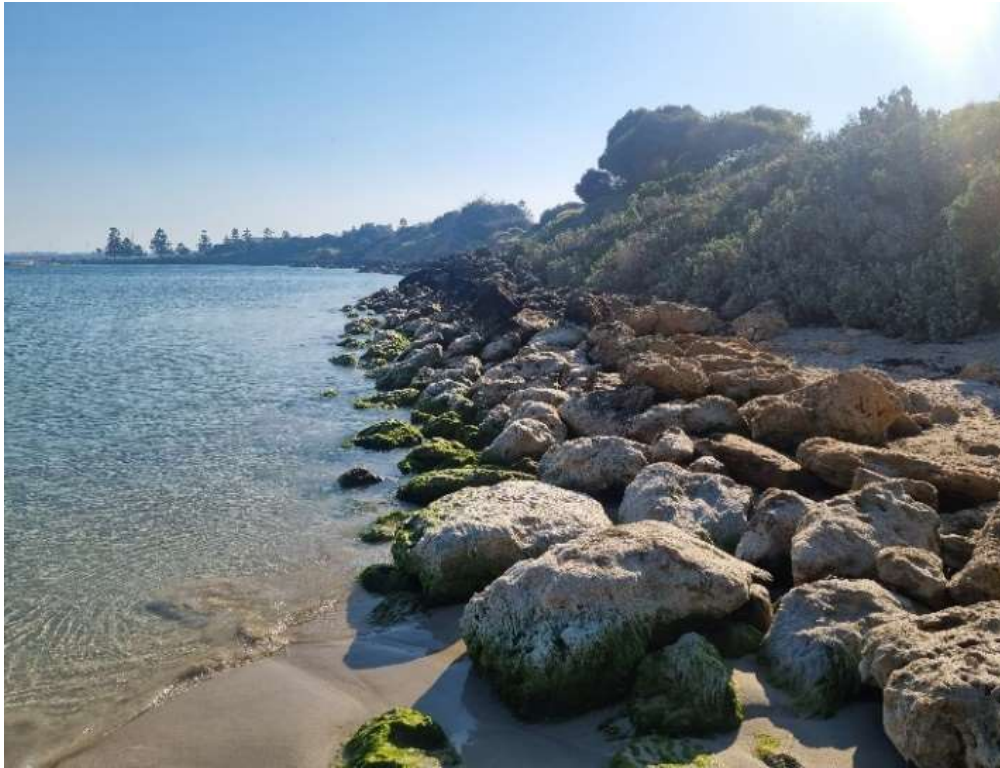
*Figure 7-11: Limestone seawall south of Wells Park (+850m), showing southern end, facing northeast during site visit 18/09/2024.*

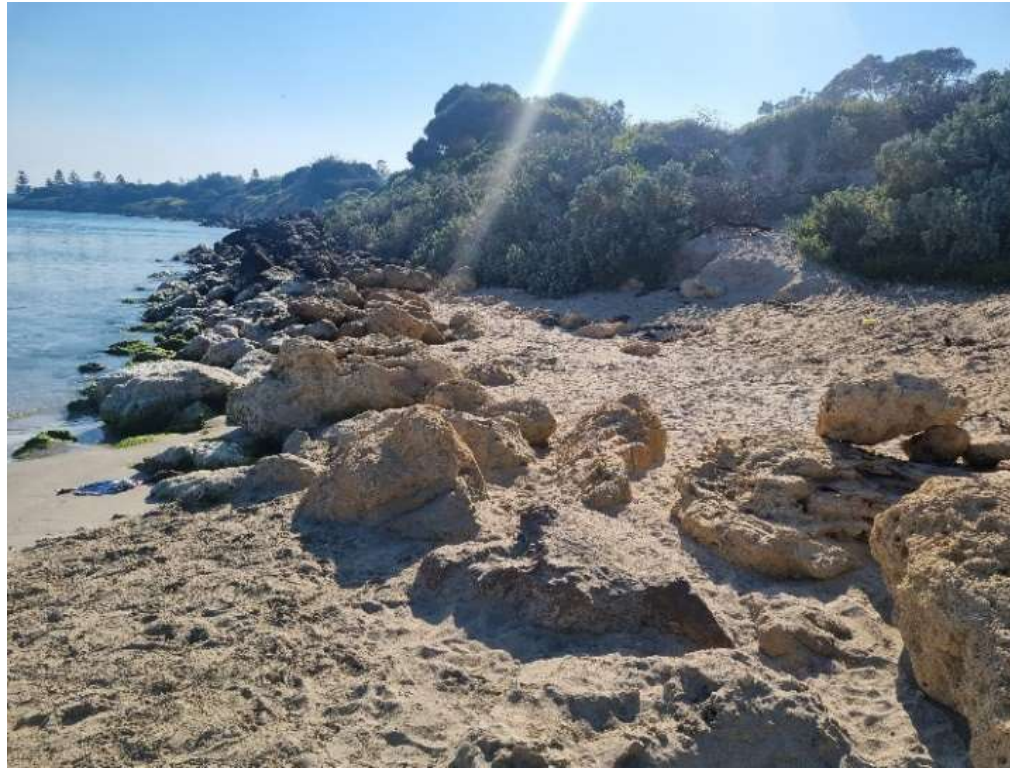
*Figure 7-12: Limestone seawall south of Wells Park (+850m), showing southern end, facing east during site visit 18/09/2024.*

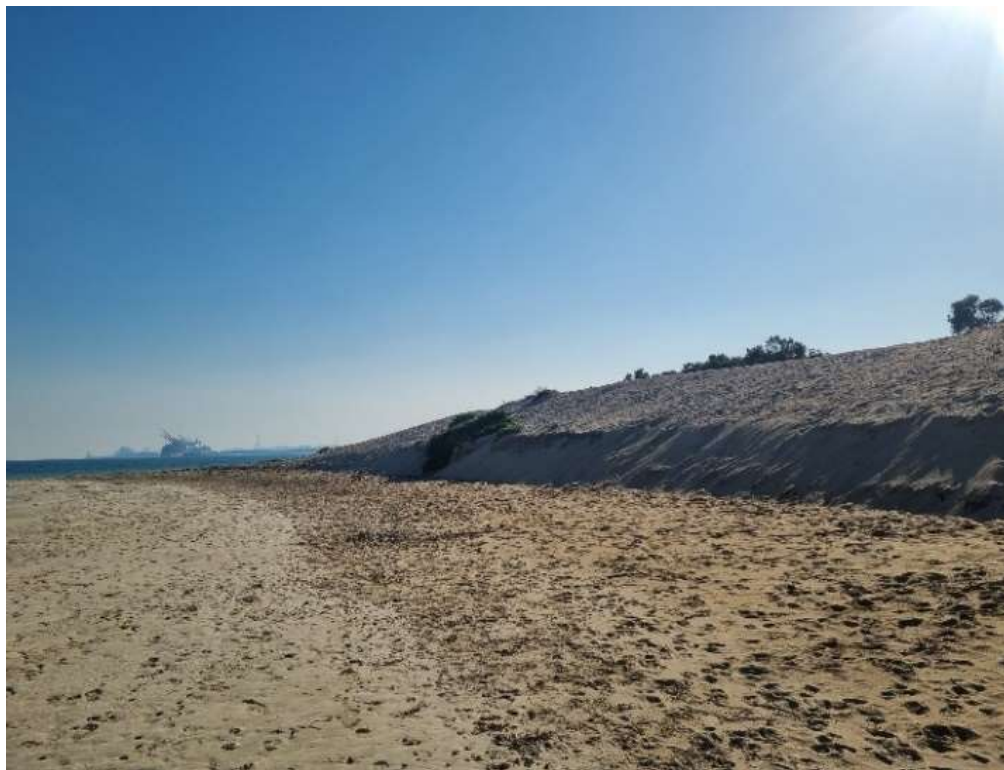
*Figure 7-13: Dune adjacent to southern artificial headland (+500m), facing north-east during site visit 18/09/2024.*

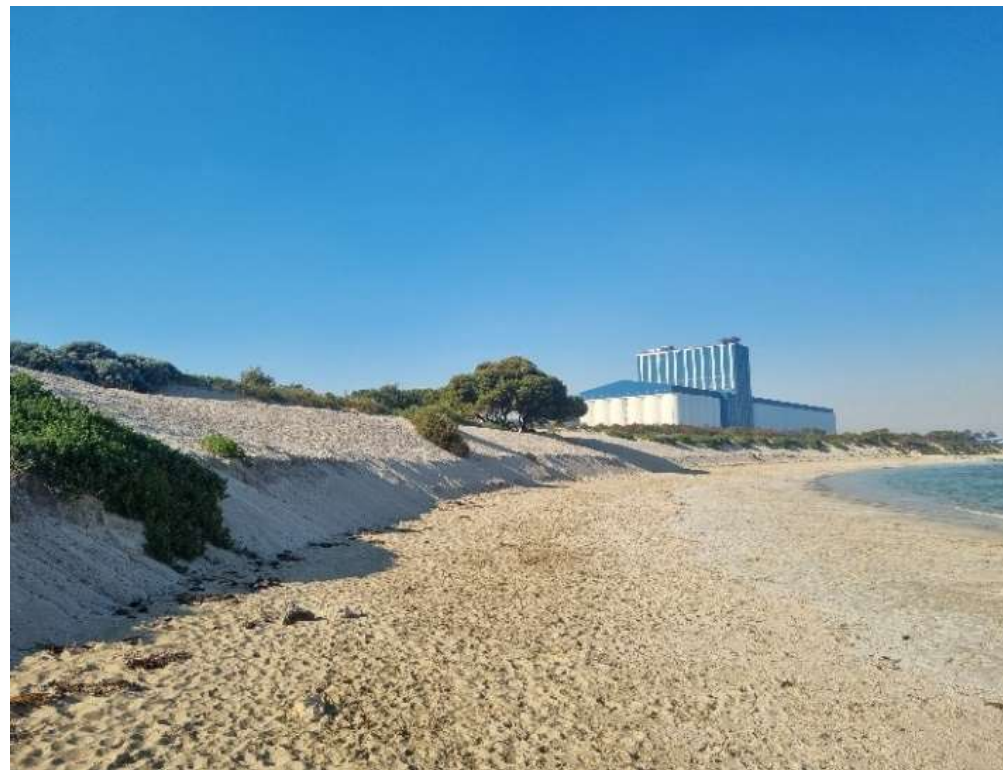
*Figure 7-14: Dune adjacent to southern artificial headland (+500m), facing south-west during site visit 18/09/2024.*

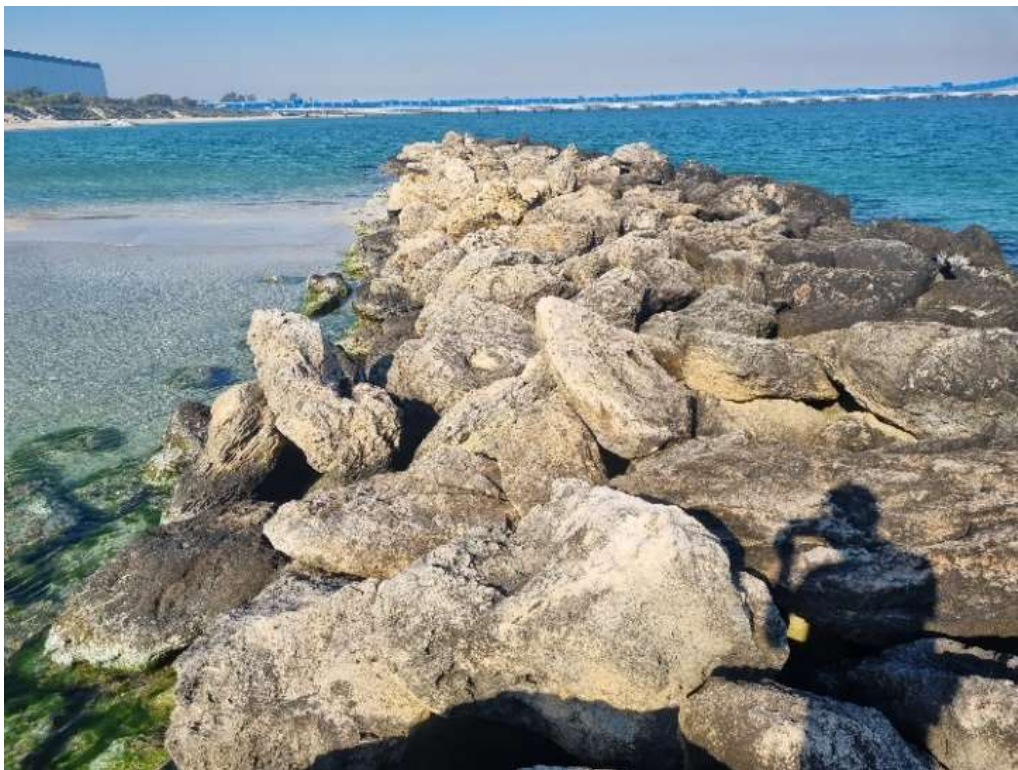
*Figure 7-15: Southern artificial headland, taken from crest, during site visit 18/09/2024.*

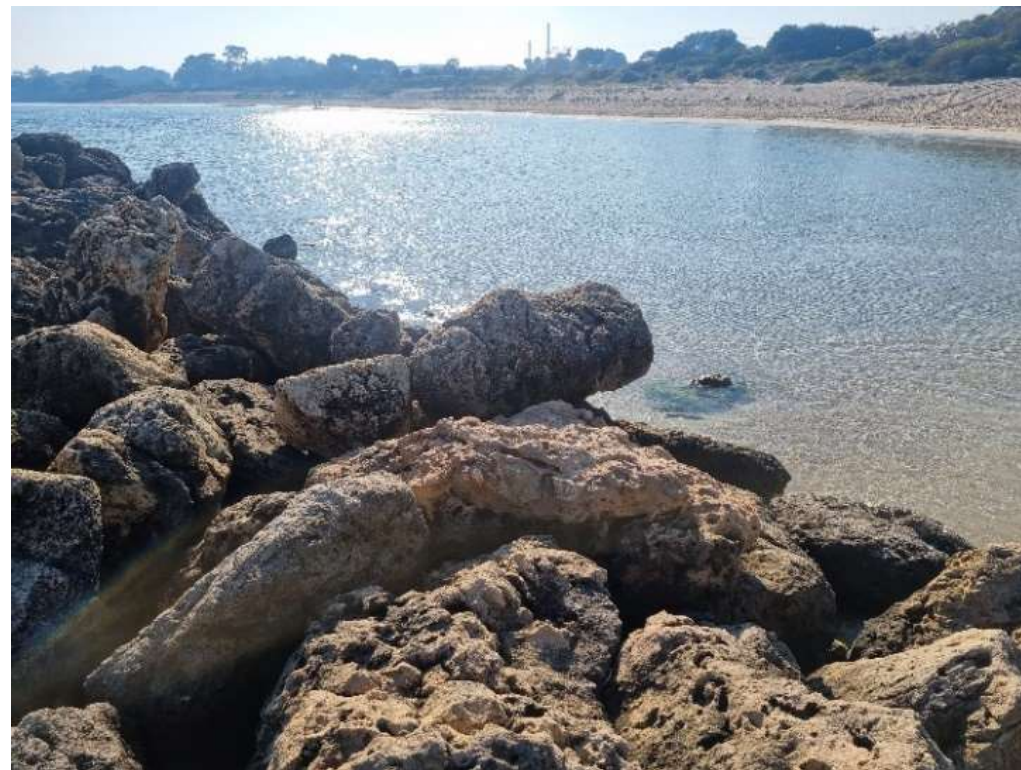
*Figure 7-16: Southern artificial headland, taken from crest, during site visit 18/09/2024.*

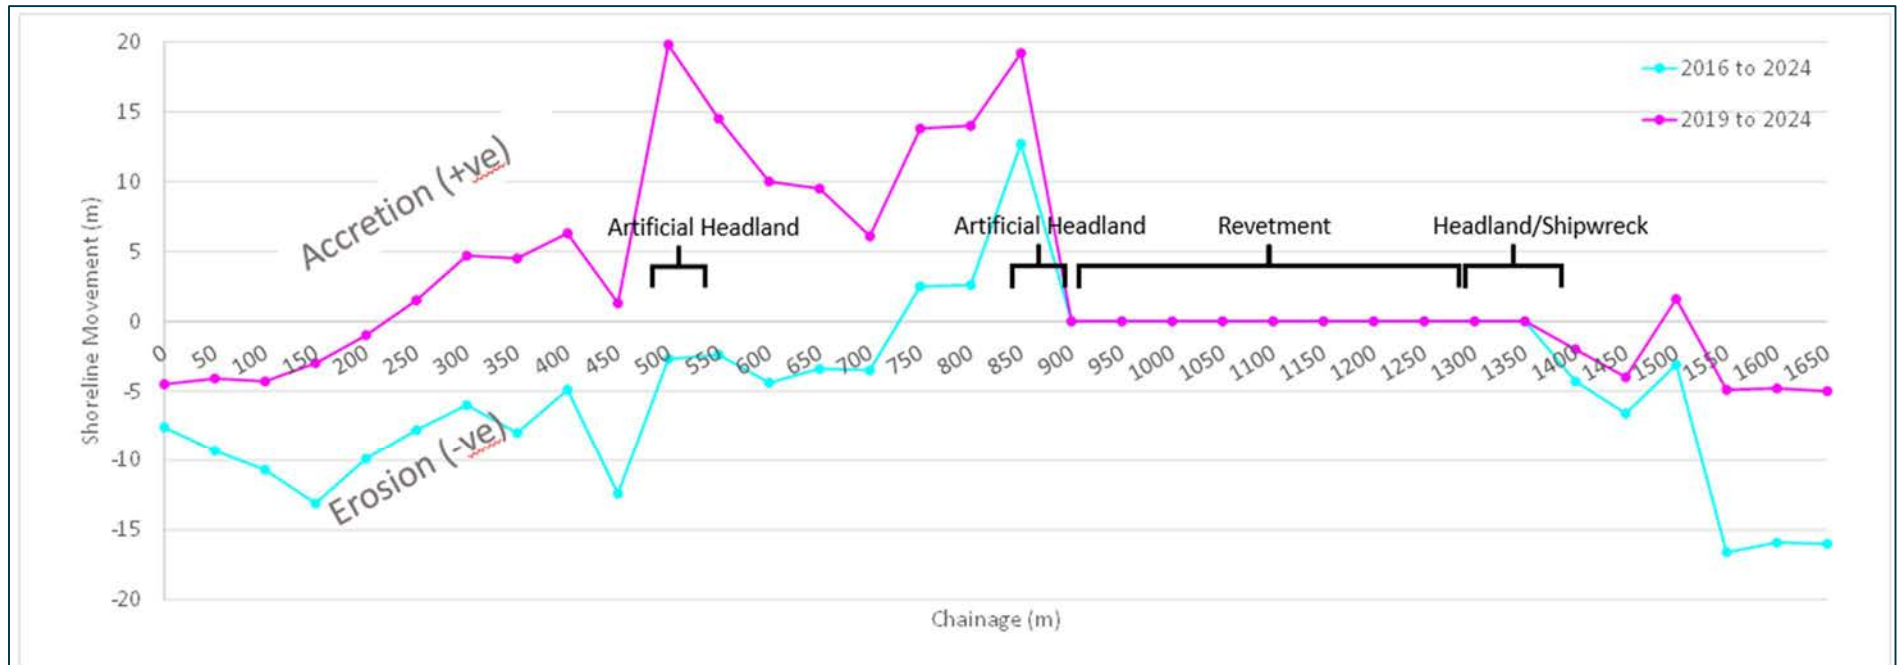
| ID | Category | Content |
|---|---|---|
| 8. | <b>Performance / Effectiveness of coastal management</b> | <p>Mid (eight year) and short-term (five year) shoreline mapping has been undertaken using satellite imagery, and beach changes in 50 m increments are presented in Figure 7-18. No changes were observed along the seawall stretch of coastline.</p> |

Figure 7-18: Results of Kwinana Beach shoreline changes, showing short and mid-term changes, for chainage reference refer to Figure 7-17

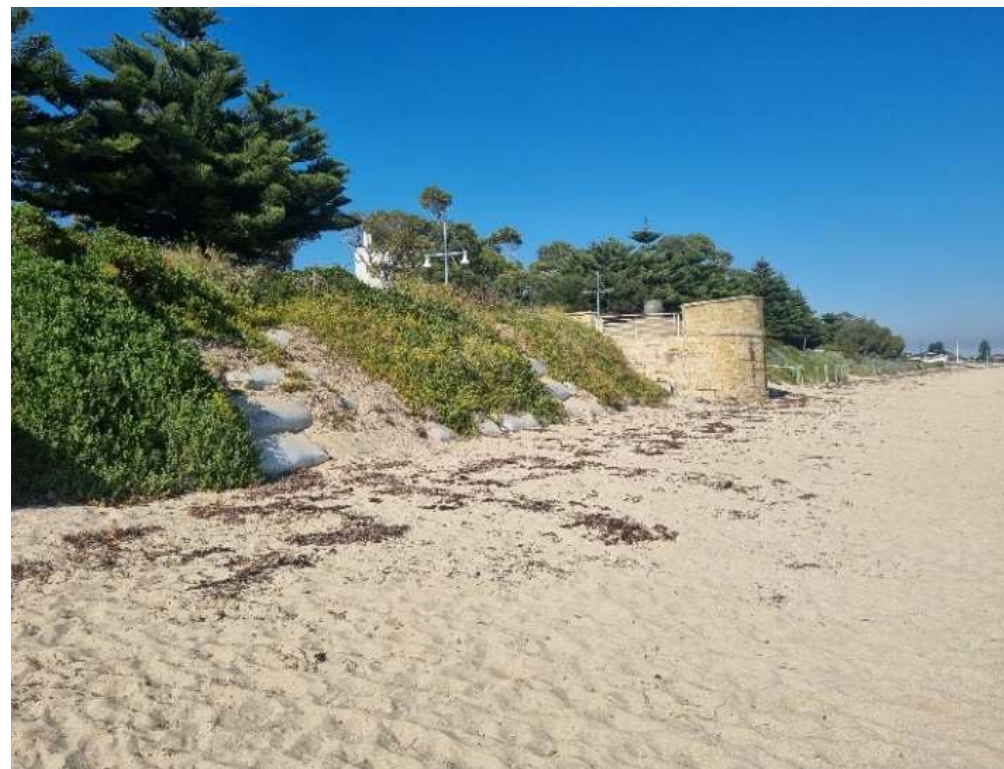
*Figure 8-4: Photo taken of revegetation above Flinders Ln GSC seawall, approximate chainage +3350 m. Taken during site visit 18 September 2024.*

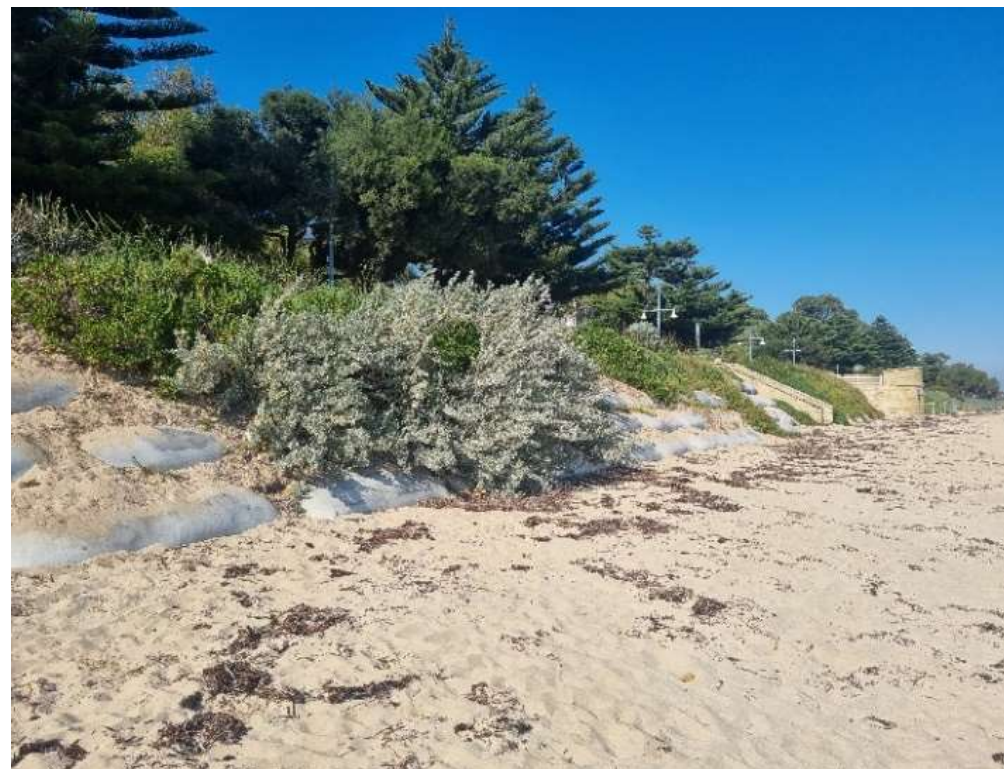
*Figure 8-6: Photo taken of revegetation above Flinders Ln GSC seawall, approximate chainage +3370 m. Taken during site visit 18 September 2024.*

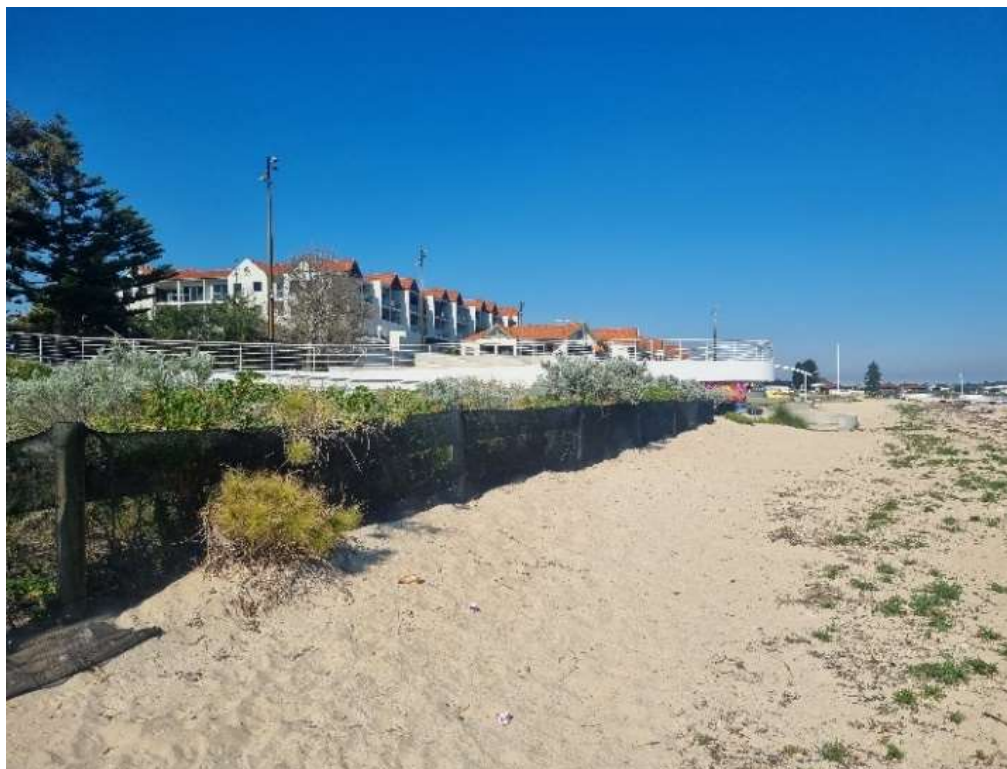
*Figure 8-7: Dune vegetation fencing along the Val St. foreshore (+3025m).  
Taken during site visit 18 September 2024.*

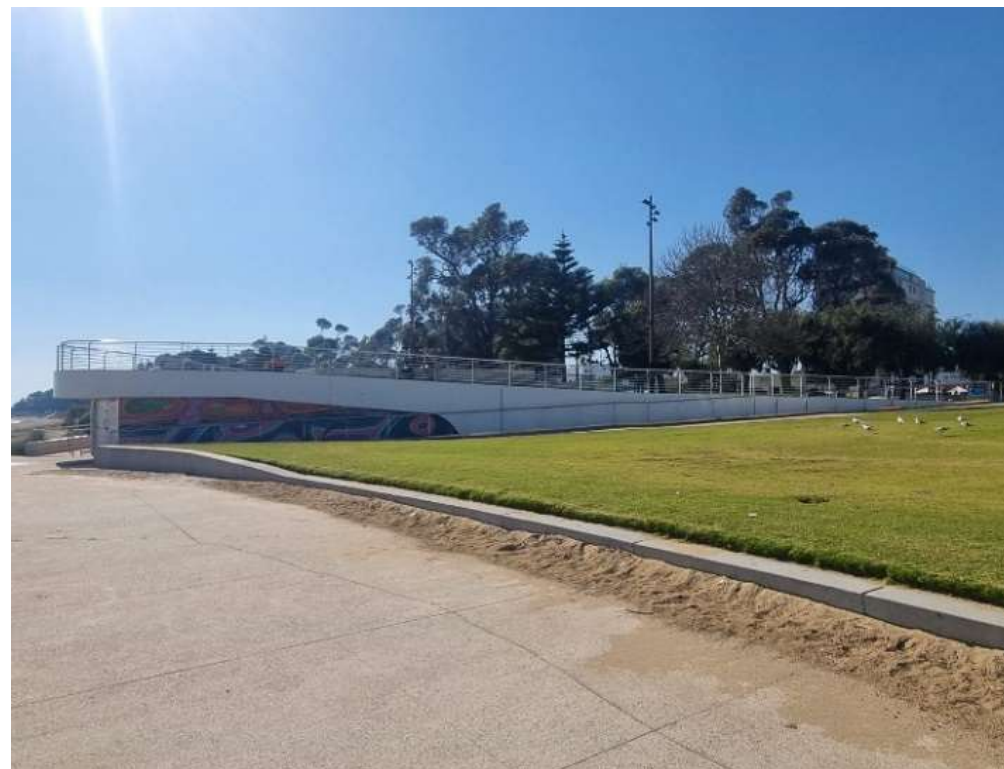
*Figure 8-8: Val St. foreshore concrete retaining structures (+3000m). Taken  
during site visit 18 September 2024.*

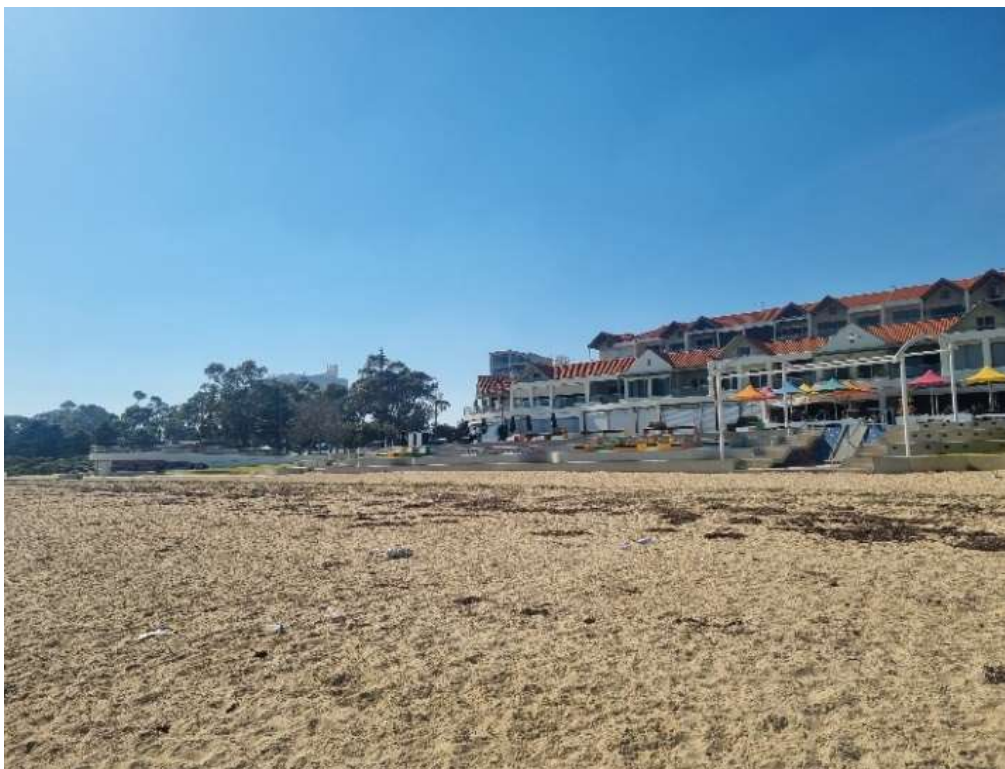
*Figure 8-9: Val St. foreshore concrete retaining structures (+2925m). Taken during site visit 18 September 2024.*

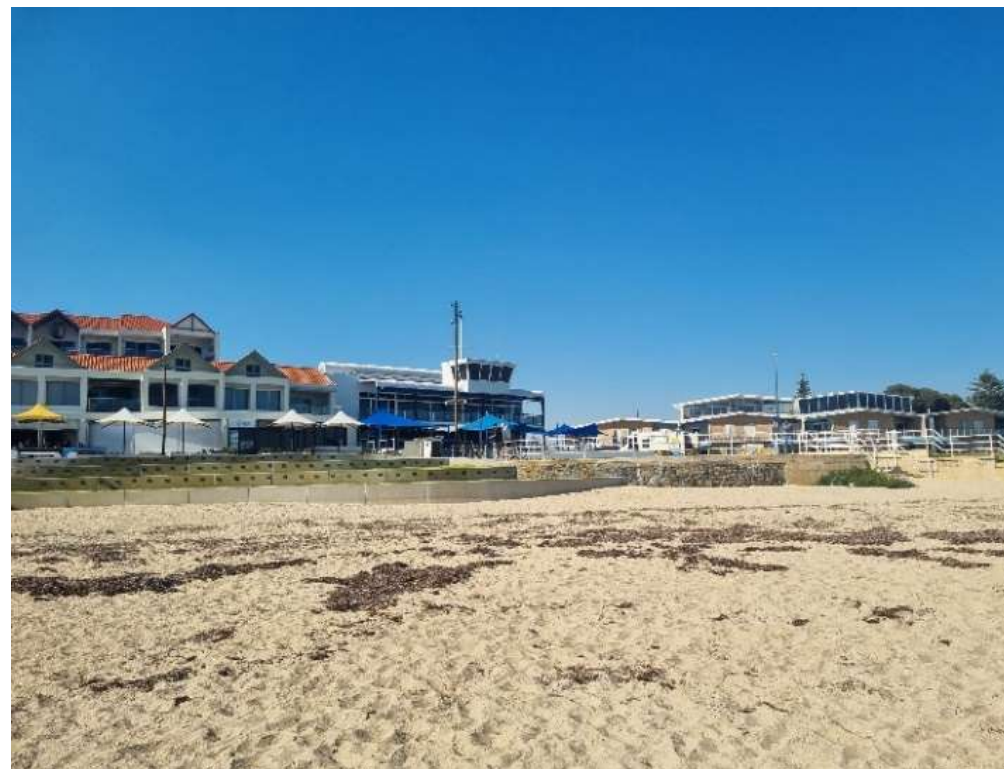
*Figure 8-10: Val St. foreshore concrete retaining structures (+2925m). Taken during site visit 18 September 2024.*

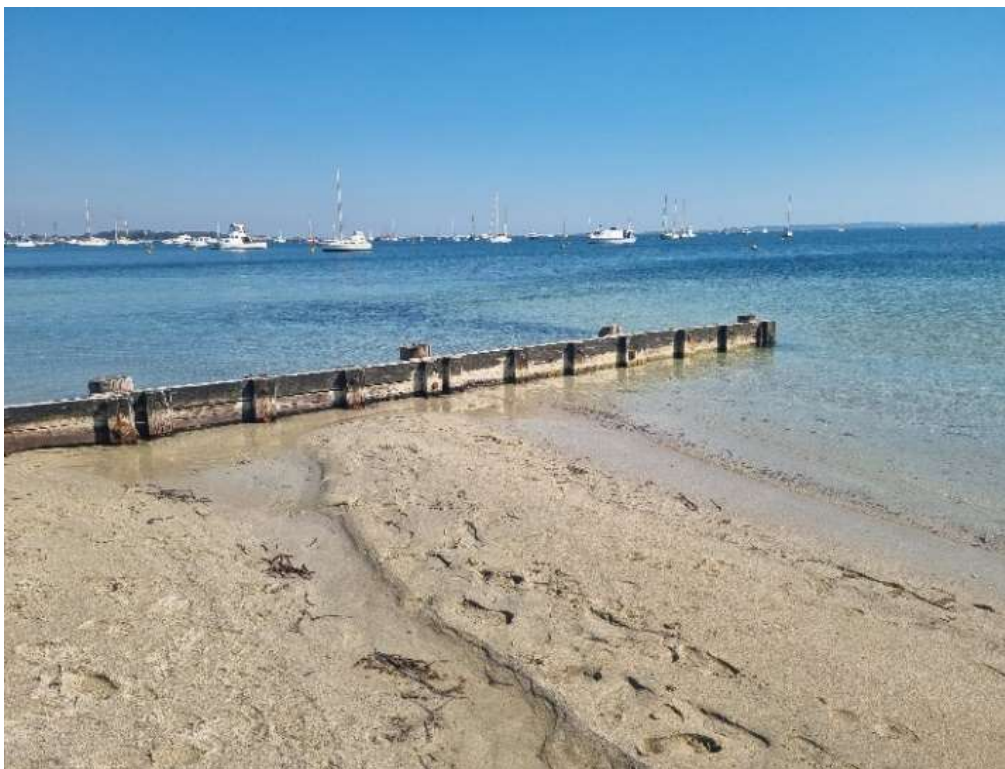
*Figure 8-11: Hymus St. timber groyne (+1350m). Taken during site visit 18 September 2024.*

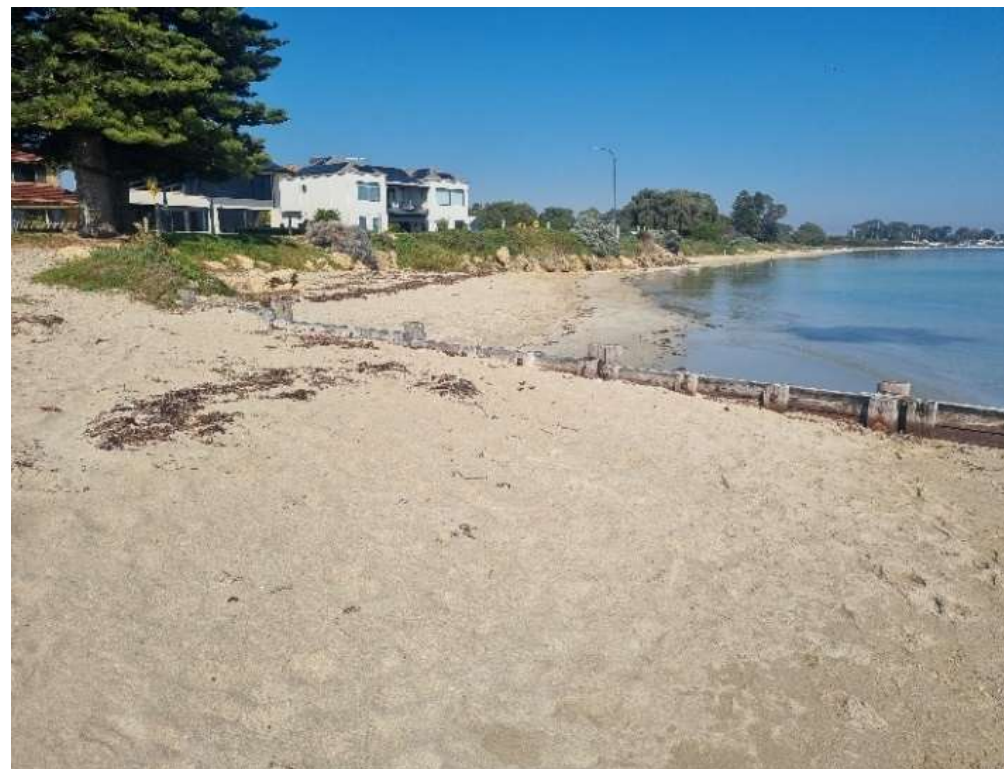
*Figure 8-12: Hymus St. timber groyne and informal seawall (+1350m). Taken during site visit 18 September 2024.*

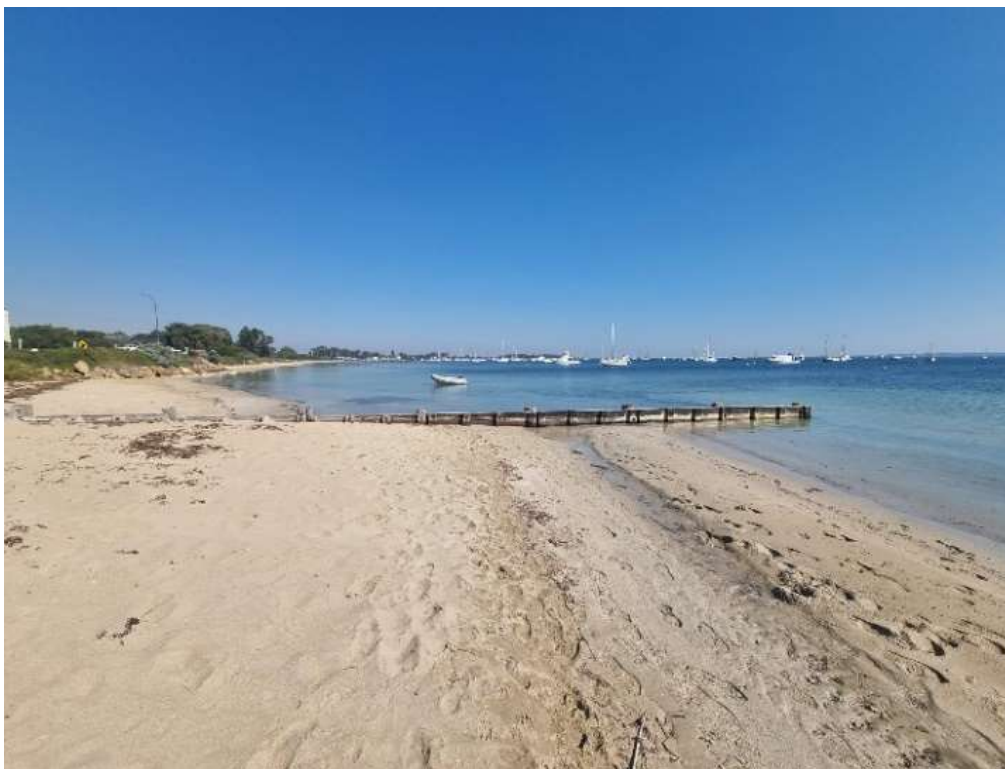
*Figure 8-13: Hymus St. timber groyne and informal seawall (+1375m). Taken during site visit 18 September 2024.*

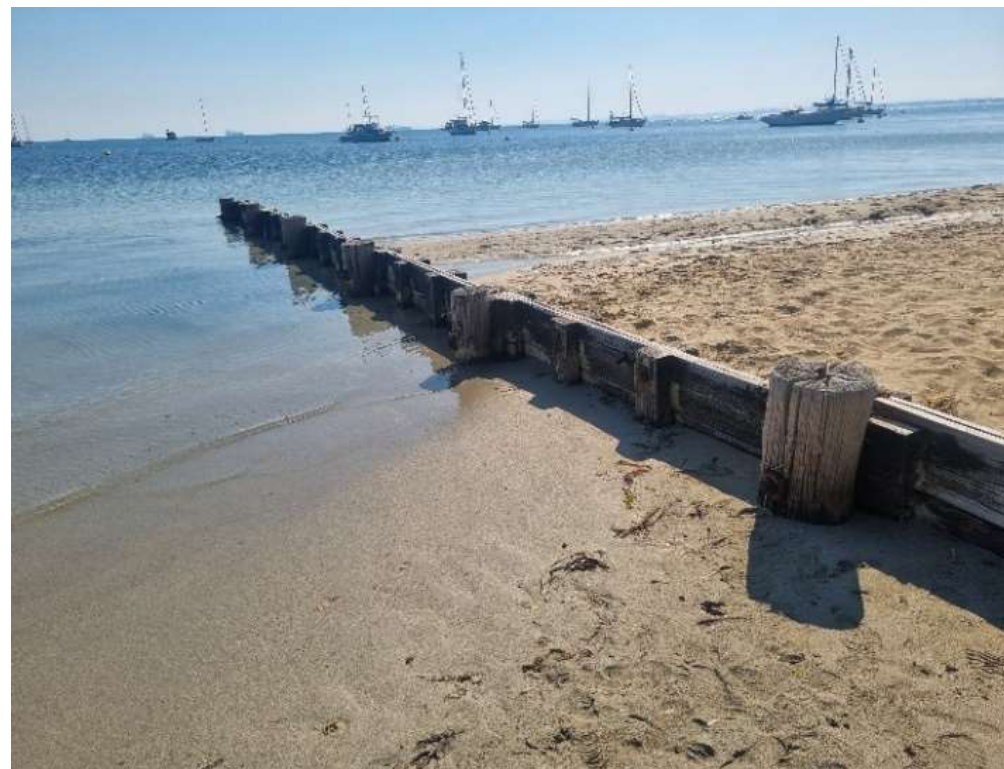
*Figure 8-14: Hymus St. timber groyne (+1350m). Taken during site visit 18 September 2024.*

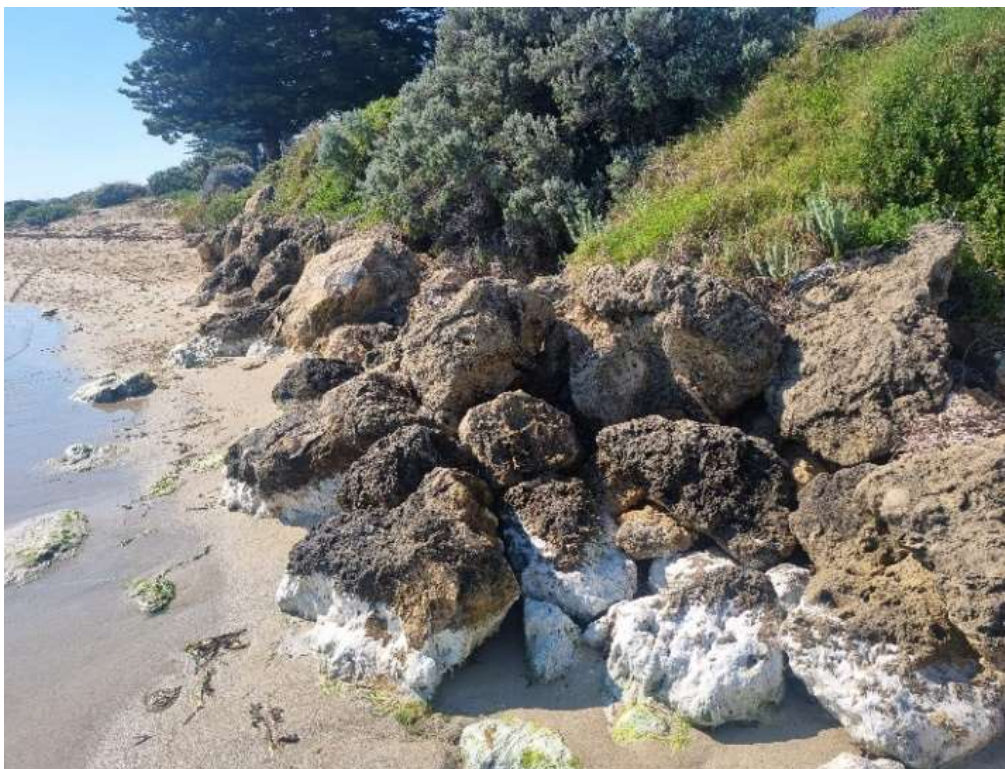
| ID | Category | Content |
|---|---|---|
| 6. | <b>Management issues and challenges</b> | <p>The Hymus St seawall is in poor condition and requires refurbishment. CoR are currently investigating replacement of the Hymus St. seawall with a purpose-built structure to accommodate planned road and median strip widening works. The Seaside Camp for Children situated immediately west of this site have requested that this design is extended to protect their frontage (City of Rockingham, 2024).</p> |

*Figure 8-15: Hymus St. informal seawall (+1375m). Taken during site visit 18 September 2024.*

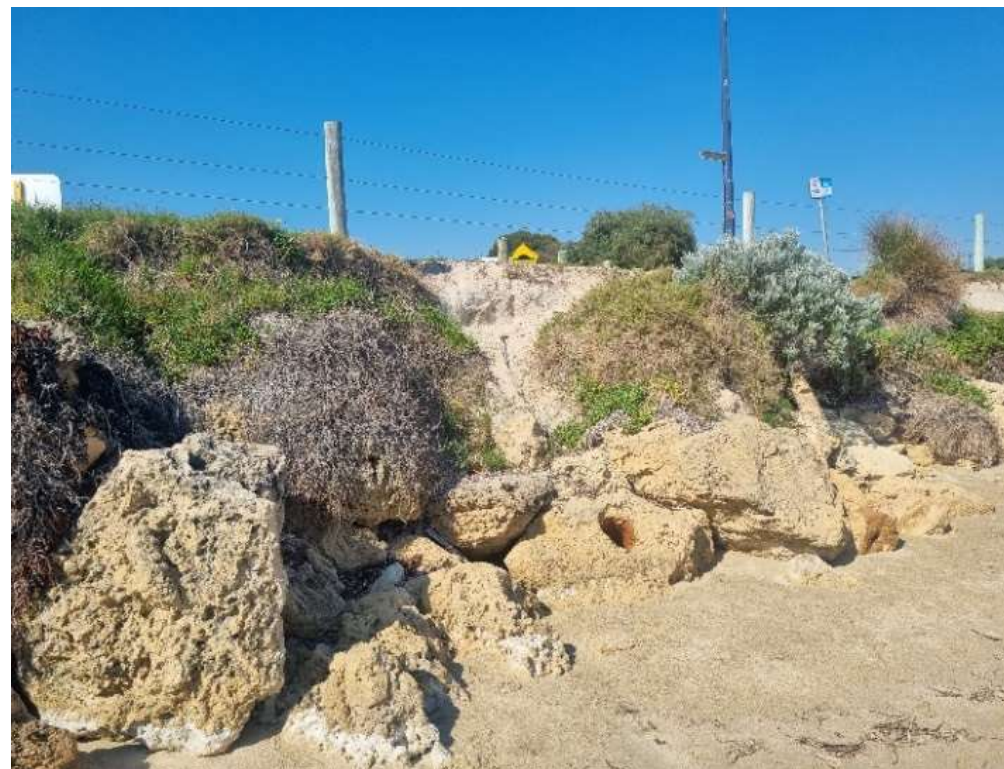
*Figure 8-16: Slope erosion at Hymus St. informal seawall (+1375m). Taken during site visit 18 September 2024.*

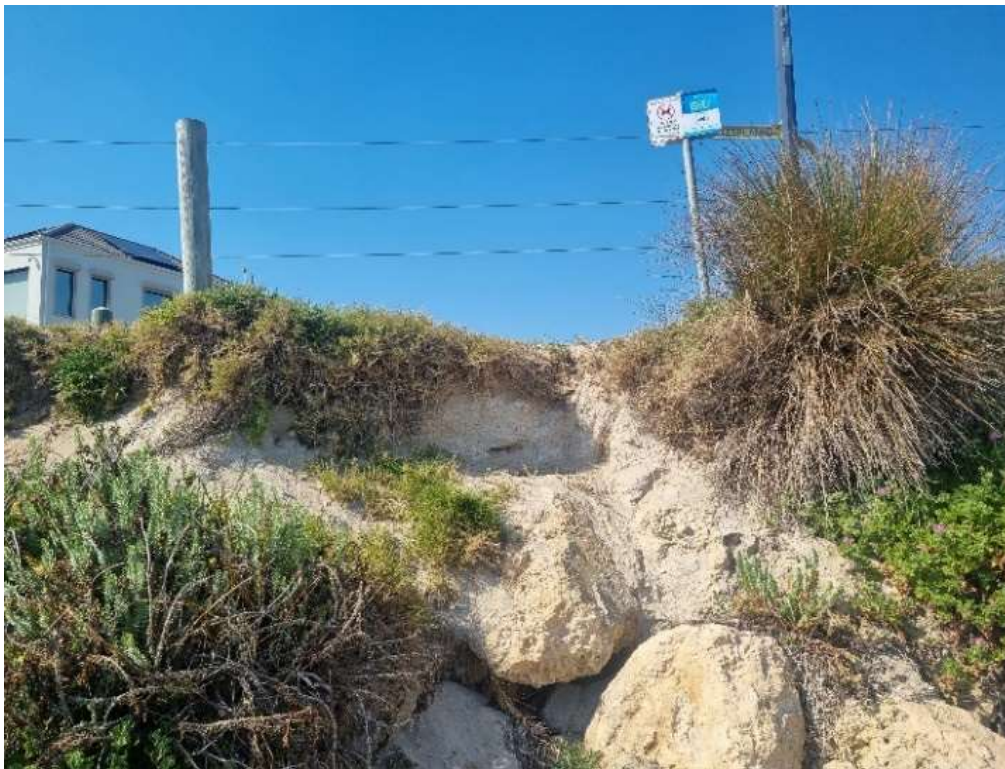
*Figure 8-17: Slope erosion at Hymus St. informal seawall (+1375m). Taken during site visit 18 September 2024.*

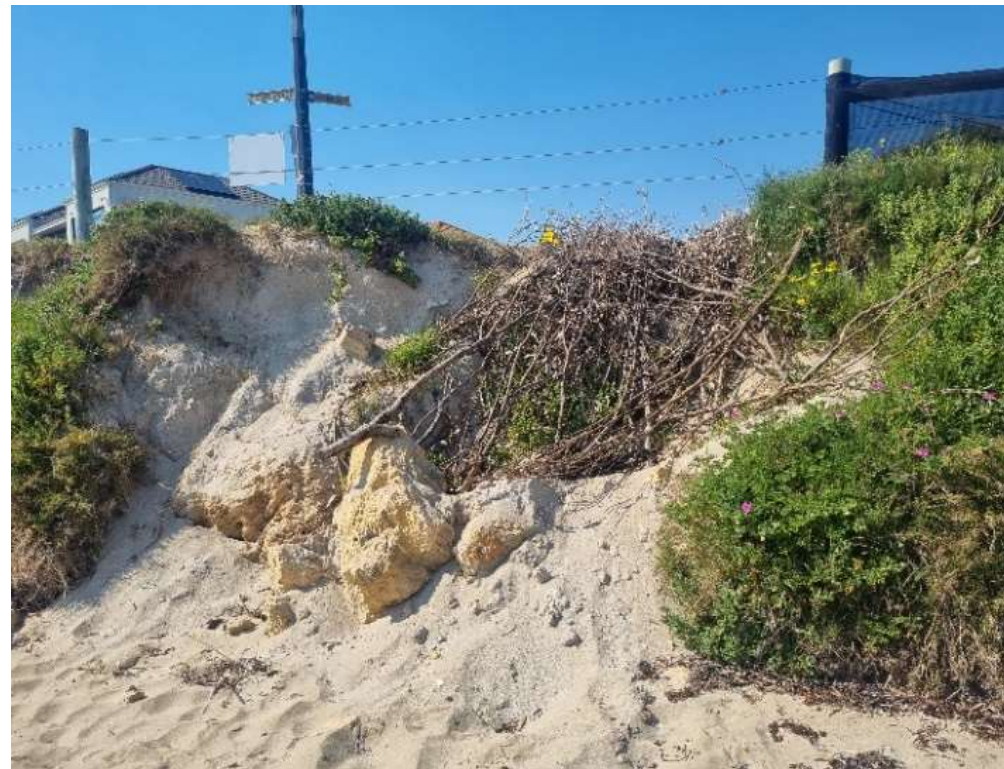
*Figure 8-18: Brushing applied to erosion at Hymus St. informal seawall (+1375m). Taken during site visit 18 September 2024.*

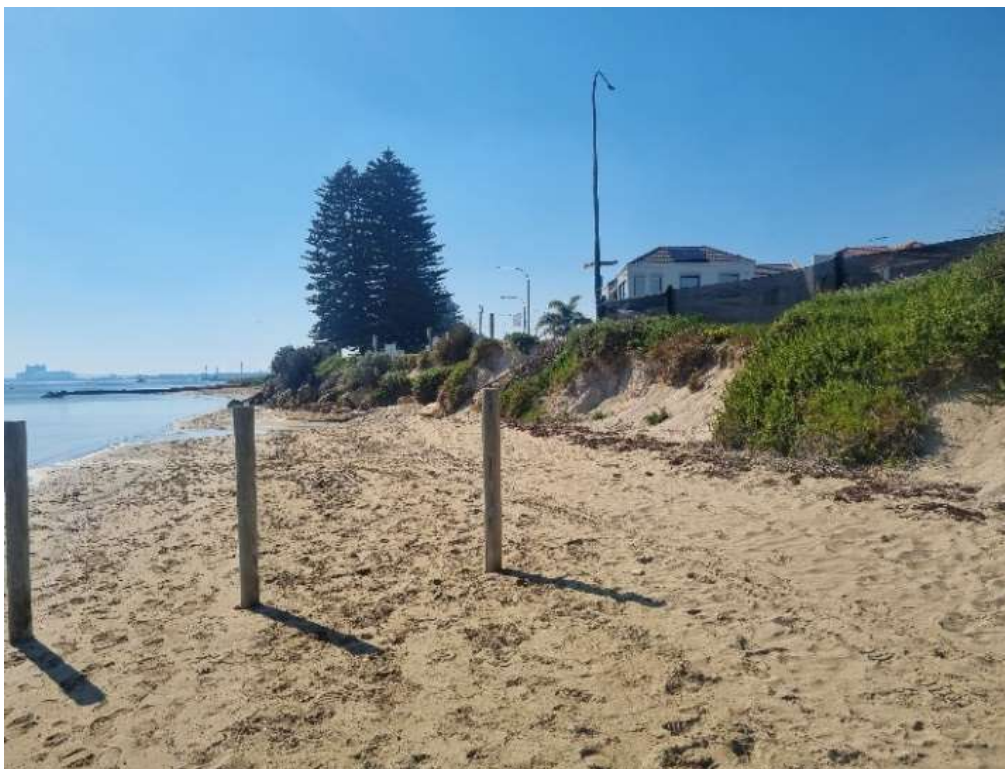
*Figure 8-19: Scarping present immediately west of Hymus St. informal seawall (+1300m). Taken during site visit 18 September 2024.*

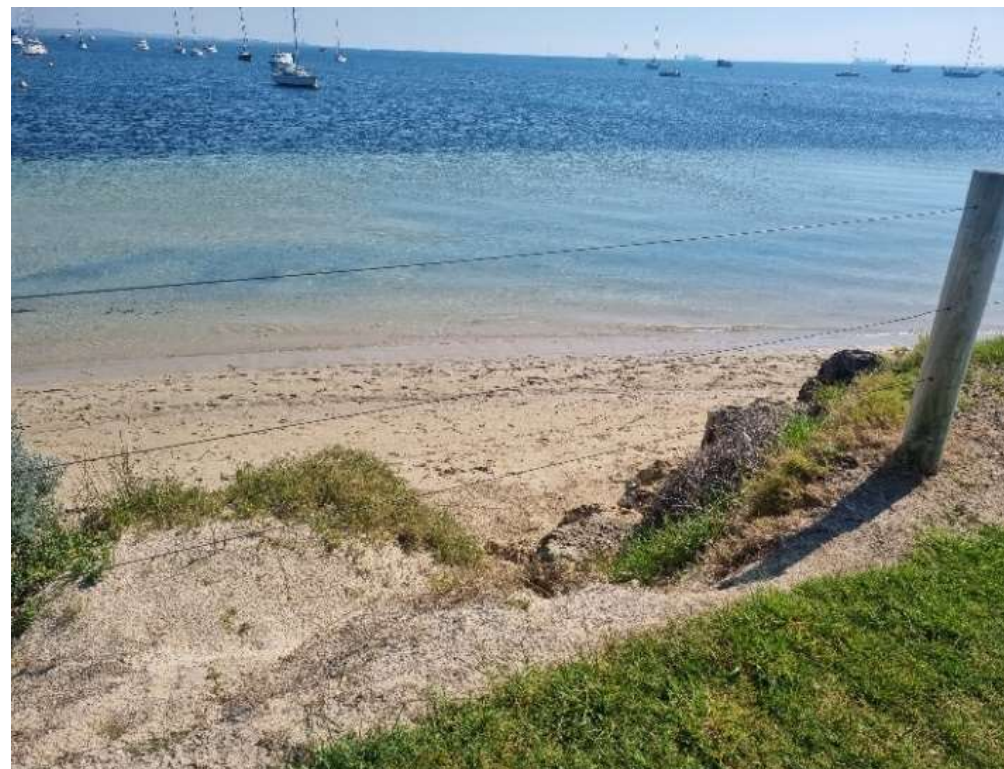
*Figure 8-20: Slope erosion at Hymus St. informal seawall (+1375m). Taken during site visit 18 September 2024.*

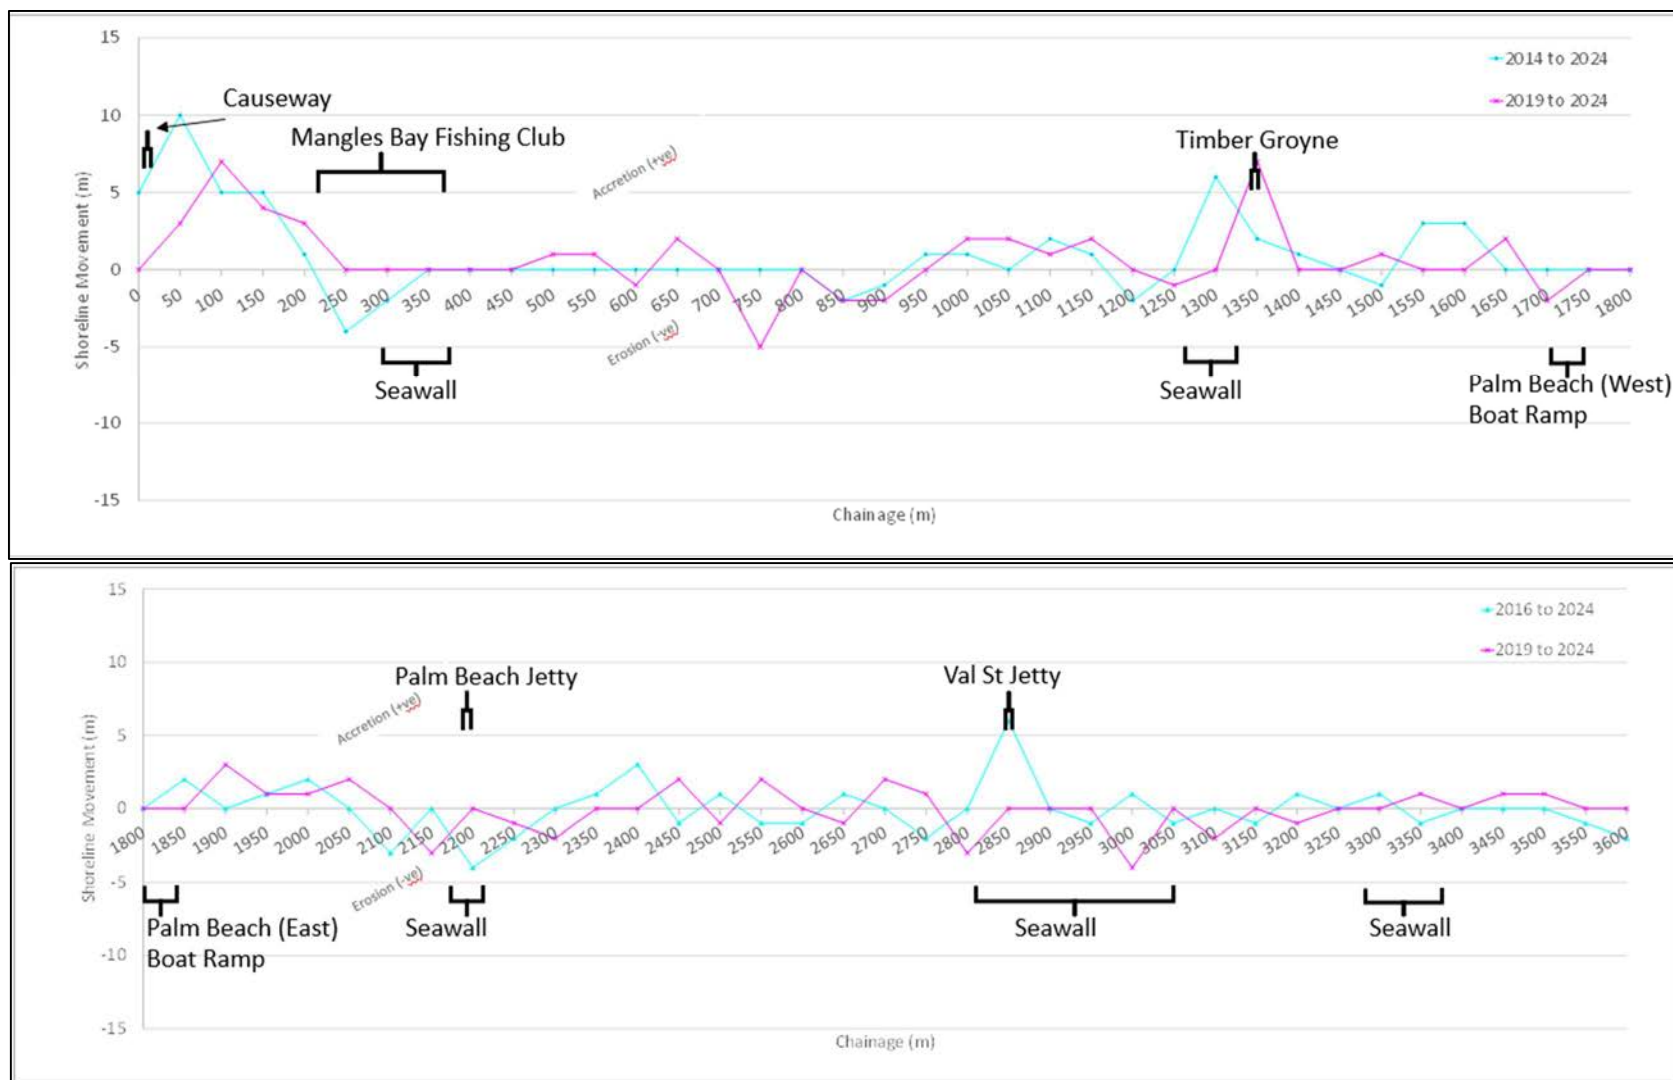
| ID | Category | Content |
|---|---|---|
| 8. | <b>Performance / Effectiveness of coastal management measure/s</b> | <p><b>Causeway to Palm Beach boat ramp (west) (+0m to +1750m)</b></p> <p>Mid-term shoreline mapping (10 years) indicates that this coastline has remained very stable with some accretion observed the westernmost 200m adjacent to the Causeway (one metre per year).</p> <p>Short term mapping (five years) indicates a similar trend of accretion at the westernmost 200m (one metre per year), and stable coastline the remaining section.</p> <p>The informal seawall adjacent to Hymus St is in poor condition, with erosion above limestone armour, likely caused by storm run-off or wave overtopping. Very little frontage exists between this location and the road immediately adjacent, increasing the importance on this structure to perform as intended. From the site visit undertaken, scarping is also present immediately west of the seawall structure (refer Figure 8-21).</p> <p><b>Palm Beach boat ramp (west) to Wanliss St carpark (+1750m to +3650m)</b></p> <p>Both mid (10 year) and short-term (five year) mapping indicates stability along this</p> |

Figure 8-23: Results of Rockingham shoreline mapping, showing short and mid-term changes, for chainage reference refer to Figure 8-21 and Figure 8-22
