# WA Coastal Erosion Hotspots

## Review of Coastal Management History - 12 Sites

Document no. Rev 1: 311012-02081-CS-REP-001

12 June 2025

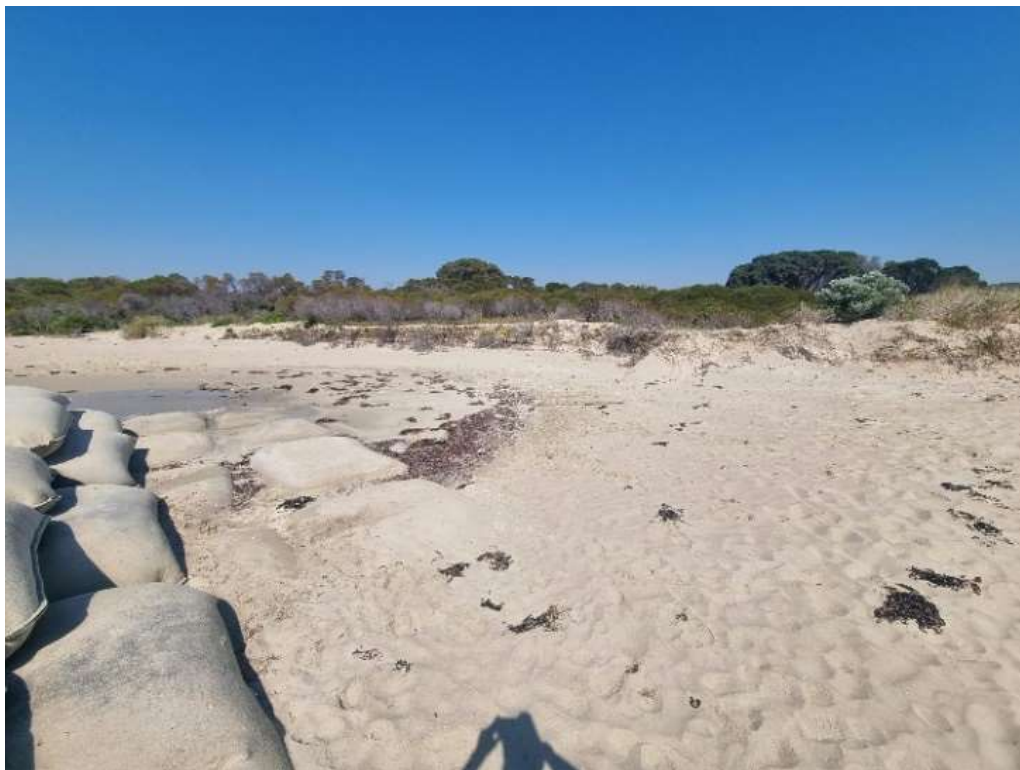
*Figure 9-1: GSC groyne neck, approximate chainage +750 m. Taken during site visit 18 September 2024.*

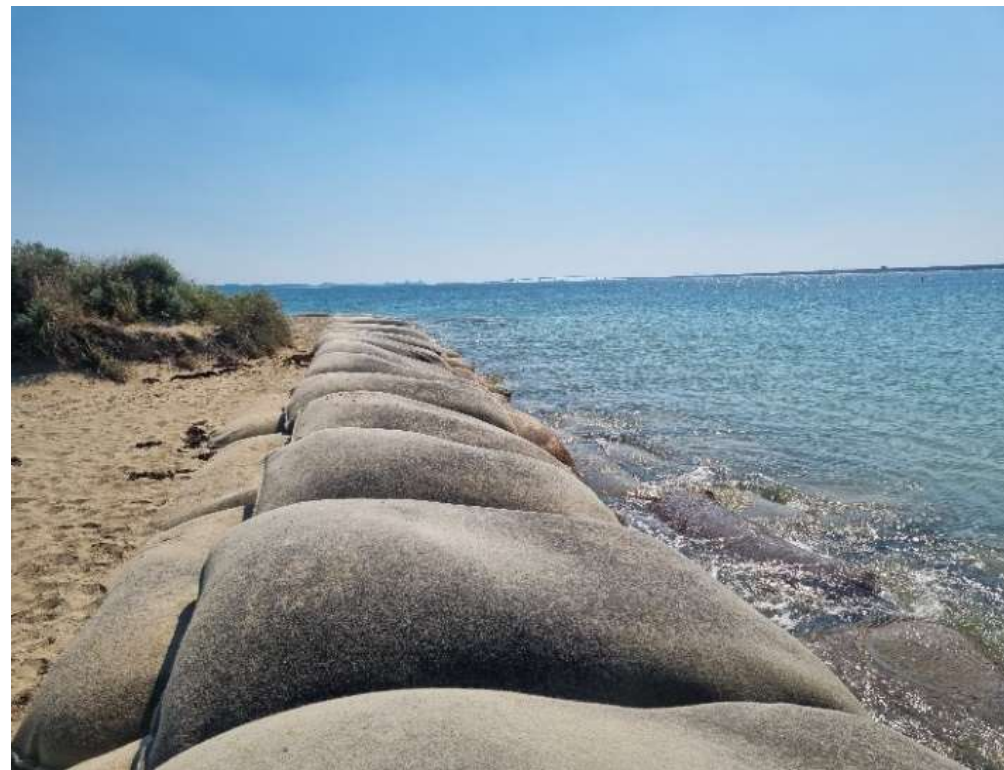
| ID | Category | Content |
|---|---|---|
| 6. | <b>Management issues and challenges</b> | <ul style="list-style-type: none"> <li>• GSC groyne is at end of design life, DBCA has concerns about the impact that degradation of plastics is having on the adjacent marine park (Fisher, 2024).</li> <li>• There has been gradual erosion of the foreshore adjacent to the GSC groyne, resulting in erosion at the terminal end of the groyne. As surge can now pass behind the groyne it's effectiveness is expected to reduce. Increased damage and breaching of the structure is expected in the future.</li> <li>• There is a division in coastal management responsibilities across the hotspot, which in turn influences coastal management responses e.g. a memorandum of understanding between DBCA and CoR is required to undertake sand nourishment of the DBCA managed area using sand from the Point Peron sand trap</li> <li>• The playing fields that belong to the Point Peron Camp School are very low lying, falling within a 1 and 5 year annual recurrence interval (ARI) inundation experienced in 2017 (Cardno, 2018).</li> <li>• The Point Peron Camp School is a significant recreational asset for DBCA. It is understood that DBCA may upgrade some facilities in the Camp School lease area in the future, with consideration of potential risks identified through the CHRMAP and the facilities to be upgraded.</li> <li>• Water Corporation is currently constructing a new treated wastewater transition tower at the Point Peron Wastewater Treatment Plant site, with the new tower expected to be operational until 2040. The new tower will enable the closure of the Point Peron Wastewater Treatment Plant, expected 2030 (City of Rockingham, 2019).</li> <li>• CoR are required to balance multiple coastal impacts when making coastal management decisions at this hotspot: a) erosion of the beach adjacent to GSC groyne, b) capacity of the sand trap and c) accumulation of sediment at the Point Peron boat ramps if the sand traps reach capacity.</li> </ul> |

*Figure 9-2: Sagging GSC groyne. Taken facing north during site visit 18 September 2024.*

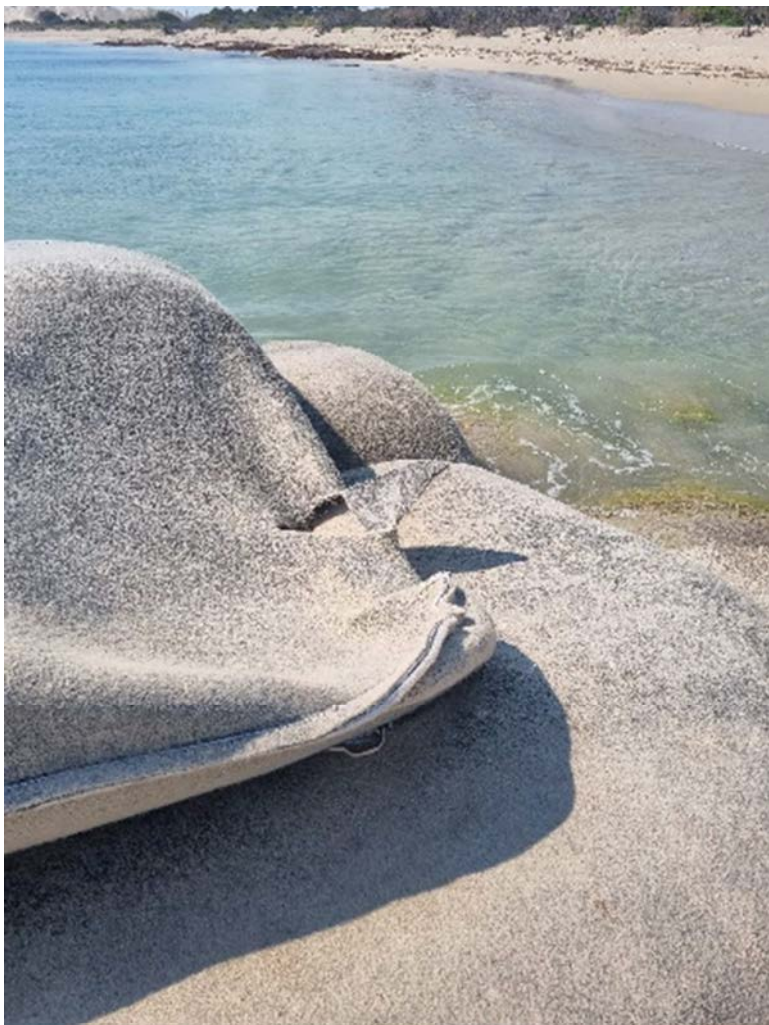
*Figure 9-3: Ripped bags at neck end of GSC groyne. Taken during site visit 18 September 2024.*

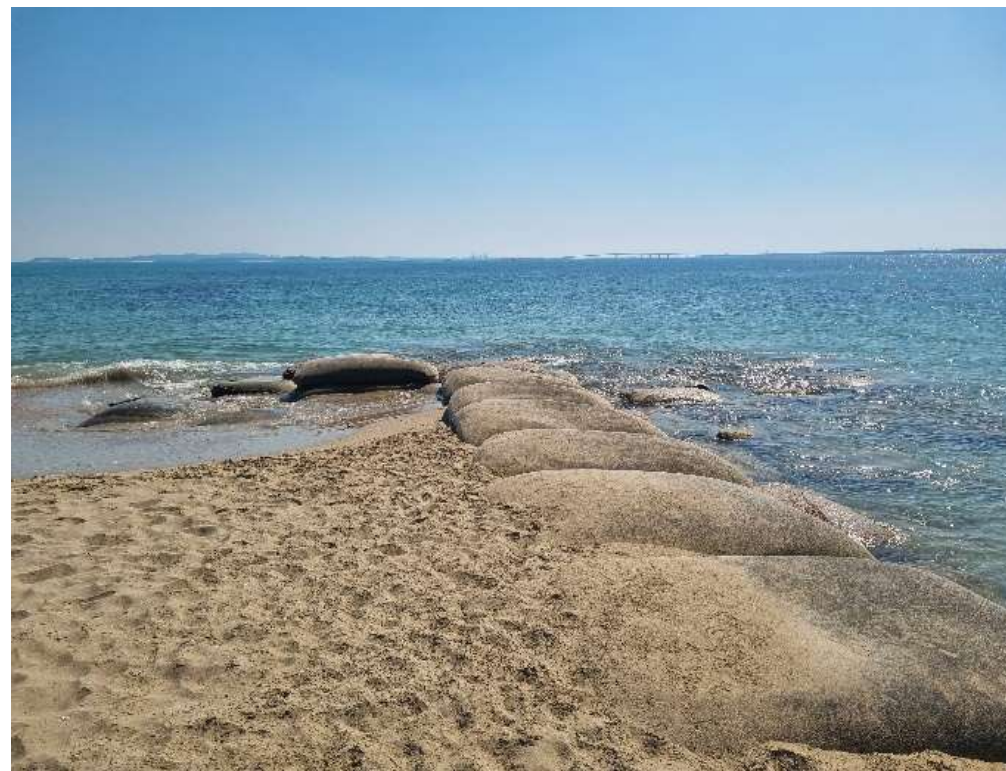
*Figure 9-4: Slumping at head of GSC groyne. Taken during site visit 18 September 2024.*

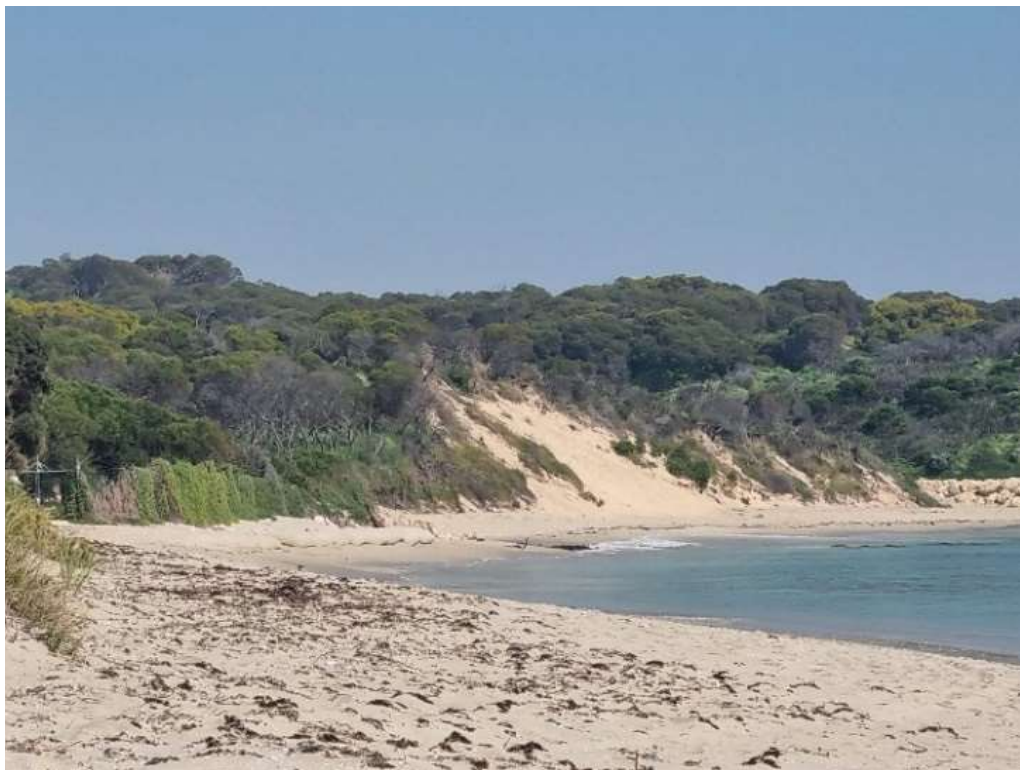
*Figure 9-5: Dune scarping in distance (+3050m), adjacent to the Point Peron holiday camp. Taken facing west during site visit 18 September 2024.*

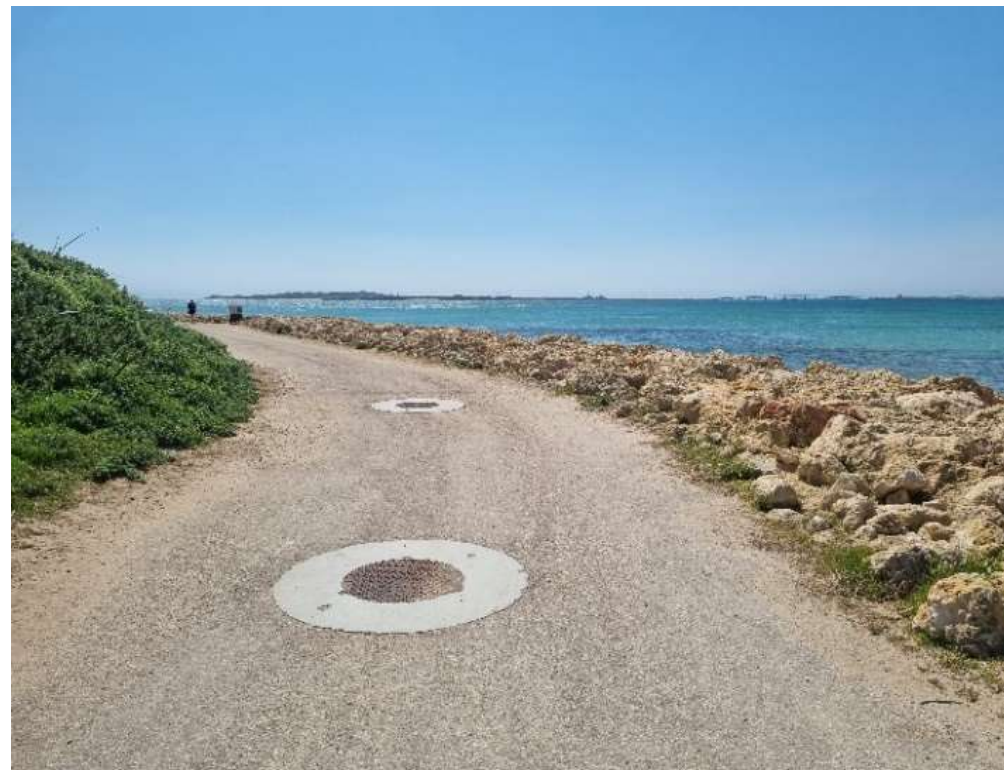
*Figure 9-6: Carpark end of DBCA revetment (+3100m) taken facing west during site visit 18 September 2024.*

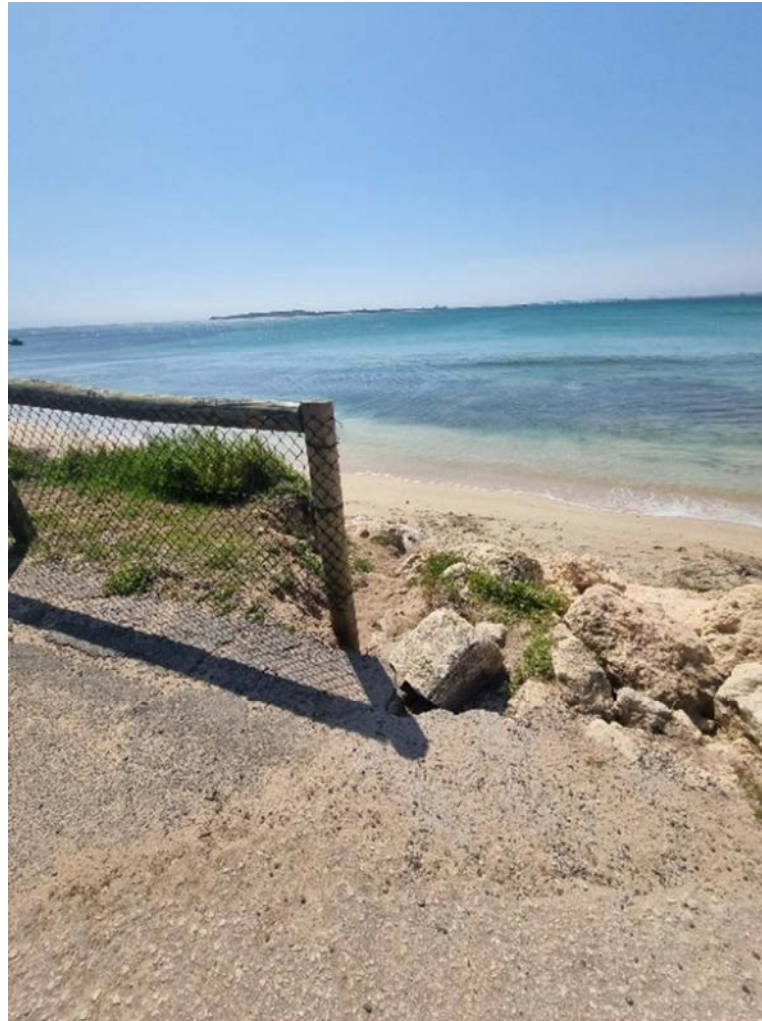
*Figure 9-9: Informal beach access (+1270m) at western end of DBCA revetment. Taken during site visit 18 September 2024.*

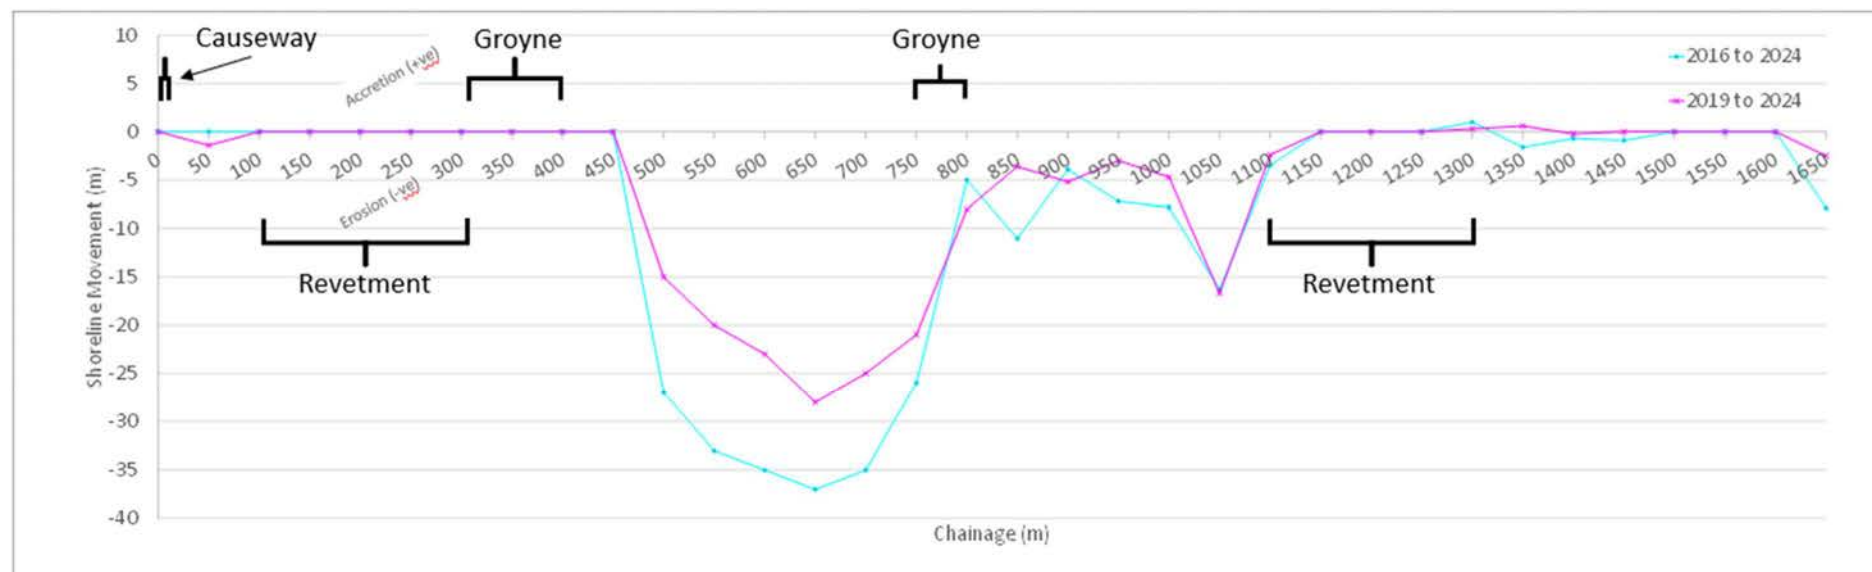
| ID | Category | Content |
|---|---|---|
| 8. | <b>Performance / Effectiveness of coastal management measure/s</b> | <p><b>Causeway to GSC Groyne (+0m to +750m)</b></p> <p>The most significant changes have been observed along a 300m stretch of beach between the two groynes (+500 to +800m). In this location, mid-term shoreline mapping indicates that up to 37 metres of beach has been lost to erosion in the last eight years, averaging four to five metres per year.</p> <p>Short-term monitoring has confirmed that this erosion trend has become more severe in the most recent five years, losing approximately 28m, an average of five to six metres per year.</p> <p>Survey profiles undertaken at the same location between July 2018 and February 2020 (JBA Surveys, 2020) also confirm the loss of ~13m of aerial beach width. Although not directly impacted by the sand scraping/trap activities, it is understood that littoral transport stressors are being transferred updrift of the sand trap.</p> <p><b>GSC Groyne to end (+750m to +1650m)</b></p> <p>Mid-term shoreline mapping indicates that erosion has occurred along the entire pocket beach extending from +800m to +1100m with the most significant up to 17 metres of beach occurring immediately east of the DBCA revetment, averaging two metres per year.</p> <p>Short-term monitoring has confirmed that this erosion trend has accelerated in the past four years, losing approximately 17m, an average of four metres per year.</p> <p>Analysis of aerial imagery shows the dune blow-out worsening where this erosive trend has been observed in both short and mid-term vegetation line mapping. It is likely that wave reflection off the DBCA revetment is continuing to focus wave action and erosive forces onto this location.</p> <p><b>Point Peron Boat Ramp Facility – rock structures</b></p> <p>The condition was not assessed due to excavation activities occurring during the site visit. It is assumed that this is in excellent condition due to the recent upgrade works.</p> <p><b>GSC Groyne</b></p> <p>The GSC groyne is deteriorating with bags slumping and rips apparent (refer Figure 9-2 and Figure 9-3. The combination of overtopping (associated with the low crest) and erosion on the down drift side could have led to recent erosion immediately west of the structure. In addition, it appears that the upgraded DBCA revetment may have interrupted the sediment supply into the compartment west of the groyne contributing to retreat on either side of the groyne. The groyne appears to be holding the vegetation line, however it is understood that this will erode quickly once more bags continue to fail and slump.</p> <p><b>DBCA revetment</b></p> <p>During the site visit 18 September 2024 , the revetment appeared in excellent condition, with well interlocked armour, consistent slopes (refer Figure 9-7 and Figure 9-8), and no signs of core exposure. This is expected given the recent upgrade was completed 2022.</p> |

Figure 9-11: Results of North Point Peron shoreline mapping, showing short and mid-term changes, for chainage reference refer to Figure 9-10.

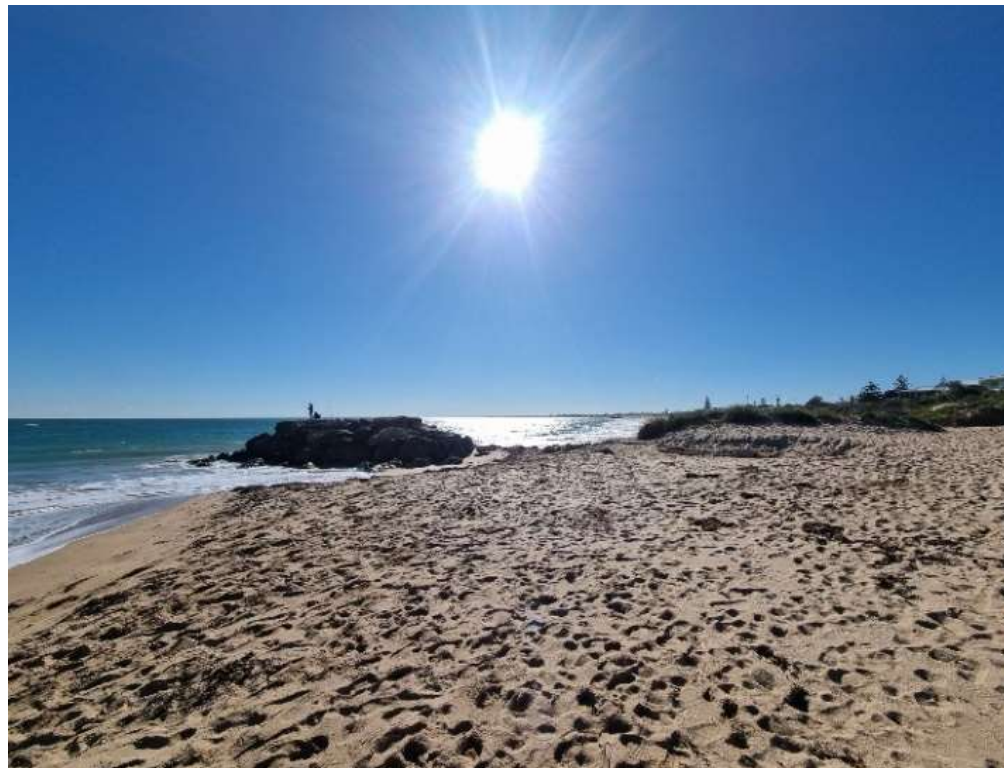
*Figure 10-2: Example of modifications made to Groyne 3 (Orion Rd). Taken facing north during site visit 1 July 2024.*

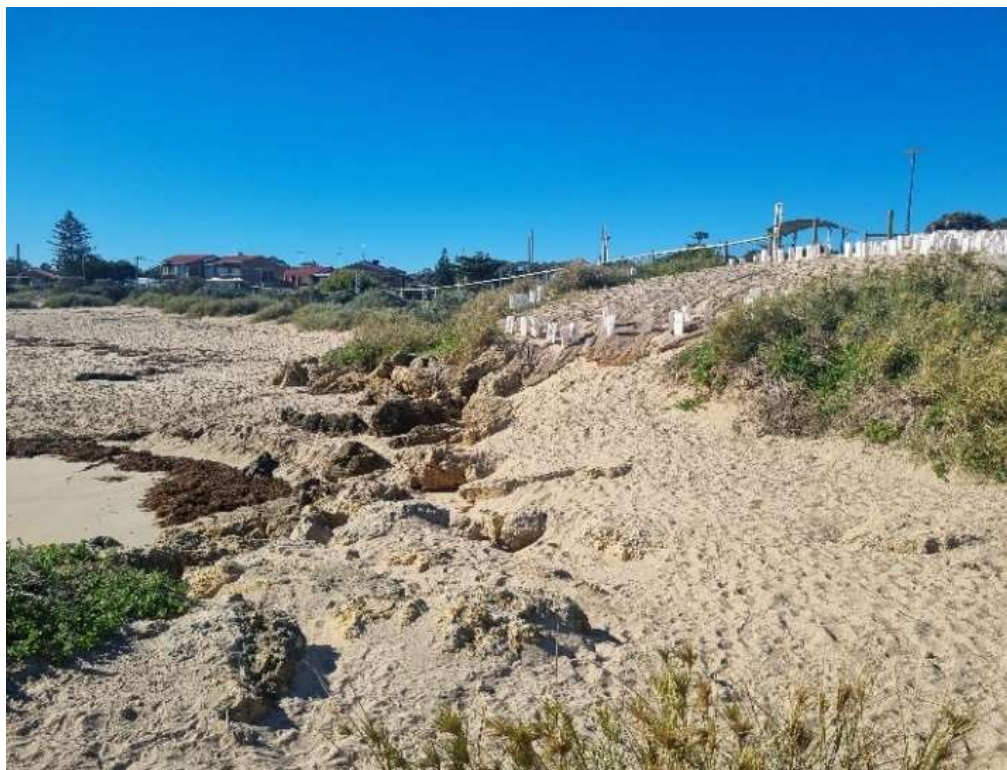
*Figure 10-3: Scattered armour transition between Groyne 2 (Henson St.) neck and dune system. Taken facing north-east during site visit 1 July 2024.*

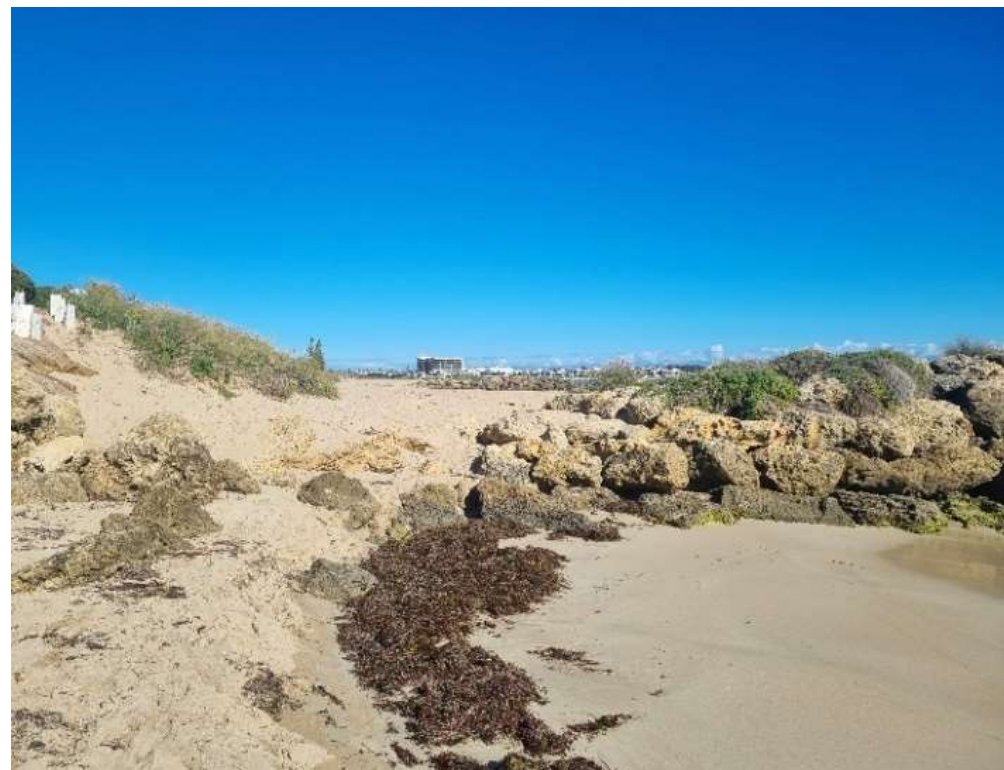
*Figure 10-4: Scattered armour transition between Groyne 2 (Henson St.) neck and dune system. Taken facing south-west during site visit 1 July 2024.*

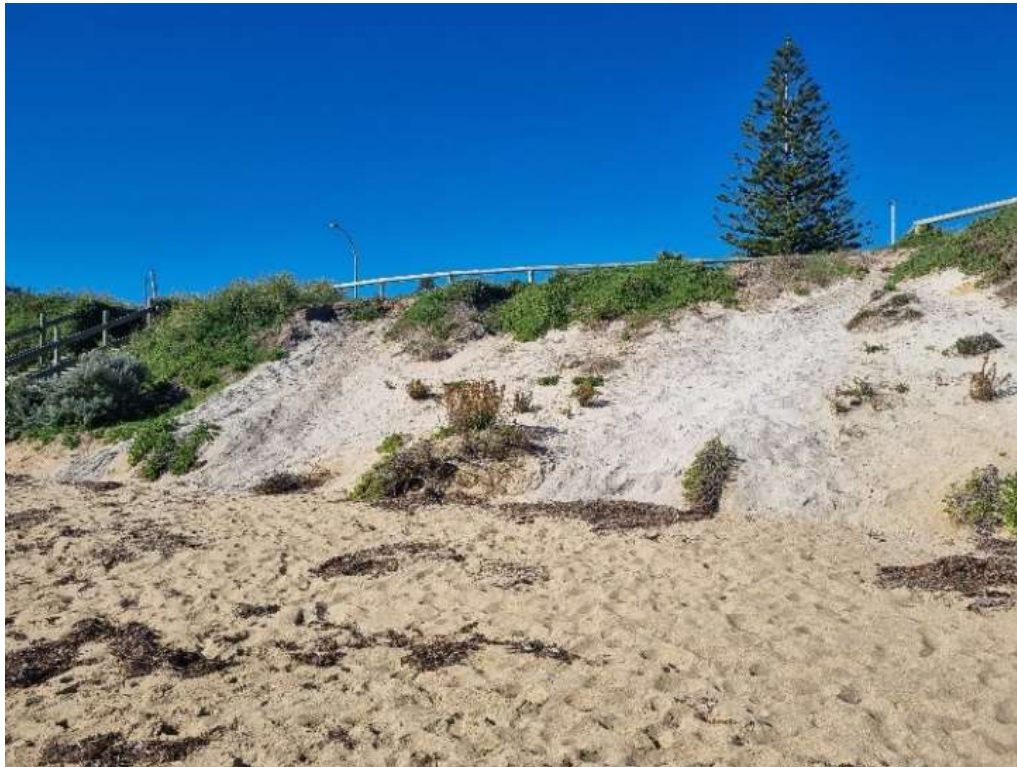
Figure 10-5: Footprints and erosion on northern side dune adjacent to Groyne 4 (Wade St.). Taken facing north-east during site visit 1 July 2024.

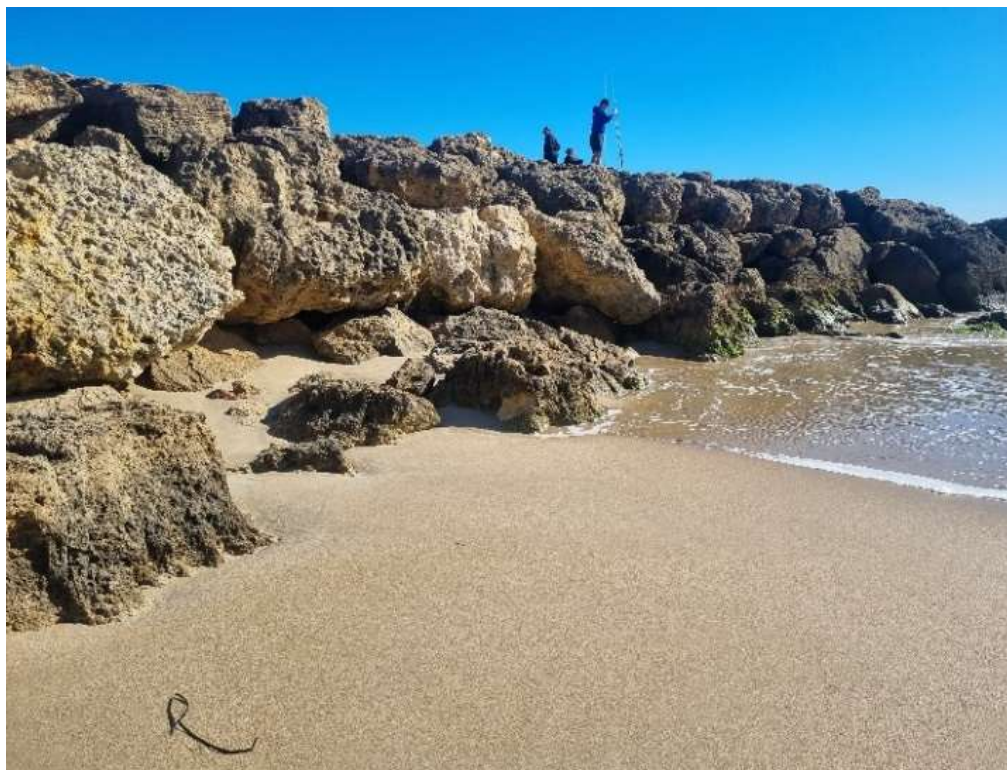
*Figure 10-7: Groyne 4 (Wade St.), some signs of poor interlocking and slope instability. Taken during site visit 1 July 2024.*

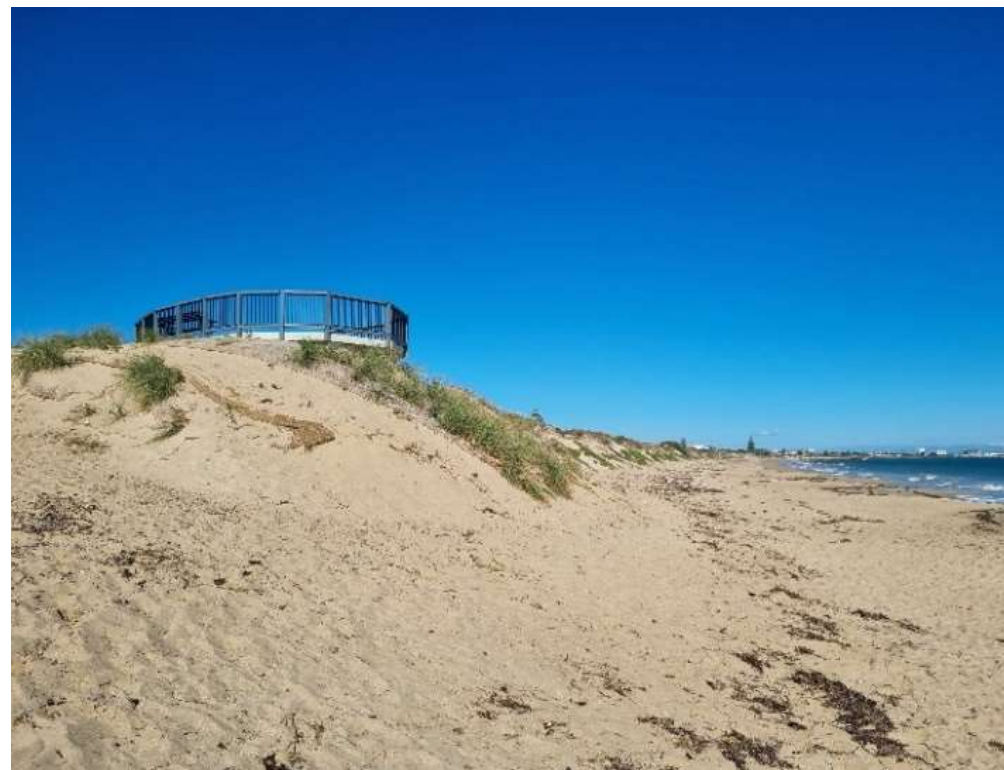
*Figure 10-8: Watersun beach lookout, dune stabilisation works recently completed. Taken facing south during site visit 1 July 2024.*

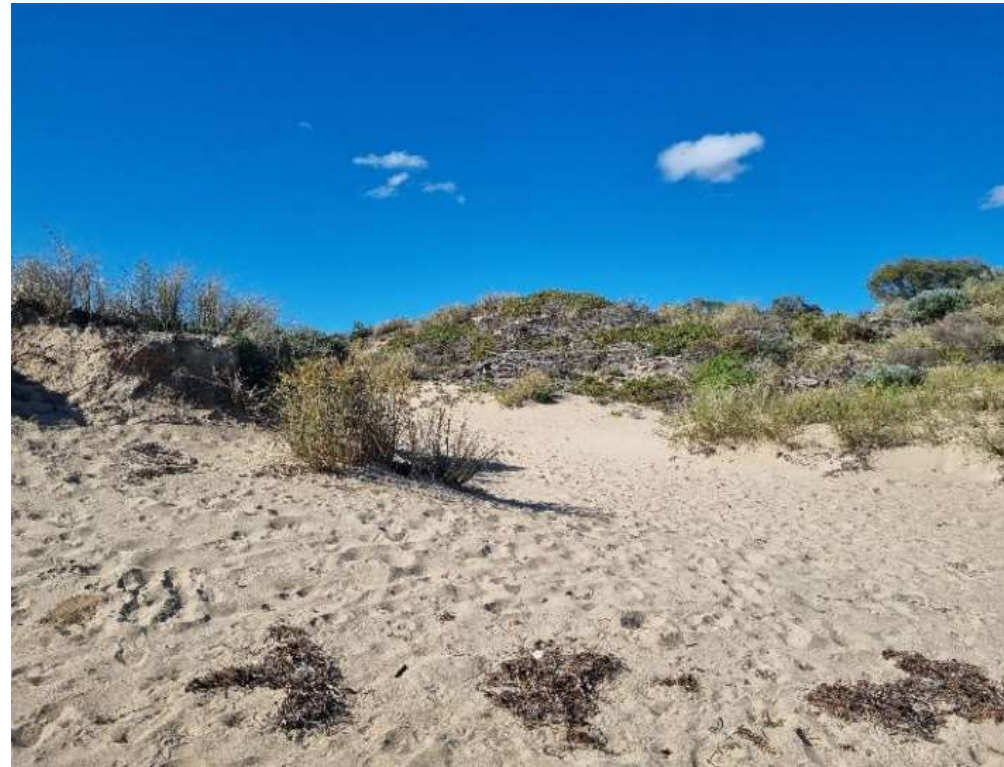
*Figure 10-10: Brushing dune stabilisation adjacent to Groyne 5 (San Remo), Taken during site visit 1 July 2024.*

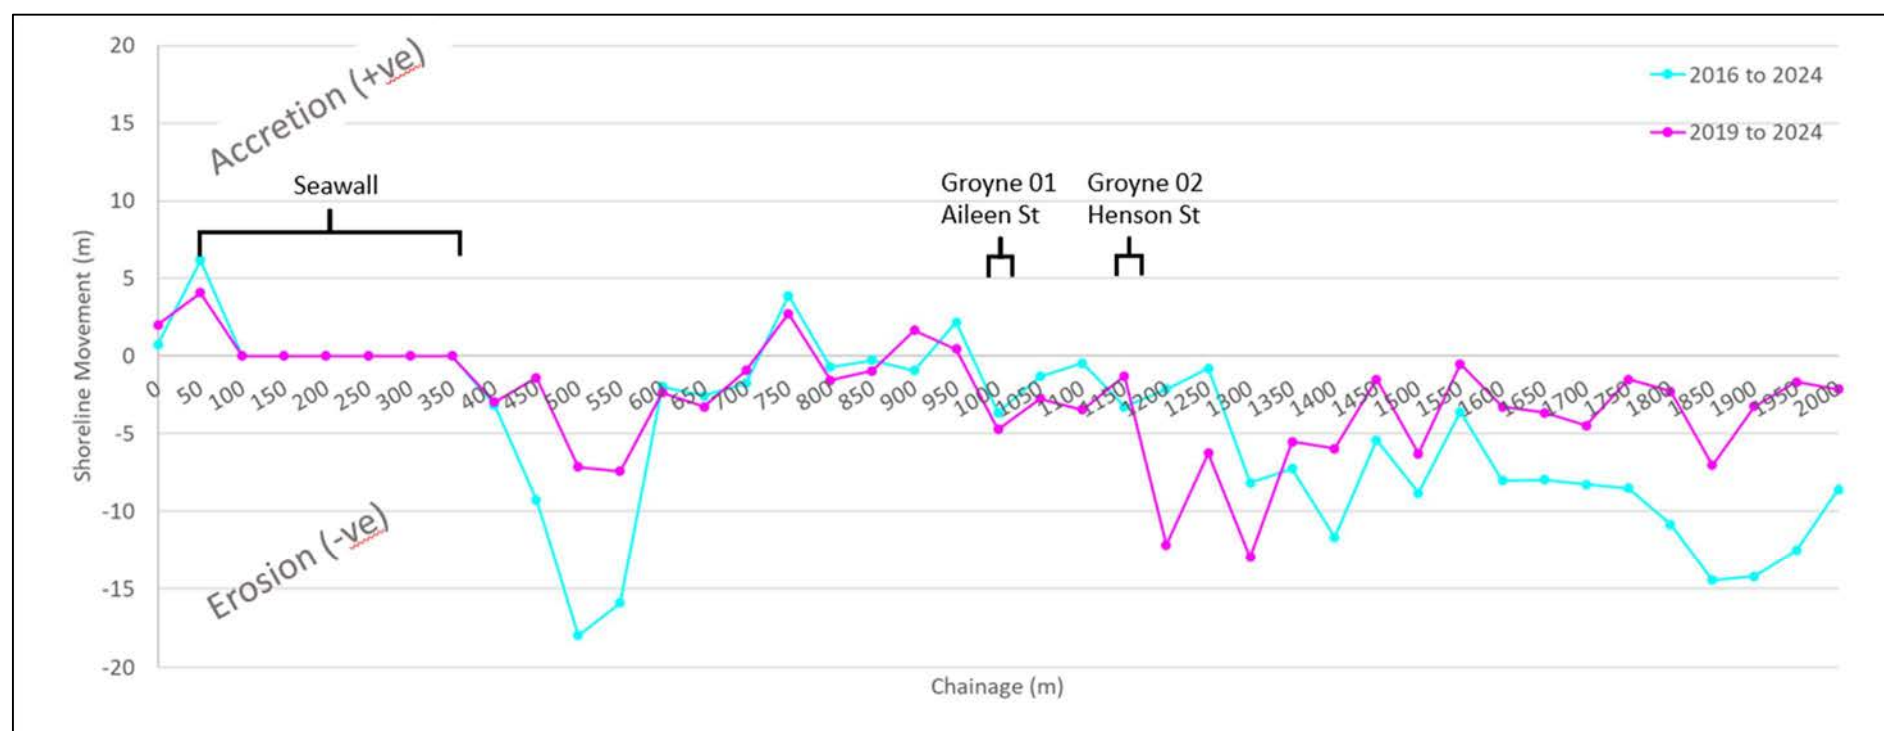
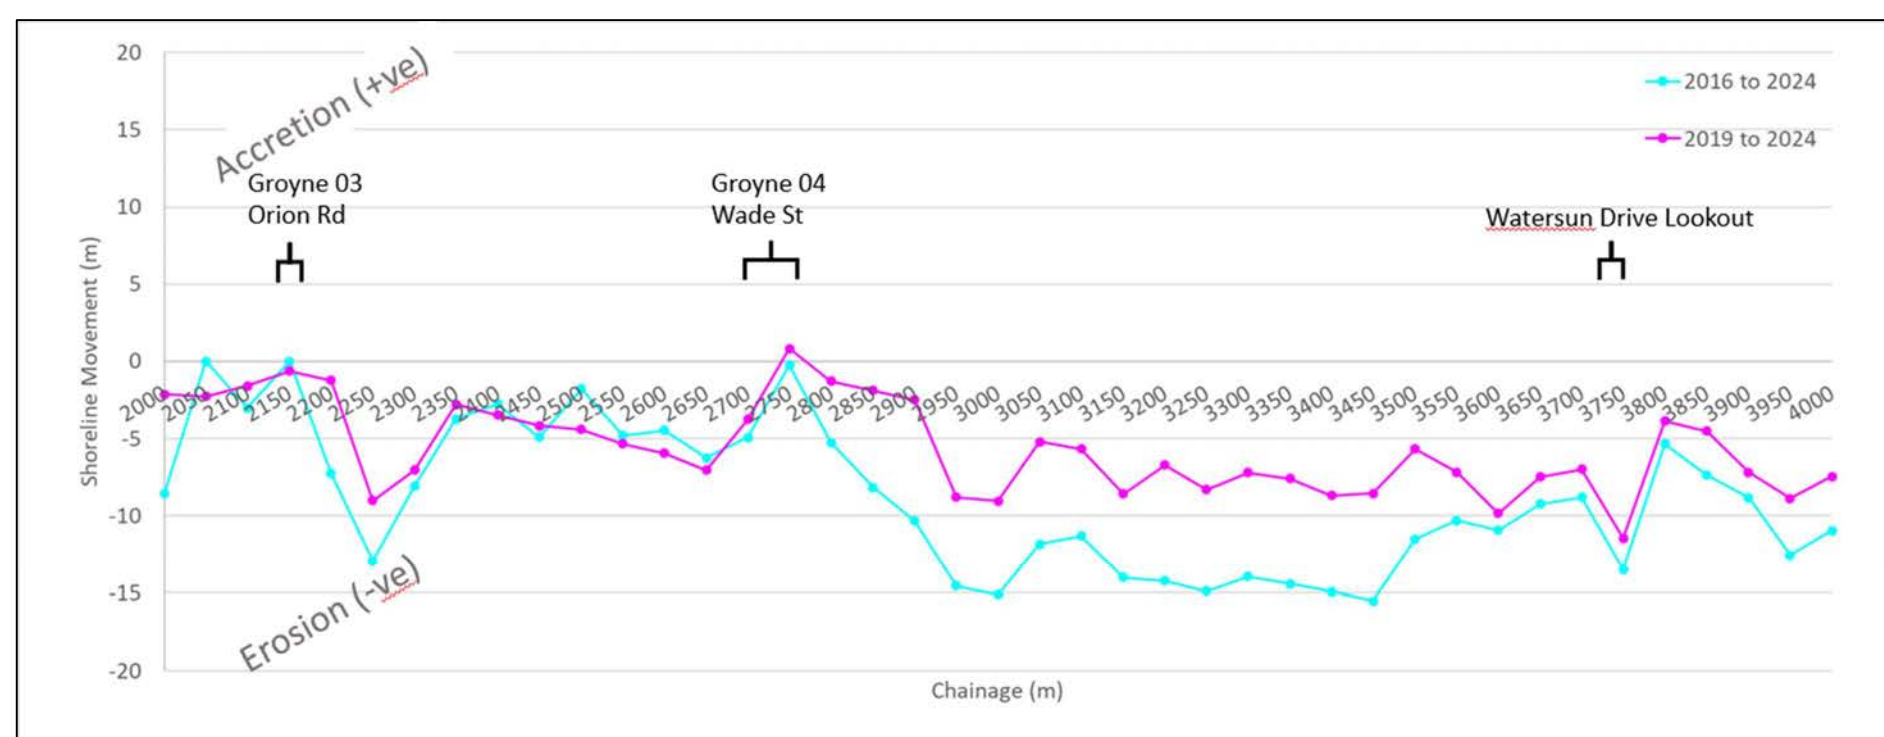
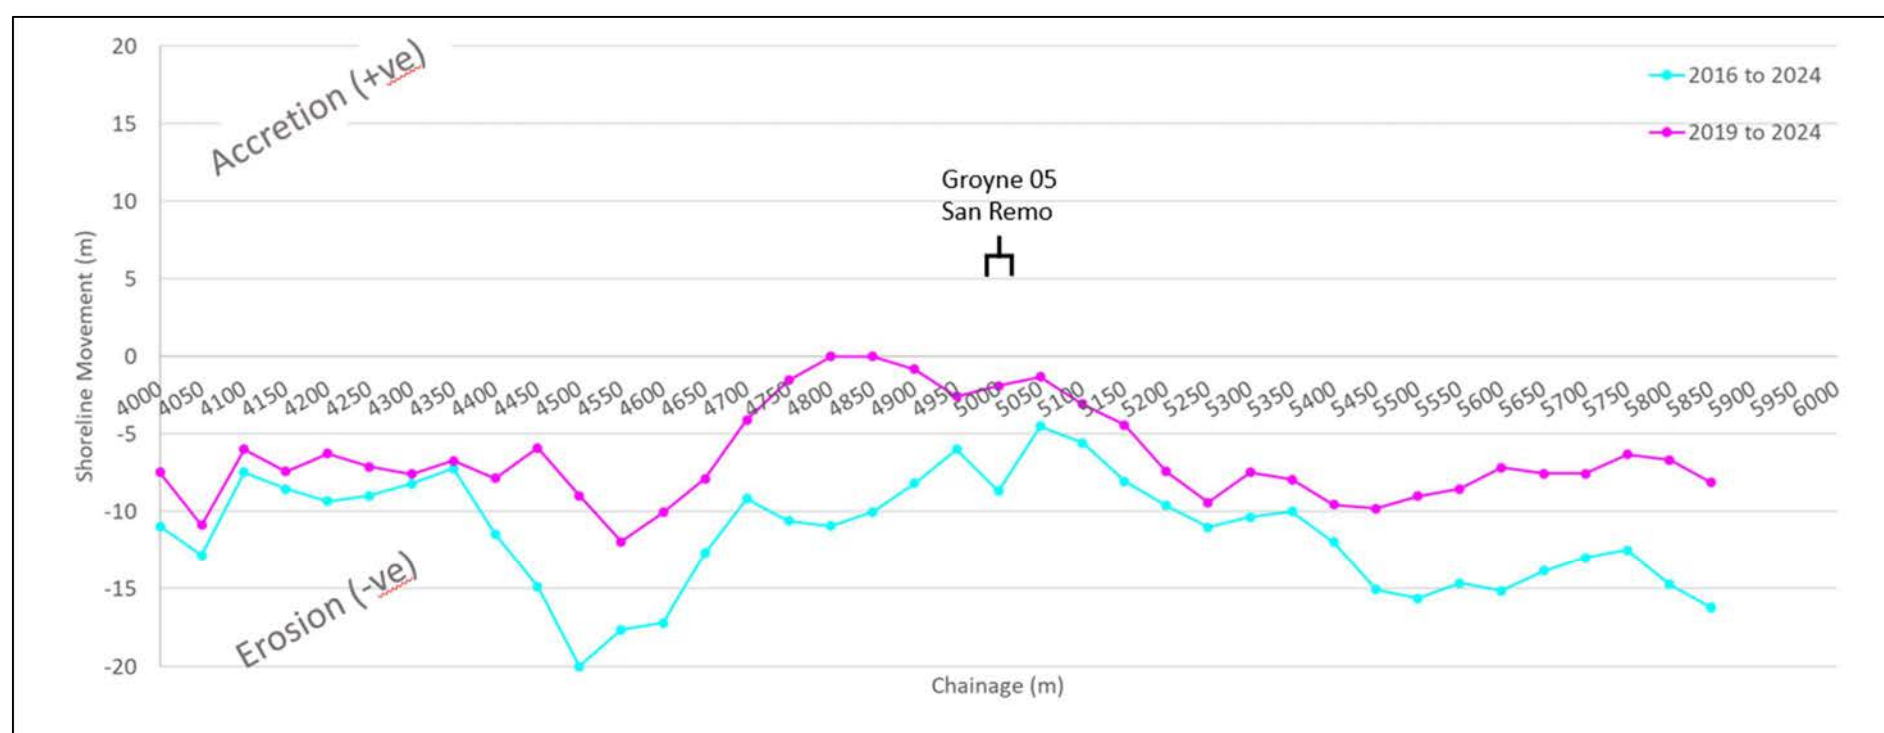
| ID | Category | Content |
|---|---|---|
| 8. | <b>Performance / Effectiveness of coastal management measure/s</b> | <p>Mid and short-term shoreline mapping has been undertaken using satellite imagery, and beach changes in 50 m increments are presented in Figure 10-14.</p> <p>Analysis of 2024 aerial imagery indicates that Groynes 1-5 are all at saturation. Therefore, sand introduced into the system from offshore sources and bypassing discharge, is typically transported northward during littoral transport and expected to continue uninterrupted along this stretch of coastline.</p> <p><b>Town Beach to First Groyne (Aileen St)</b></p> <p>The Town Beach seawall condition has been reported in 2018 (M P Rogers and Associates) and most recently in 2024 (M P Rogers &amp; Associates). This condition assessment classed the seawall from fair to good condition across chainages 100 to 380 m. Chainages 0 to 100 and 380 to 420 are understood to be buried and not visible for inspection.</p> <p>Upgrade of the seawall was originally proposed for 360 m of the seawall, but the scope was since reduced to a 200 m section immediately adjacent to the Seashells Resort.</p> <p>During the site visit conducted on 1 July 2024 voids adjacent to the footpath were observed (refer Figure 10-1. Such voids were documented in both 2018, and 2024 inspections, expected to be from a combination of wave overtopping washing through the voids, as well as settlement of the structure leading to toe scour and loss of material. The proposed seawall upgrade intends to build the new crest higher than the pedestrian access, to minimise pedestrian access over the seawall.</p> <p>Mid-term shoreline mapping indicates that the coastline, up to 400 m north of the seawall, has been undergoing erosion (up to 18 m) between 2016 and 2024. The most significant erosion occurs 100 to 250 m north of the revetment. This is equivalent to approximately two metres per year. Beyond this stretch, up to the First Groyne the vegetation lines indicate a stable shoreline.</p> <p>Short-term mapping between 2019 and 2024, indicates that the erosion trend north of the seawall has continued at approximately one to two metres per year. The vegetation lines immediately south of the First Groyne indicate a stable shoreline.</p> <p><b>First Groyne to Groyne (Orion Rd.)</b></p> <p>Short and mid-term shoreline mapping indicates that the coastline, between the First Groyne and Second Groyne (Henson St.), has been undergoing erosion (less than one metre per year annually).</p> |

Figure 10-14: Results of Mandurah northern beach shoreline mapping, showing short and mid-term changes, for chainage reference refer to Figure 10-11, Figure 10-12 and Figure 10-13.

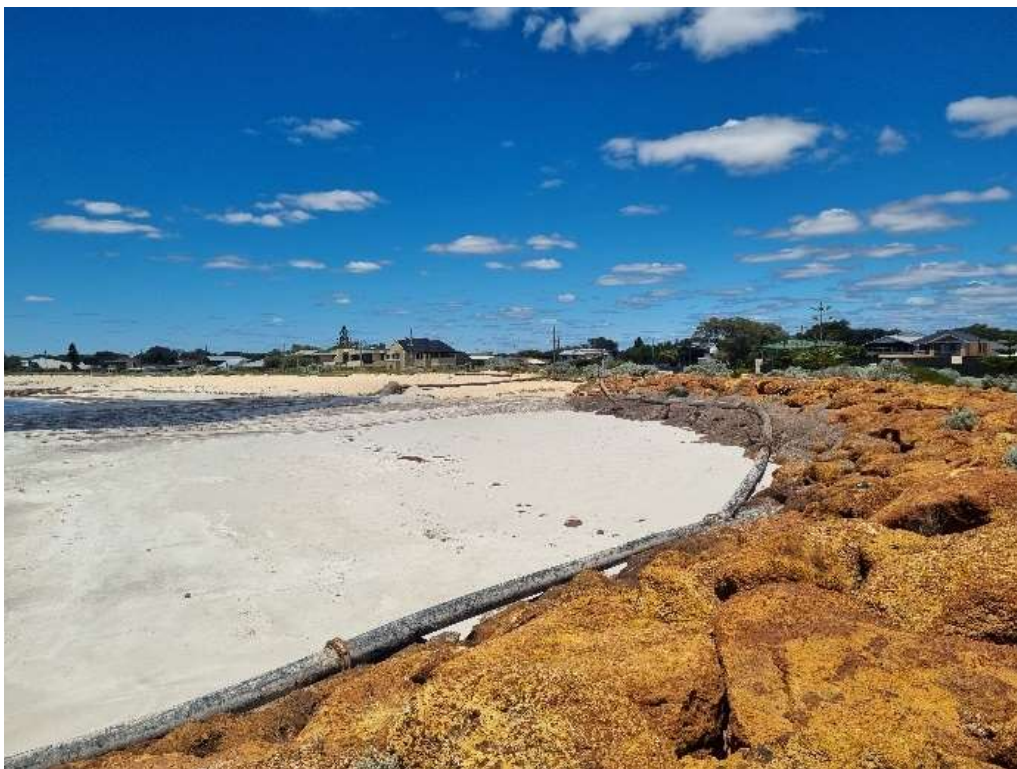
*Figure 11-1: Port Geographe eastern revetment, approximate chainage +25 m. Showing dredged material being pumped onto Wonnerup beach during site visit 27 November 2024.*

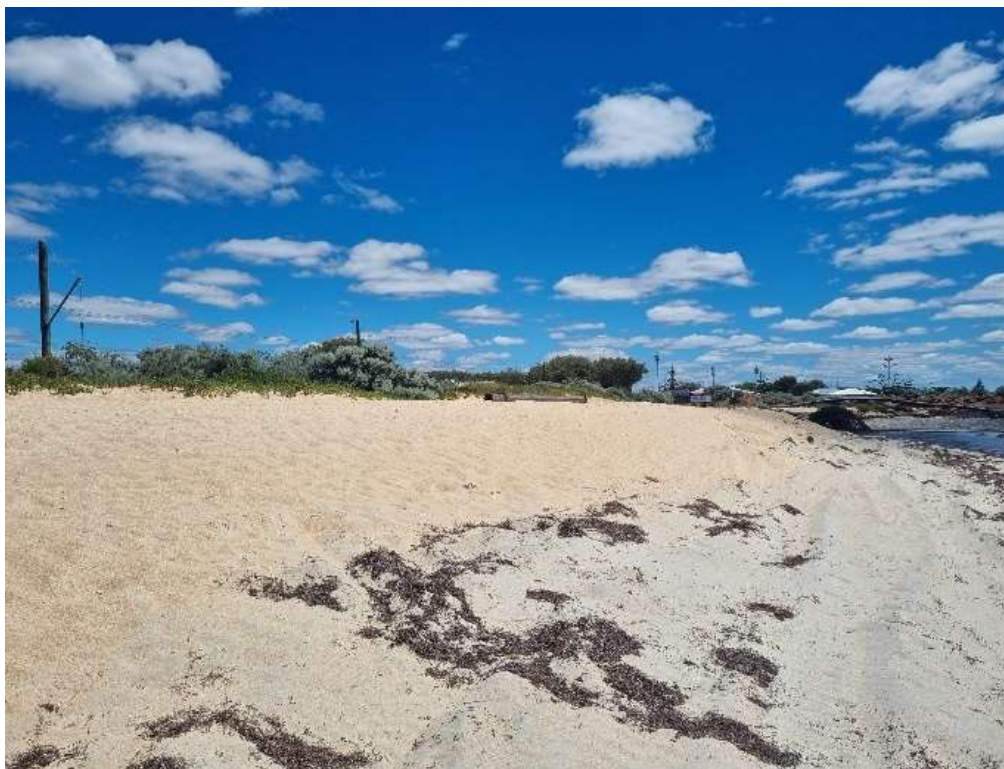
*Figure 11-2: West Wonnerup aerial beach nourished with trucked sand taken during site visit 27 November 2024.*

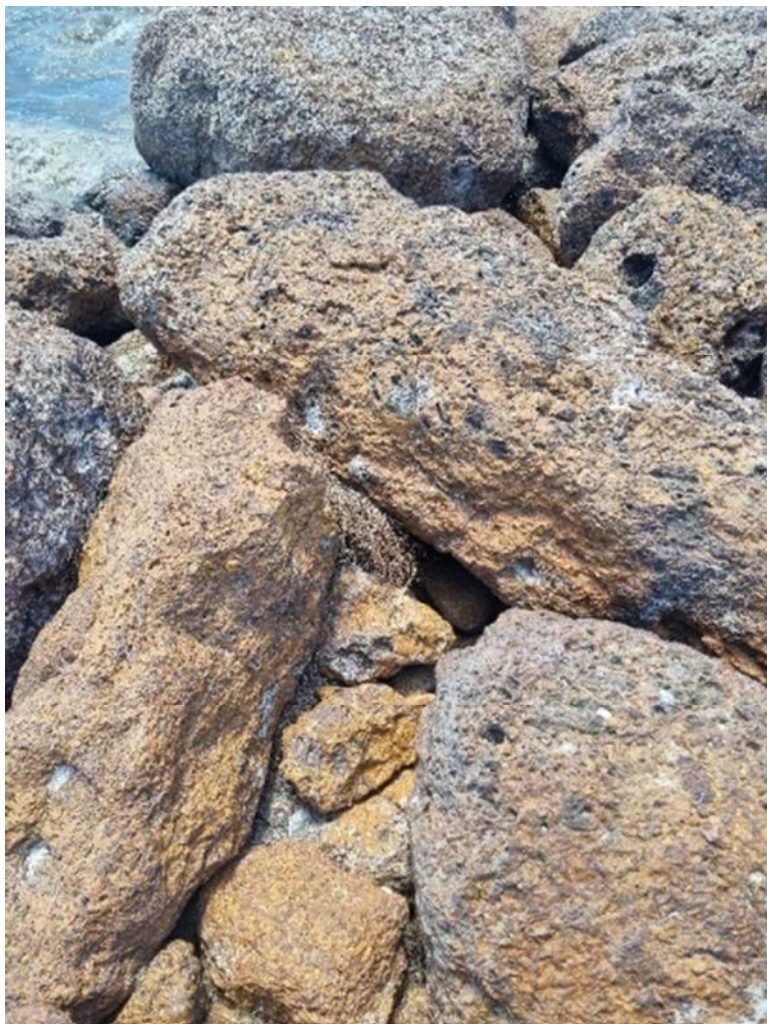
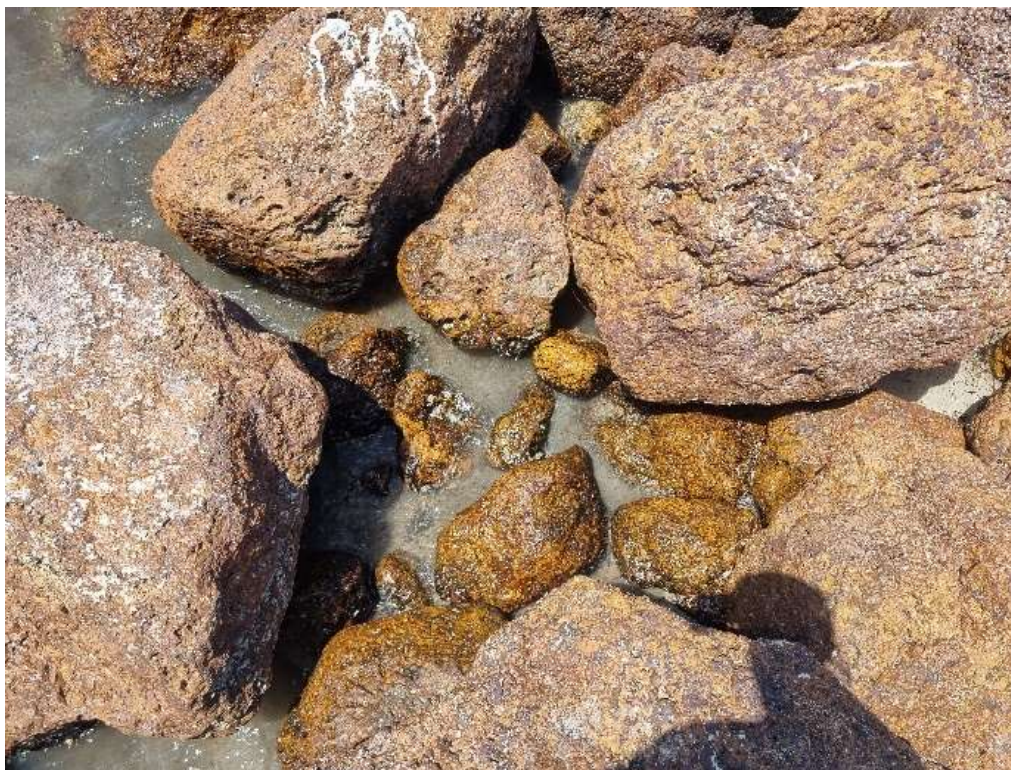
*Figure 11-3: Groyne 1 (+250m), laterite rock core exposed with minimal armour cover. during site visit 27 November 2024.*

*Figure 11-4: Groyne 1 (+250m), laterite rock core exposed with minimal armour cover. during site visit 27 November 2024.*

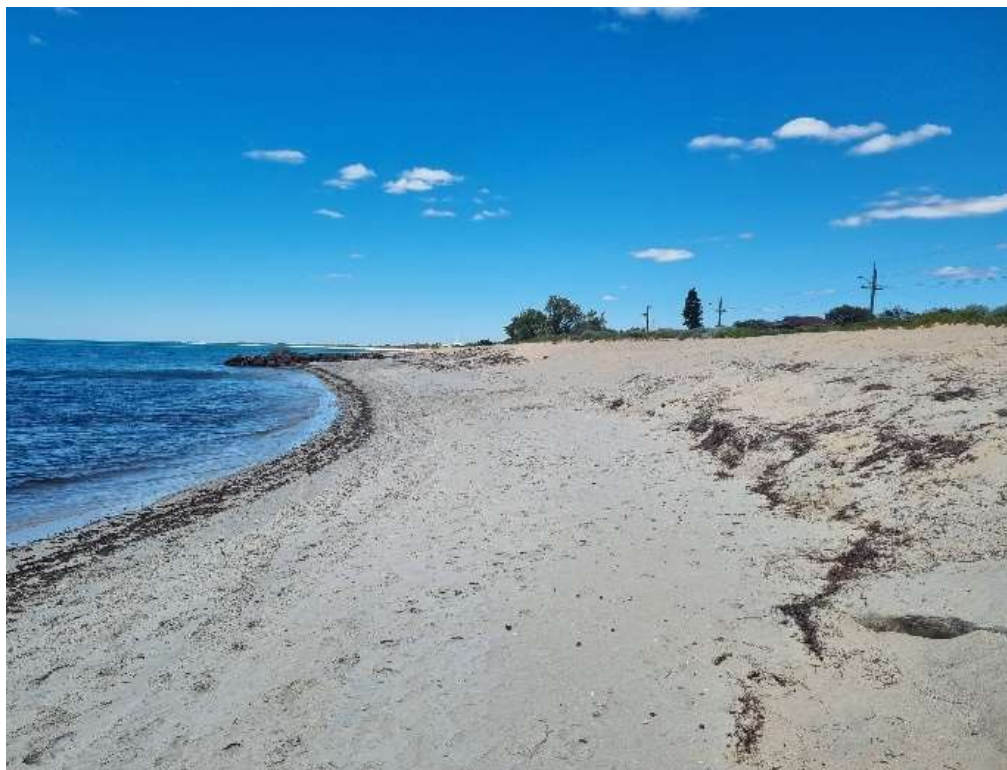
*Figure 11-5: Beach compartment between Groyne 1 & 2 (+300m), beach crest consisting of recently nourished sand taken during site visit 27 November 2024.*
