# WA Coastal Erosion Hotspots

## Review of Coastal Management History - 12 Sites

Document no. Rev 1: 311012-02081-CS-REP-001

12 June 2025

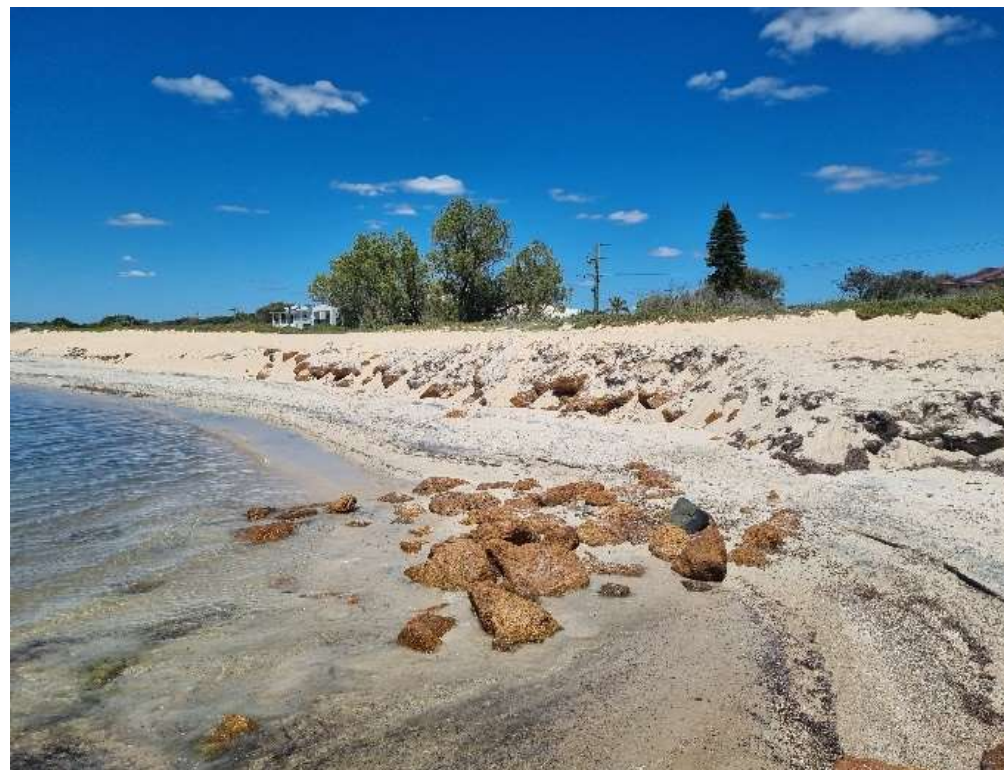
*Figure 11-6: Immediately north of Groyne 2, laterite armour rock scattered on beach and informal seawall present (+360m) taken during site visit 27 November 2024.*

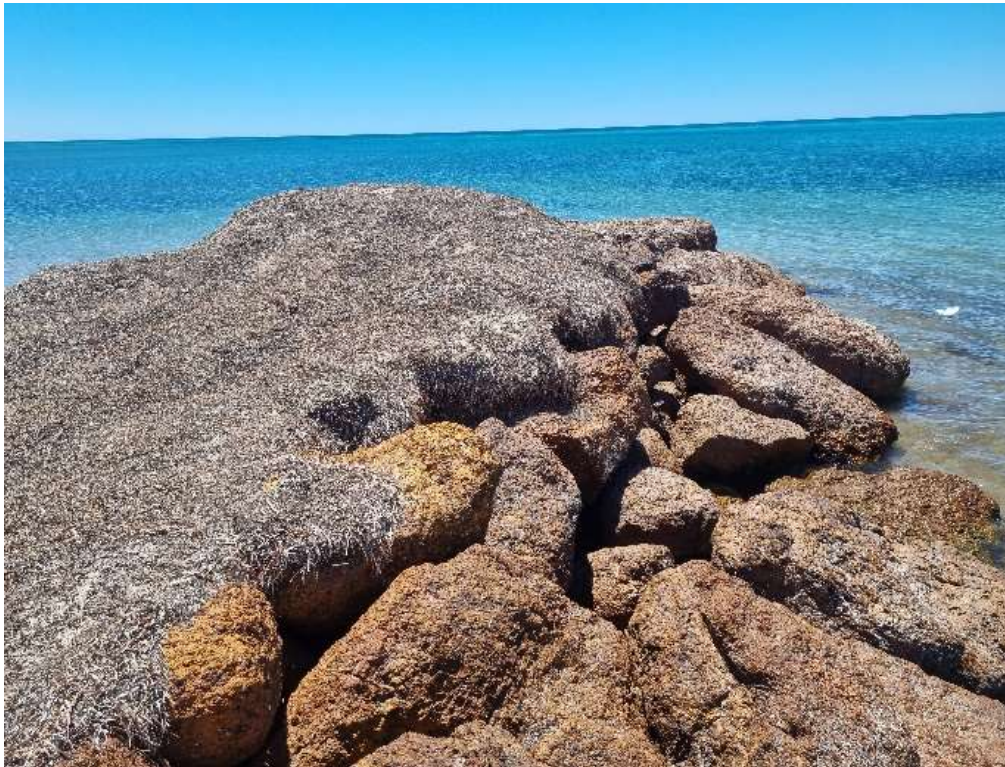
*Figure 11-7: Wrack accumulated on crest of Groyne 2 (+350m) taken during site visit 27 November 2024.*

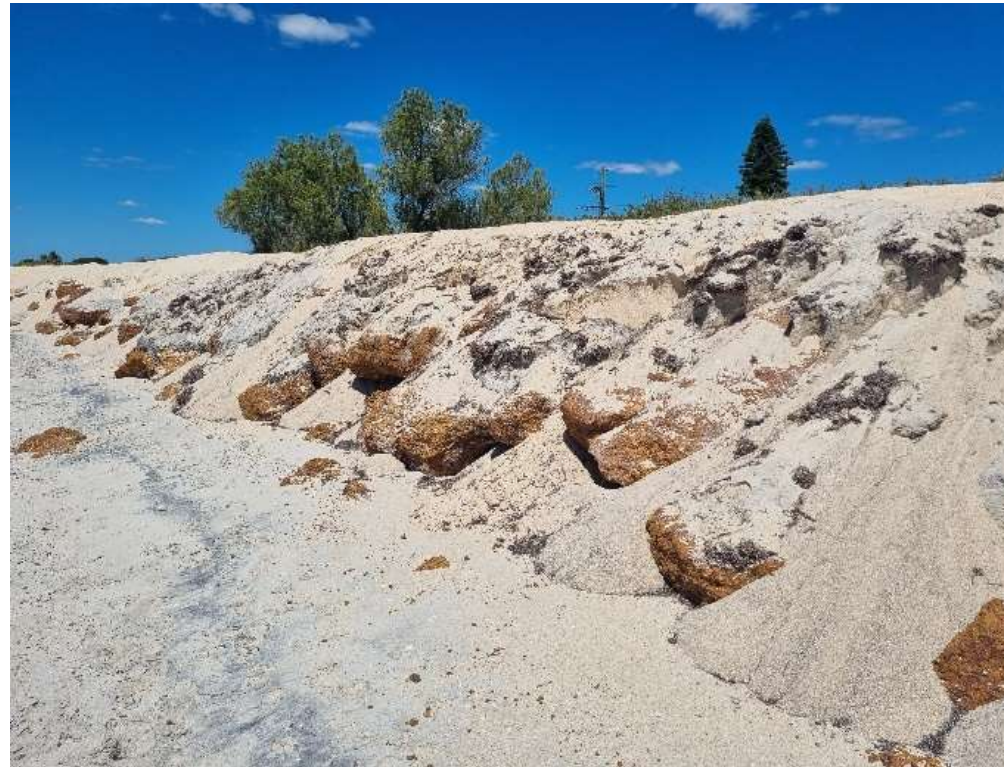
*Figure 11-8: Informal seawall (+370m) taken during site visit 27 November 2024.*

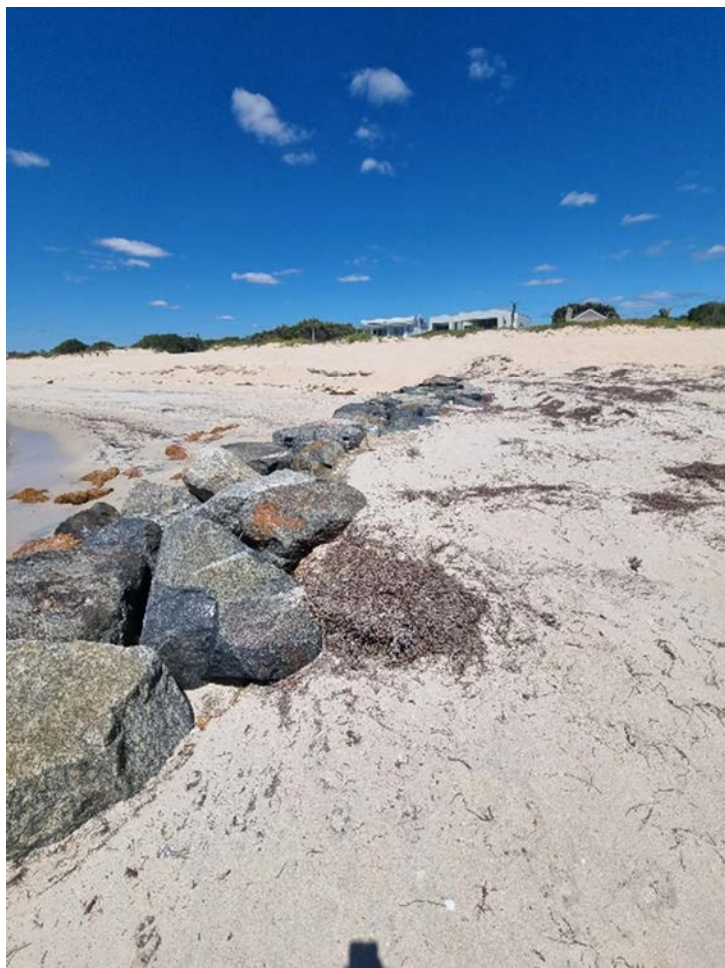
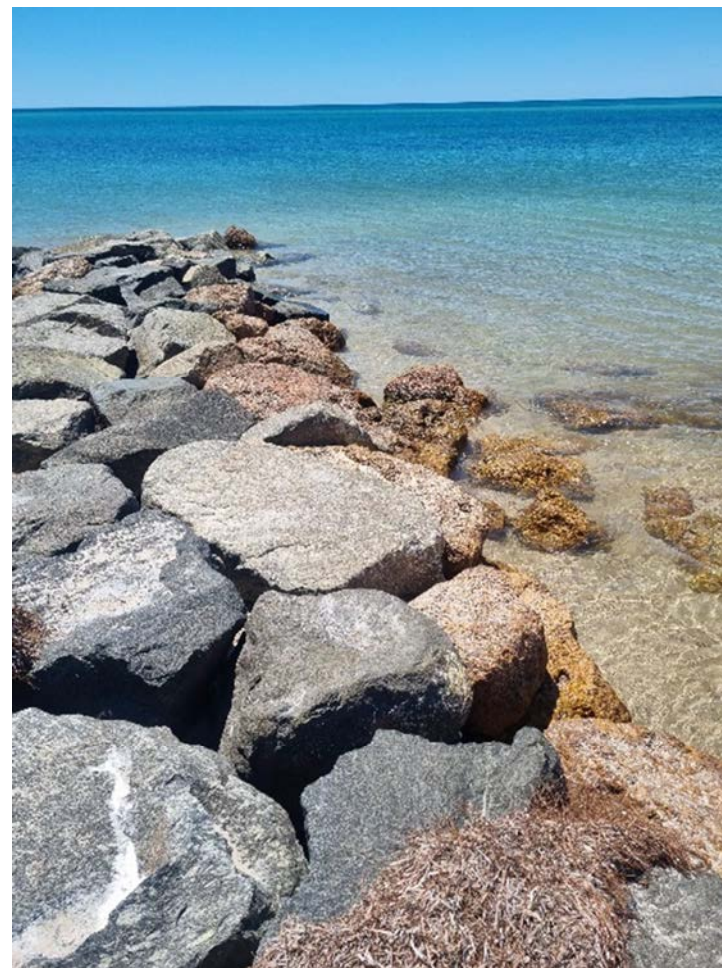
*Figure 11-9: Groyne 3 (+475m), some scattered laterite immediately north, taken during site visit 27 November 2024.*

*Figure 11-10: Groyne 3 (+475m), some scattered laterite immediately north, taken during site visit 27 November 2024.*

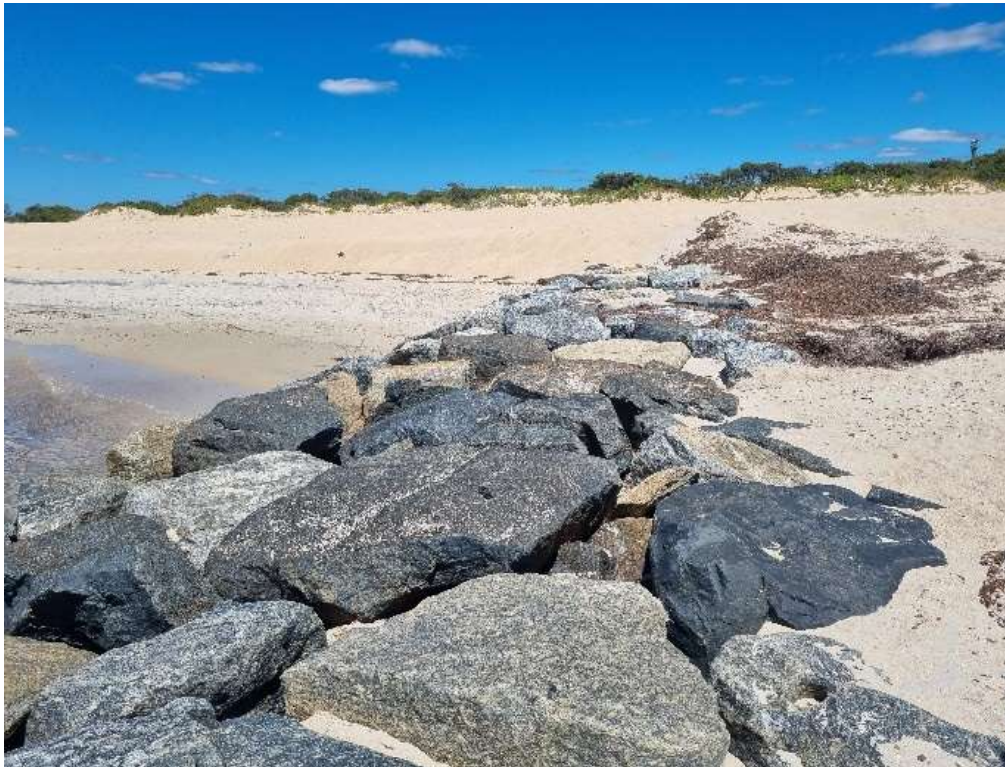
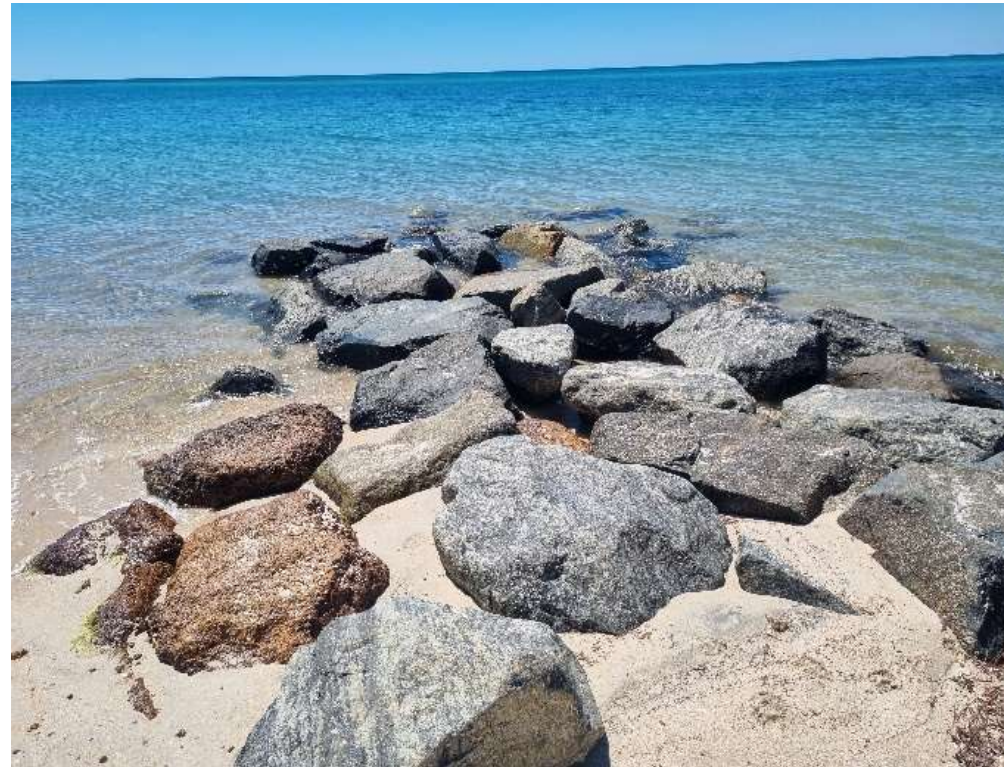
*Figure 11-11: Groyne 4 taken during site visit 27 November 2024.*

*Figure 11-12: Groyne 4 taken during site visit 27 November 2024.*

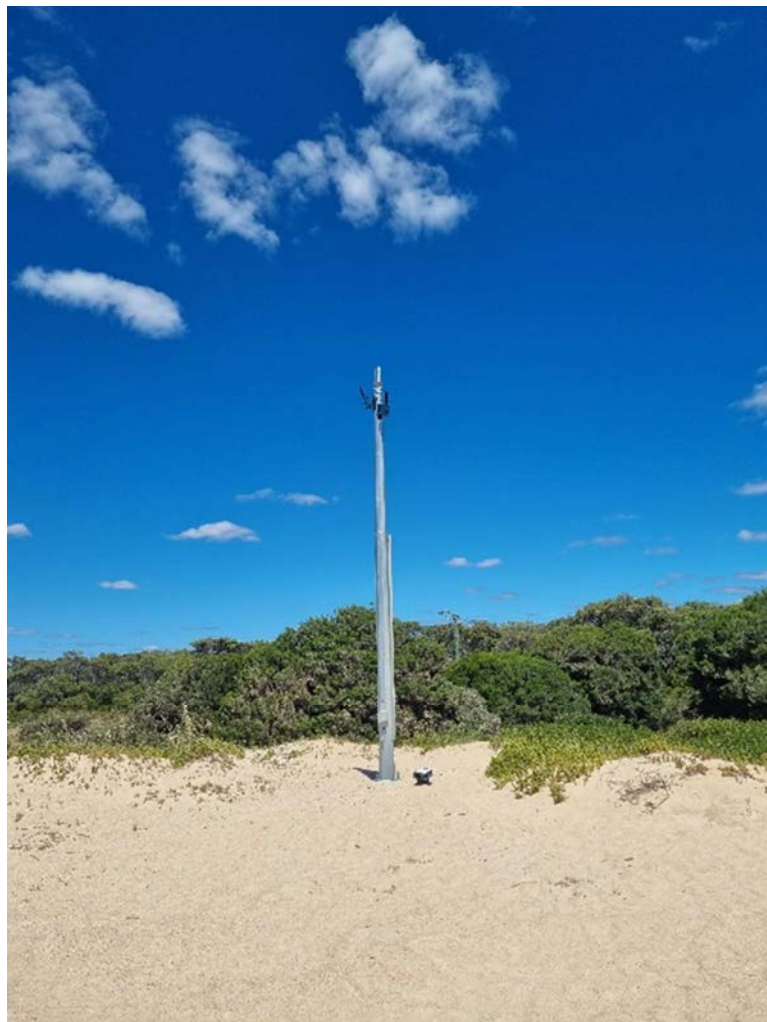
*Figure 11-13: Remote image capture station (+575m), taken during site visit 27 November 2024.*

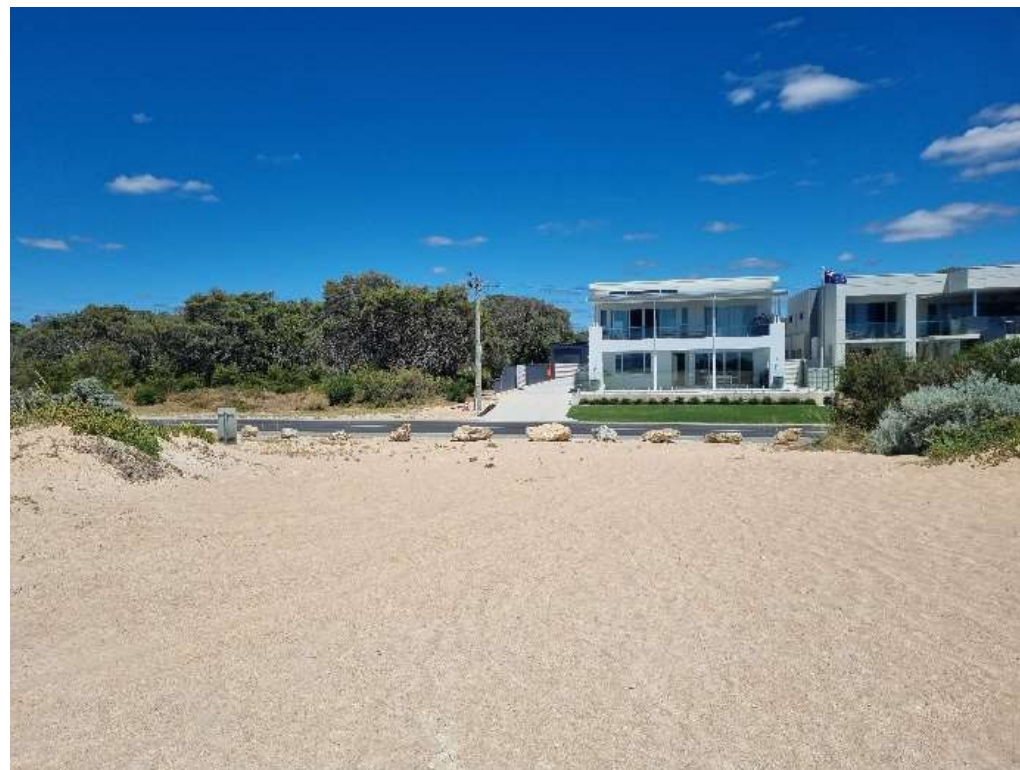
*Figure 11-14: Beach access for nourishment equipment (+525m) taken during site visit 27 November 2024.*

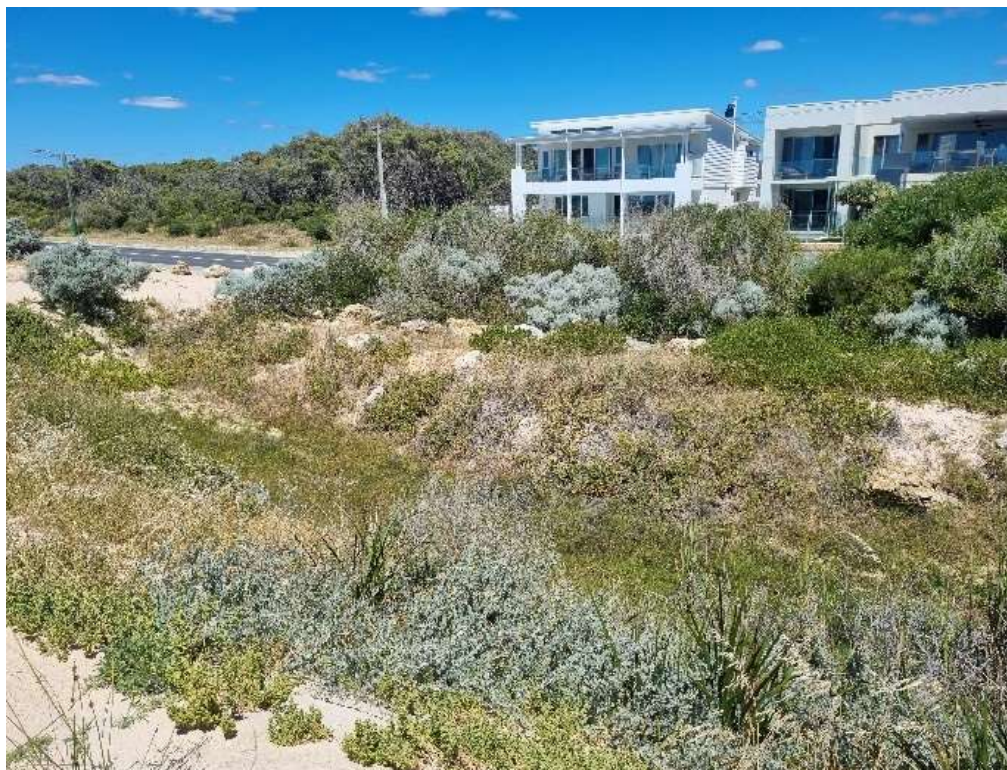
*Figure 11-15: informal seawall behind primary dune (+500m), taken during site visit 27 November 2024.*

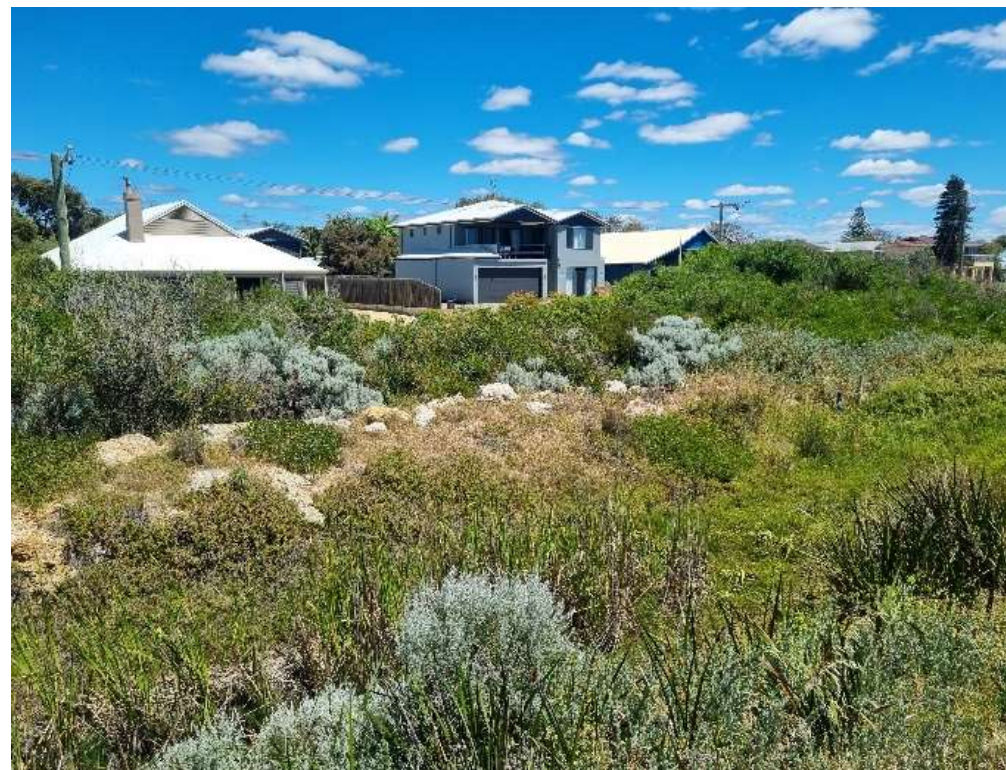
*Figure 11-16: Buried informal seawall behind primary dune (+500m), taken during site visit 27 November 2024.*

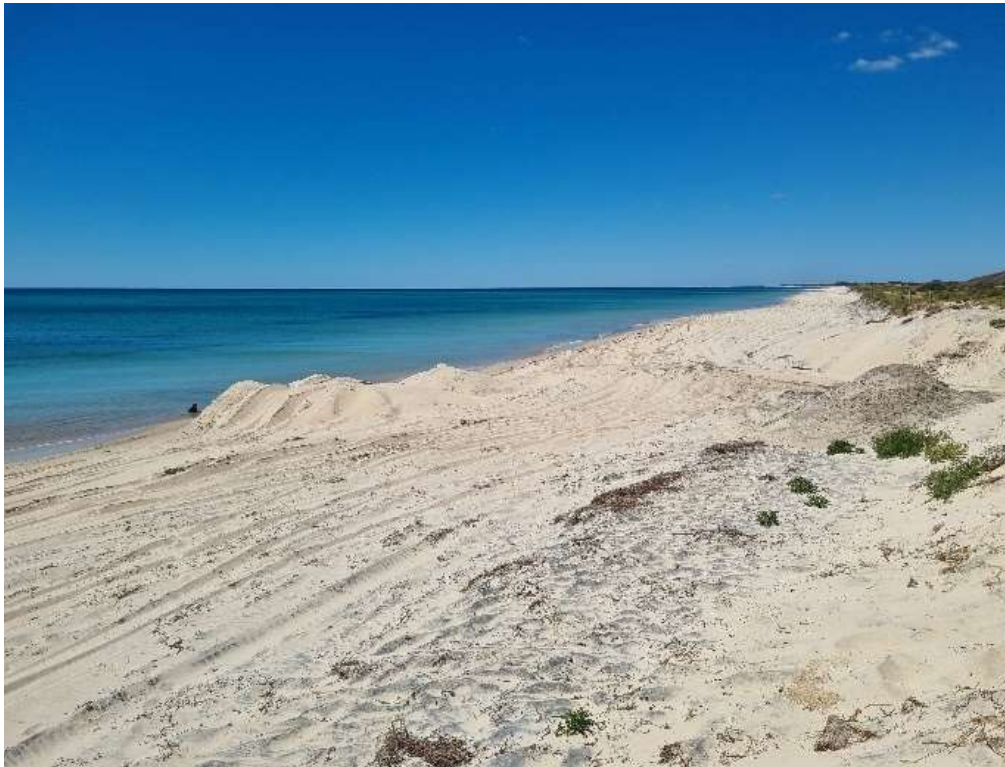
*Figure 11-17: Four-wheel-drive beach access/trailer launch (+1875m) taken during site visit 27 November 2024.*

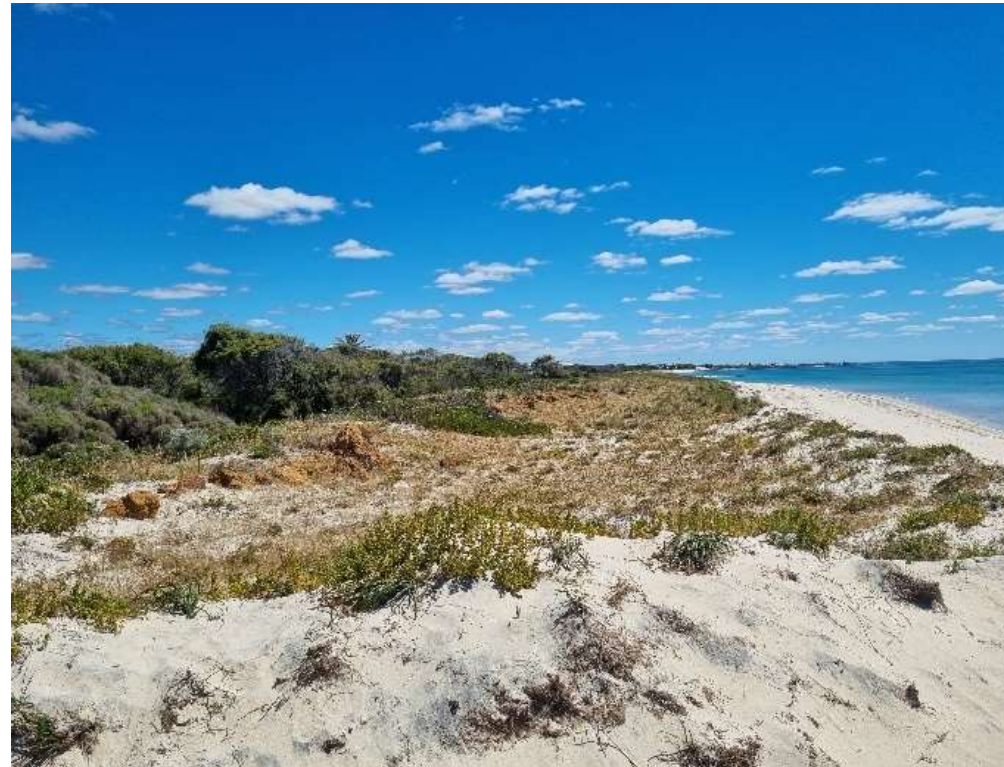
*Figure 11-18: Buried informal seawall behind primary dune (+1800m), taken during site visit 27 November 2024.*

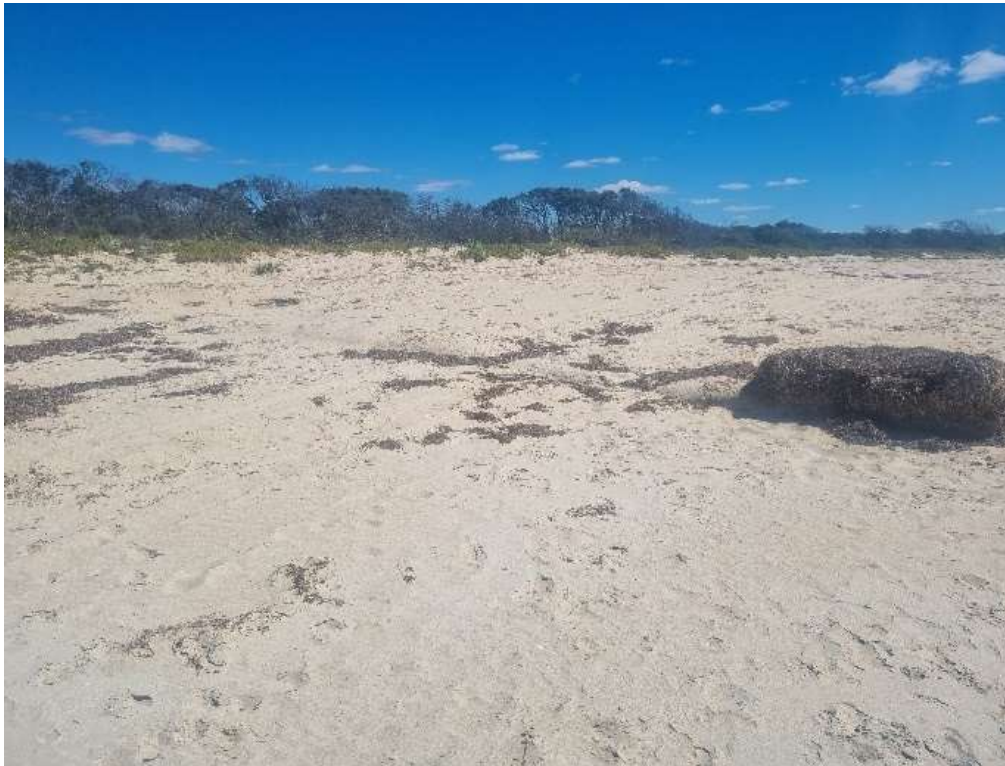
*Figure 11-19: GSC Groyne 8, exposed bags driven over by four-wheel-drives taken during site visit 27 November 2024.*

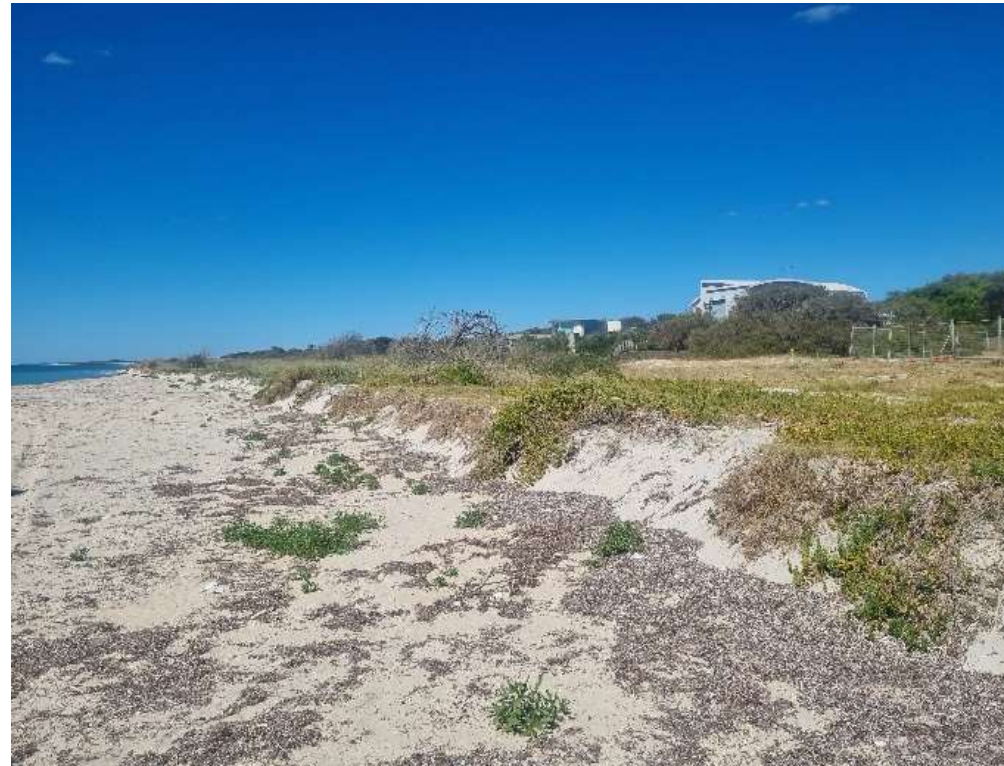
*Figure 11-20: Scarping to vegetation between Groyne 9 and 10 taken during site visit 27 November 2024.*

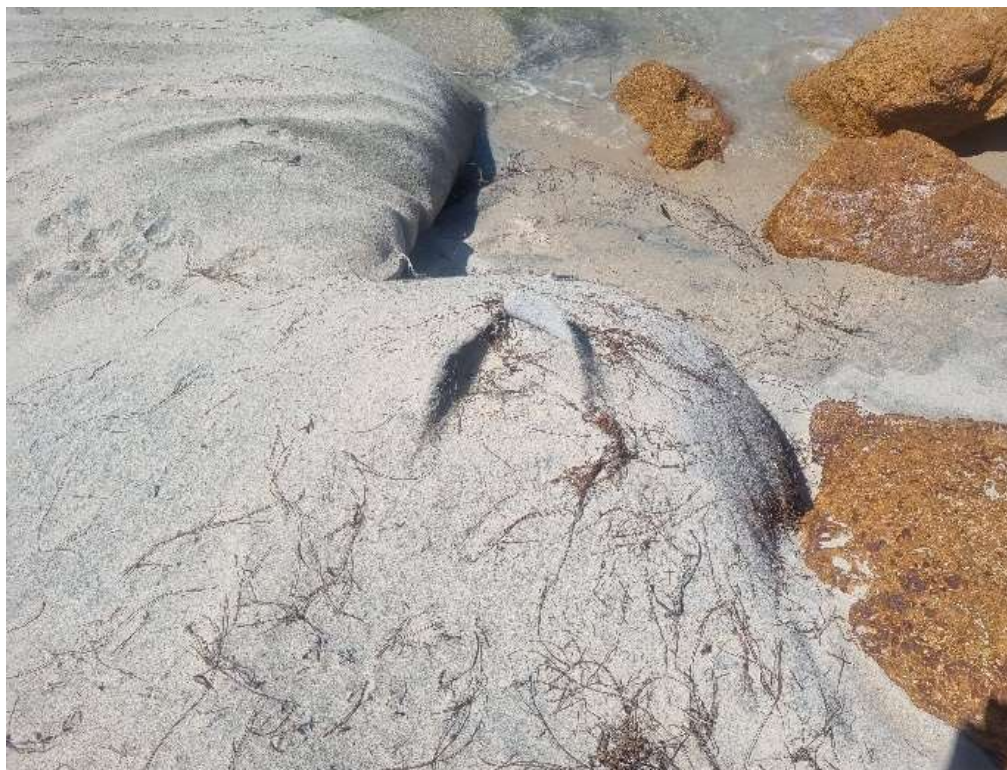
*Figure 11-21: Ripped hole within GSC at Groyne 10 taken during site visit 27 November 2024.*

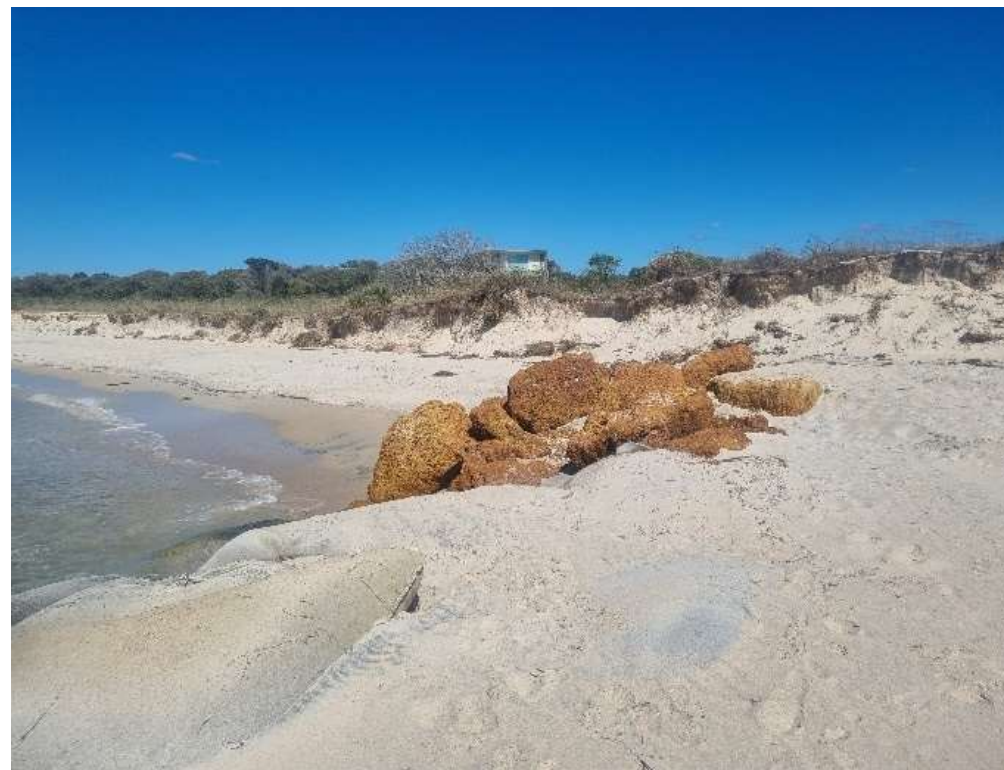
*Figure 11-22: Informal groyne extension with laterite armouring at Groyne 10 (+1240m) taken during site visit 27 November 2024.*

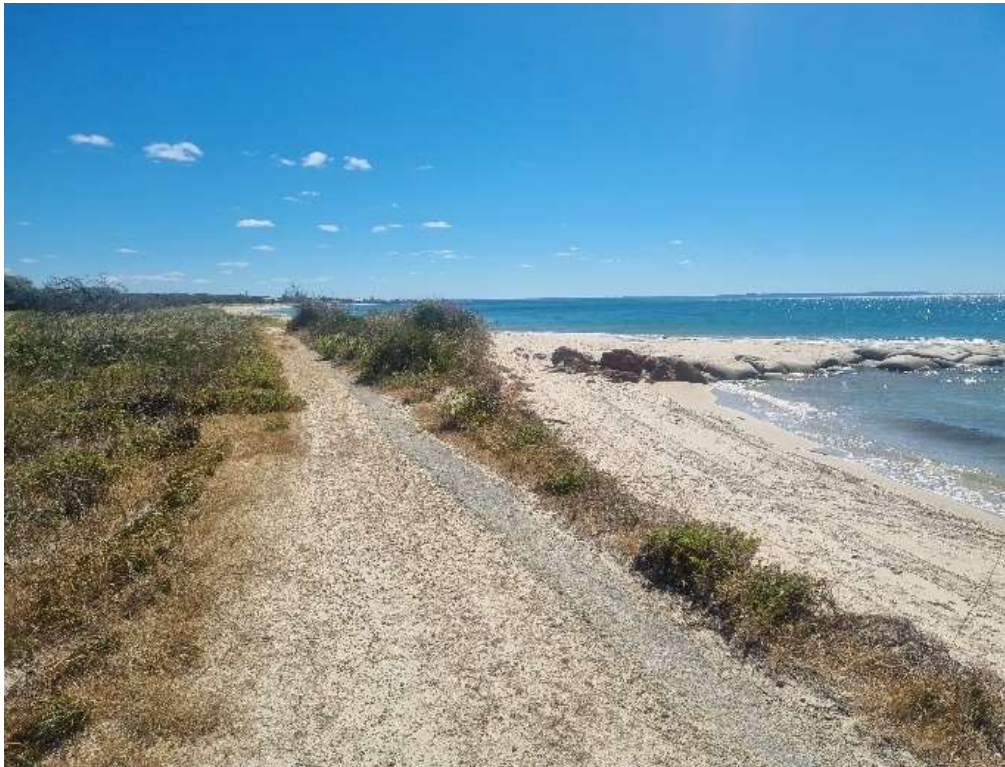
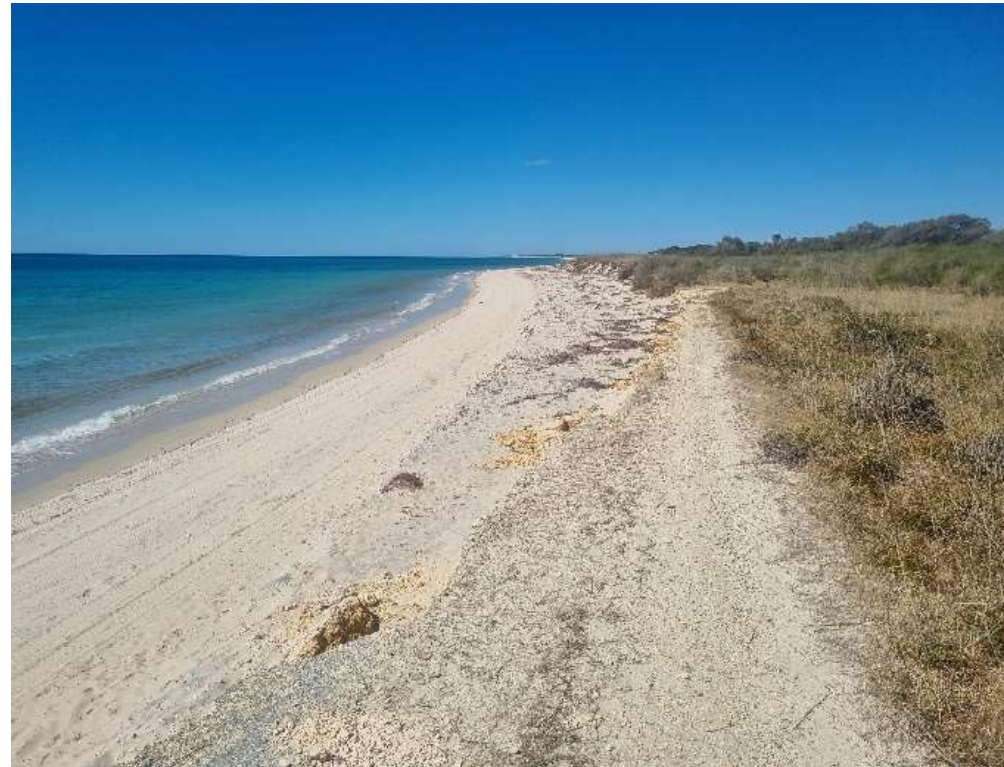
*Figure 11-23: Eroded access track immediately north of groyne 10 (+1260m) taken during site visit 27 November 2024.*

*Figure 11-24: Eroded access track immediately north of groyne 10 (+1260m) taken during site visit 27 November 2024.*

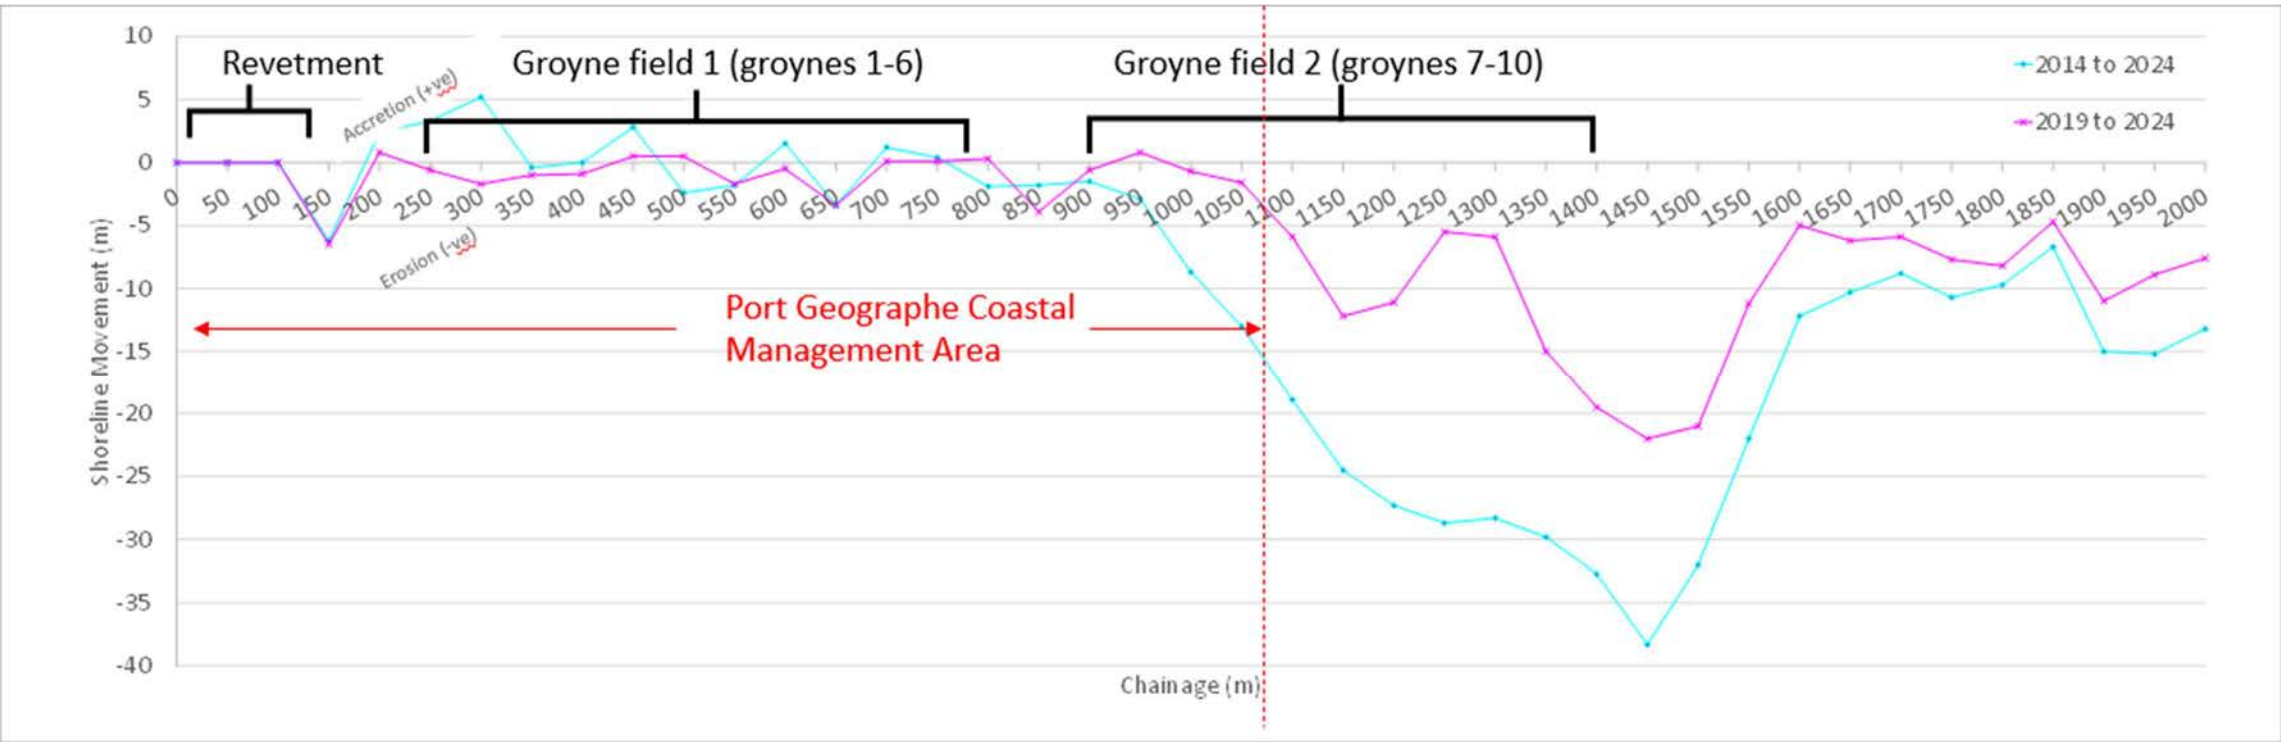
| ID | Category | Content |
|---|---|---|
| 8. | <b>Performance/ Effectiveness of coastal management measure/s</b> | <p><b>Eastern Port Geographe Coastal Management Unit (+0m to +1075m)</b></p> <p>Mid-term shoreline mapping indicates that this coastline has mostly remained stable with some minor erosion (up to one metre annually) noticeable at the last 50m of the NE extent of the management unit.</p> <p>Short-term shoreline mapping indicates stability along this stretch of coastline.</p> <p>Groyne one to six (rubble mound), are in poor to moderate condition, with minimal interlocking and exposed core in the first two groynes. Despite this, analysis of aerial imagery indicates that they are continuing to maintain their respective sand compartments and improving the natural sand buffer available along this stretch of coast.</p> <p><b>NE Wonnerup beach (+1075m to +2050m)</b></p> <p>Mid-term shoreline mapping indicates increasing erosion until the most severe section at chainage +1450m, where erosion has averaged up to four metres annually. NE of this location the erosion trend reduces to one to two metres annually up until the end of the hotspot (+2050m).</p> <p>Short term shoreline mapping indicates a similar erosion trend, up to four metres per year at the most severe chainage +1450m.</p> |

| ID | Category | Content |
|---|---|---|
| | | <p>There is noticeable slowing of erosion since construction of GSC groyne's 7-9, (+950 to +1100m).</p> <p>Analysis of bathymetric surveys undertaken by DoT between Summer 2009 and 2023 (refer Figure 11-30) confirms the erosion trend within the nearshore environment. Between 0.5-1.0m of seabed deepening is noticeable within 50-100m of the shoreline from chainage +1250 extending approximately 1.3km to the NE.</p> <p>All four GSC groynes appear to be relatively stable with no slumping present. However, those located within the sub-aerial beach appear vulnerable to damage, specifically from vehicle contact. Exposed bags have been damaged in these locations with some repair patches applied by CoB. Despite the damage to the onshore containers, as shown in vegetation line mapping, these containers are continuing to perform as required.</p> |

Figure 11-28: Results of Wonnerup shoreline mapping, showing short and mid-term changes, for chainage reference refer to Figure 11-27.

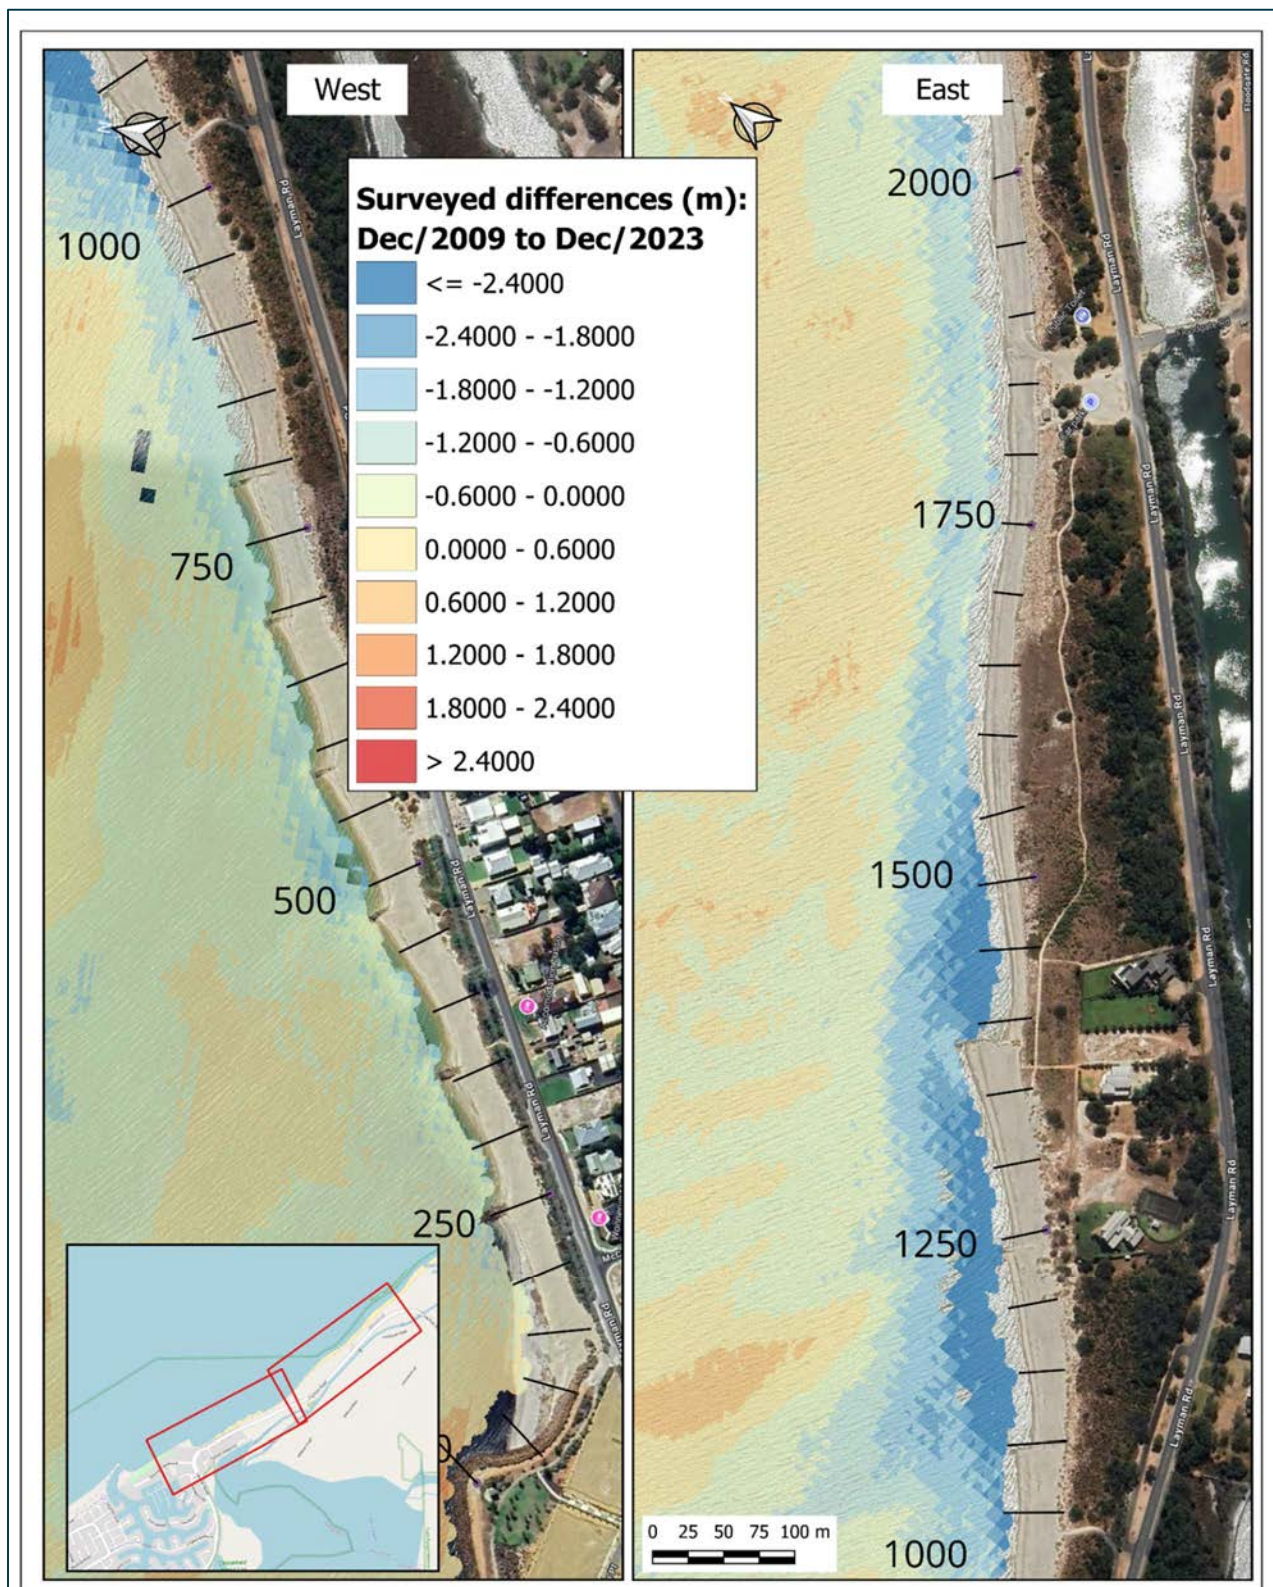
Figure 11-30: Wonnerup bathymetric survey- difference plot showing changes from December 2009 to December 2023.

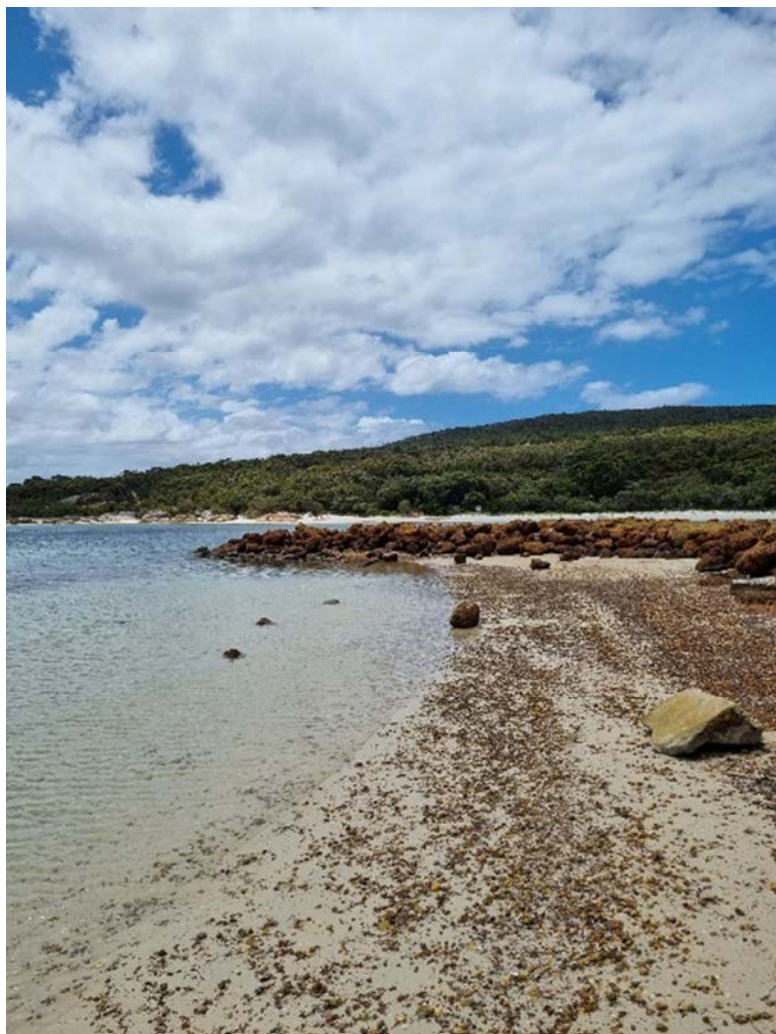
| ID | Category | Content |
|---|---|---|
| 8. | Performance / Effectiveness of coastal management measure/s | <p><b>Emu Harbour to end of northern training wall (+0m to +225m)</b></p> <p>At the northern groyne and along the training wall there are zones of isolated slope failure with core left exposed. Additionally, there are signs that overtopping has occurred behind the crest. This structure has been documented as being in poor to moderate condition previously by PRDW (2015) and Evocoast (2017). Additionally loose armour rock can be seen scattered along seabed adjacent to the training wall.</p> <p><b>Headland Beach (+225m to +475m)</b></p> <p>Analysis of satellite imagery shows the vegetation line in the lee of the artificial headland has shifted with the tombolo, 15m to the northeast in the short-term (5 years). Further analysis confirms this trend has been occurring since 2005. Additionally, the headland beach appears to have accreted up to 18m in the mid-term (up to 2m per year), with the most significant growth seen in the centre of the embayment.</p> <p>Small quarry run/core material was visible (refer Figure 12-9) extending landwards of the artificial headland during the site visit (5 December 2024). This material is likely a remnant from the initial construction of the rock headland structure (1995) previously buried by beach sand.</p> <p>During the site visit, the artificial headland appeared in good condition with neat defined slopes, good interlocking, and thorough protection of core material apparent.</p> <p>Coastal vegetation and tree roots east of the damaged revetment have been eroded with up to three metres of exposed slope and vertical scour apparent. There appears to be fencing restricting public access to pathways.</p> <p>The eastern end of the seawall (+475m) is severely damaged, with complete slope failure leaving fill material and geotextile material exposed.</p> <p><b>Rubble mound seawall (+475m to +950m)</b></p> <p>During the site visit, the seawall appeared in moderate condition, with some steeper sections observed with exterior armour scattered at the toe, indicating isolated slope collapse. Geotextile material is exposed along large sections of the seawall crest.</p> <p><b>Emu Point Beach (+950m to +2250m)</b></p> <p>Mid-term analysis indicates up to 18m of erosion (two metres per year) has been experienced along the eastern section of this beach. The most significant is located immediately adjacent to the end of the revetment (+950m). Accretion up to 19m (two metres per year) has been observed along a 600m section of beach near the Griffiths St access area.</p> |

*Figure 12-3: Northern groyne taken facing northeast during site visit 5 December 2024.*

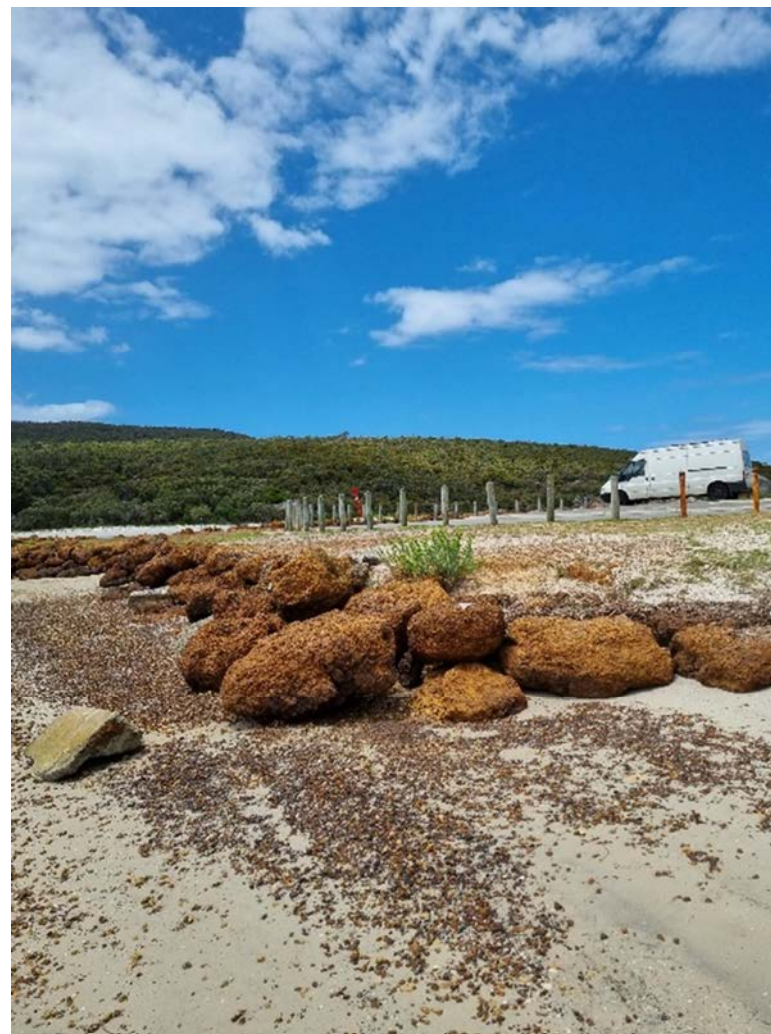
*Figure 12-4: Northern seawall end, taken facing east during site visit 5 December 2024*

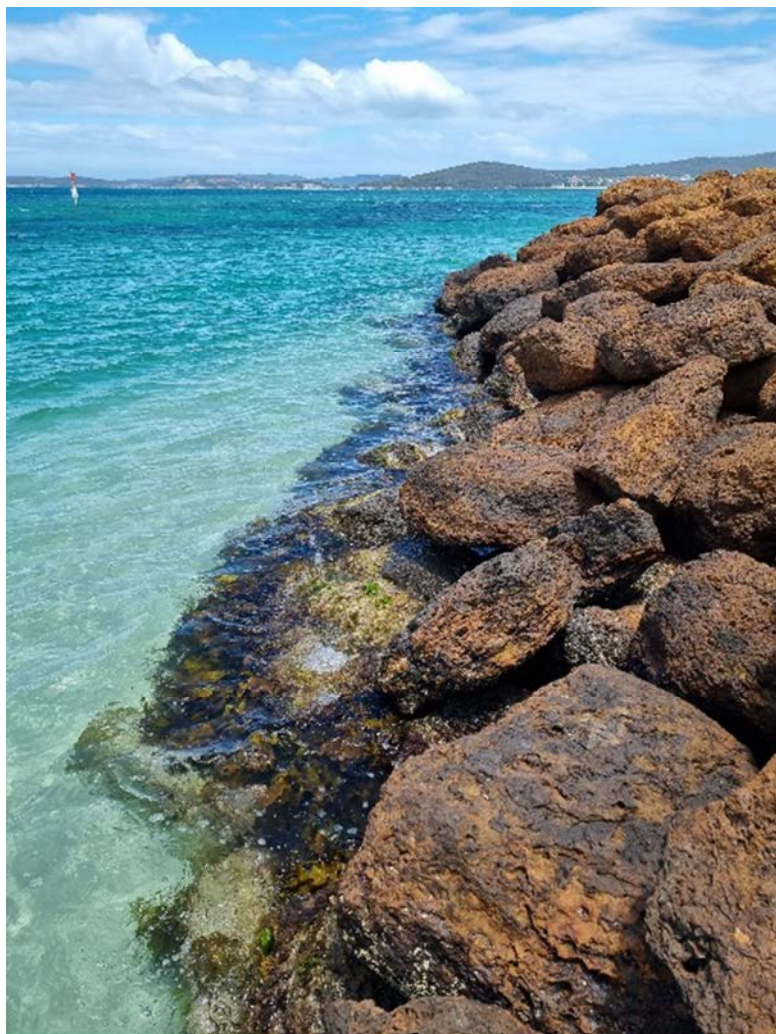
*Figure 12-7: Artificial headland, taken facing southwest during site visit 5 December 2024.*
