# WA Coastal Erosion Hotspots

## Review of Coastal Management History - 12 Sites

Document no. Rev 1: 311012-02081-CS-REP-001

12 June 2025

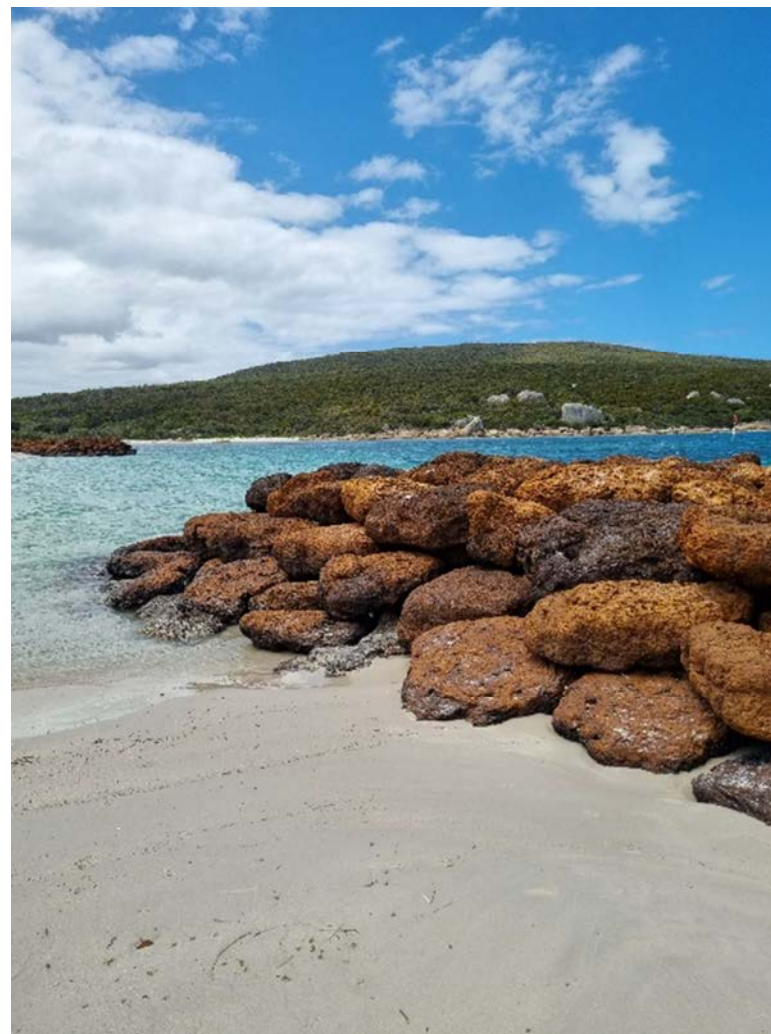
*Figure 12-8 : Artificial headland, taken facing east during site visit 5 December 2024.*

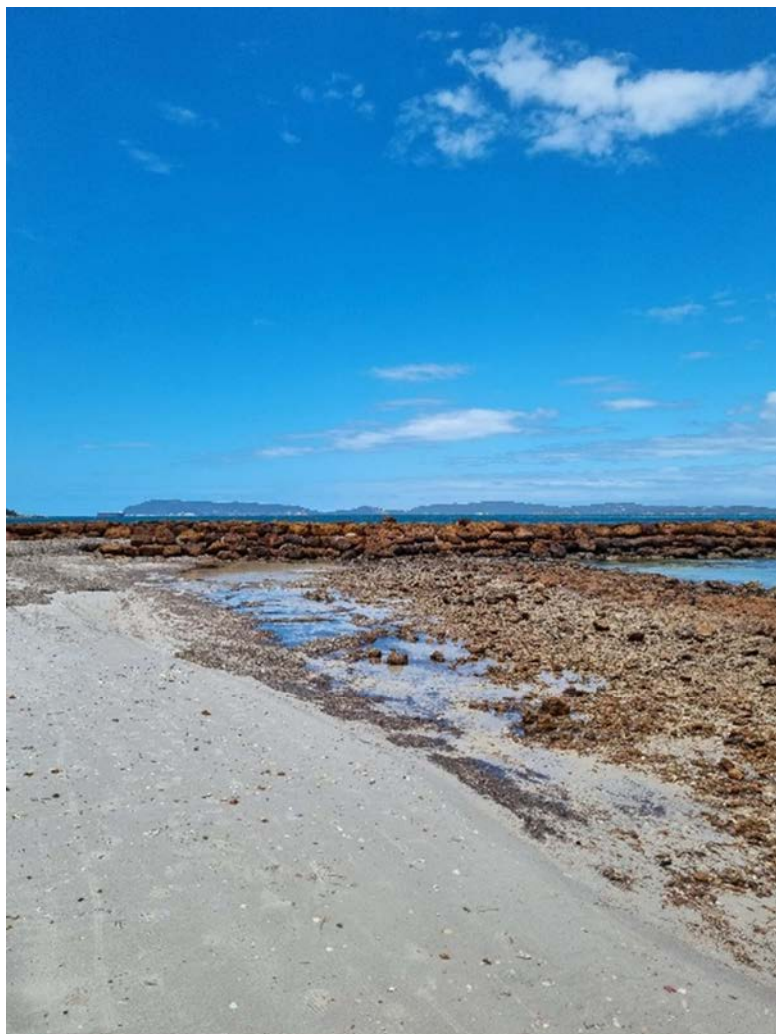
*Figure 12-9: Exposed rock along artificial headland tombolo, taken facing southeast during site visit 5 December 2024.*

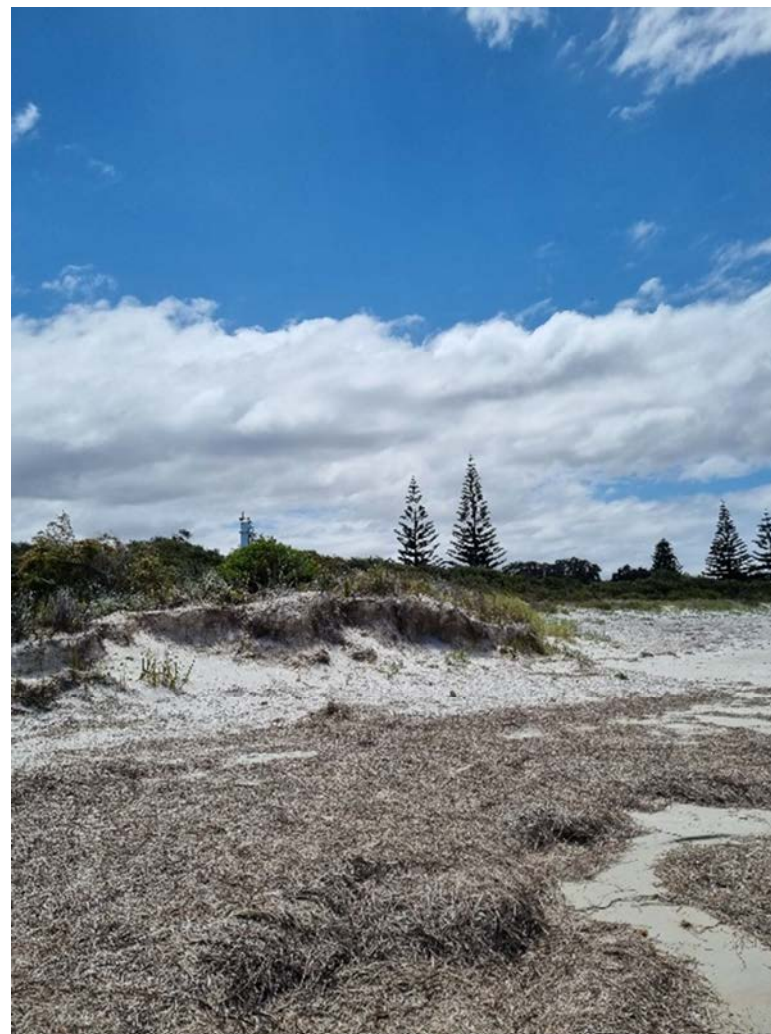
*Figure 12-10: Scour along headland beach taken facing east during site visit 5 December 2024.*

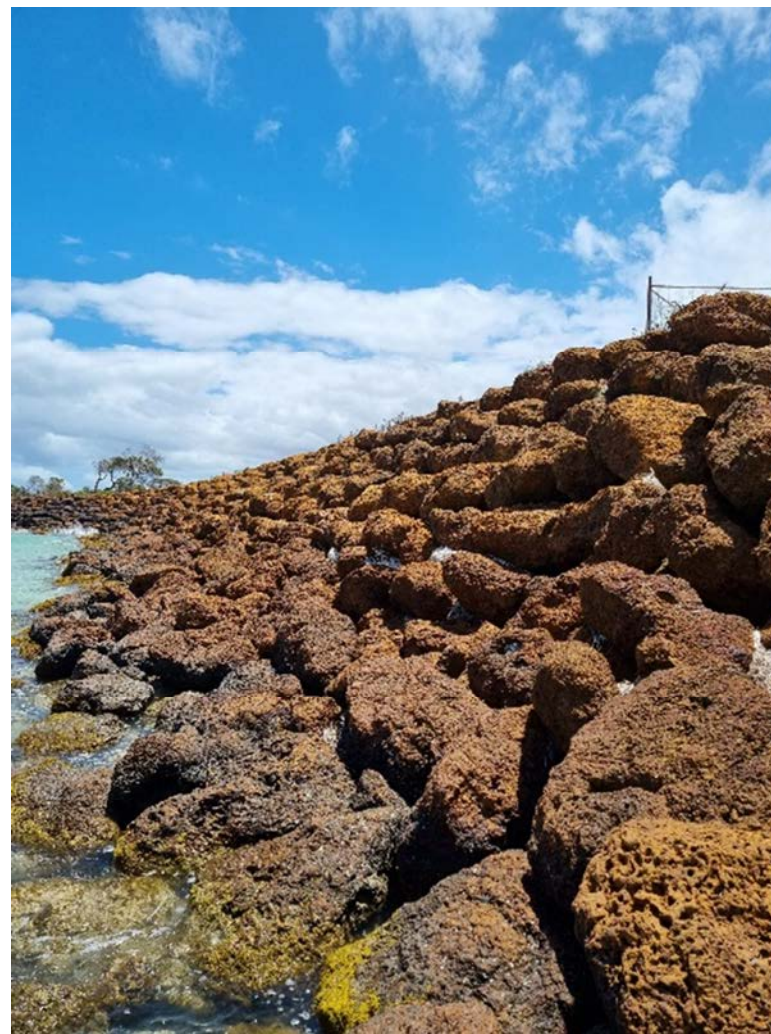
*Figure 12-14: Seawall extending south-west of damaged section, taken during site visit 5 December 2024.*

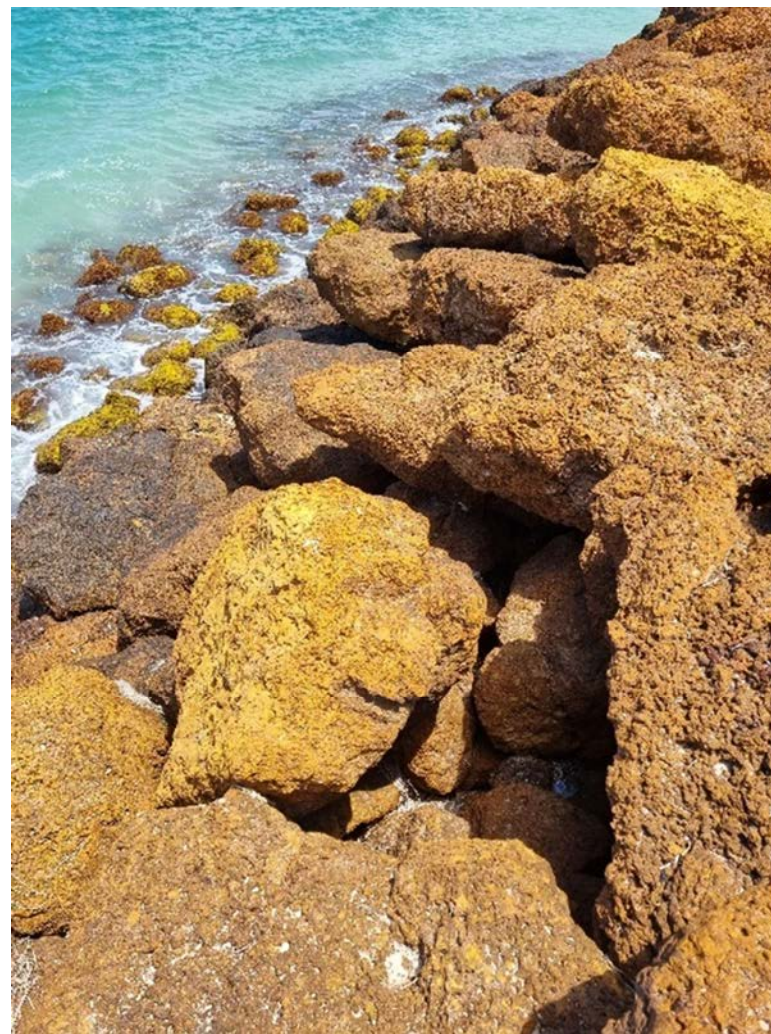
*Figure 12-16: Poor interlocking and scattered toe armour (+625m), taken during site visit 5 December 2024.*

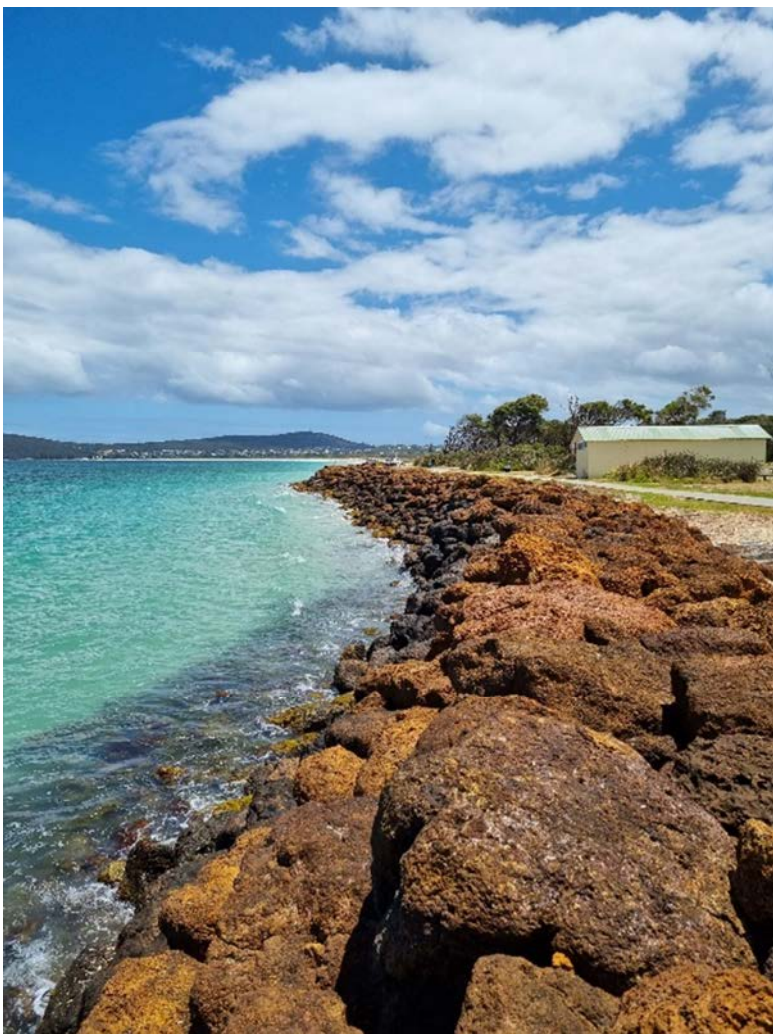
*Figure 12-17: Seawall extending west (+700m) taken during site visit 5 December 2024.*

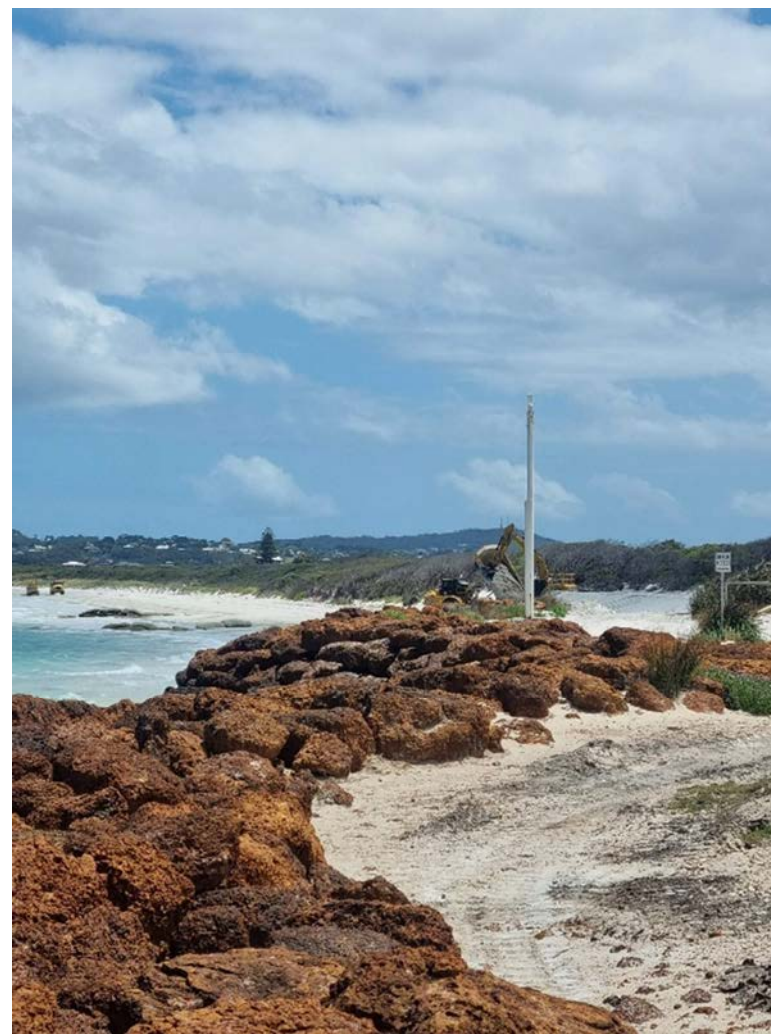
*Figure 12-18: Sand nourishment works at eastern end of Emu Beach (+1000m), taken during site visit 5 December 2024.*

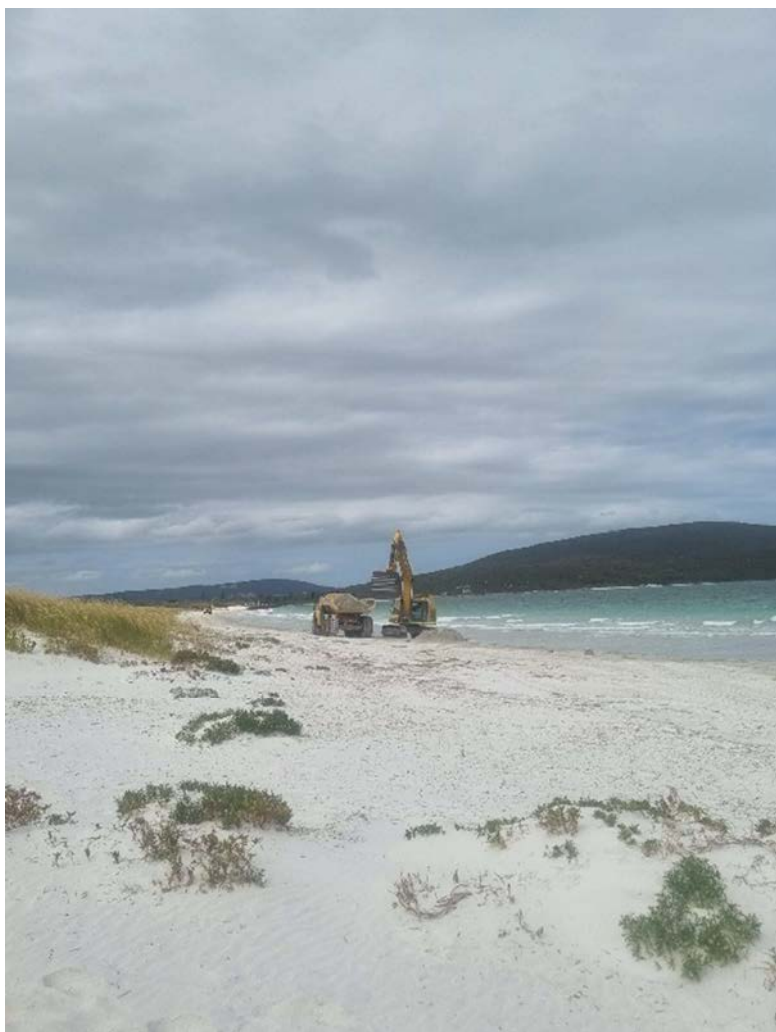
*Figure 12-19: Sand nourishment works (excavation) at Griffiths St beach access (+2000m), taken during site visit 5 December 2024.*

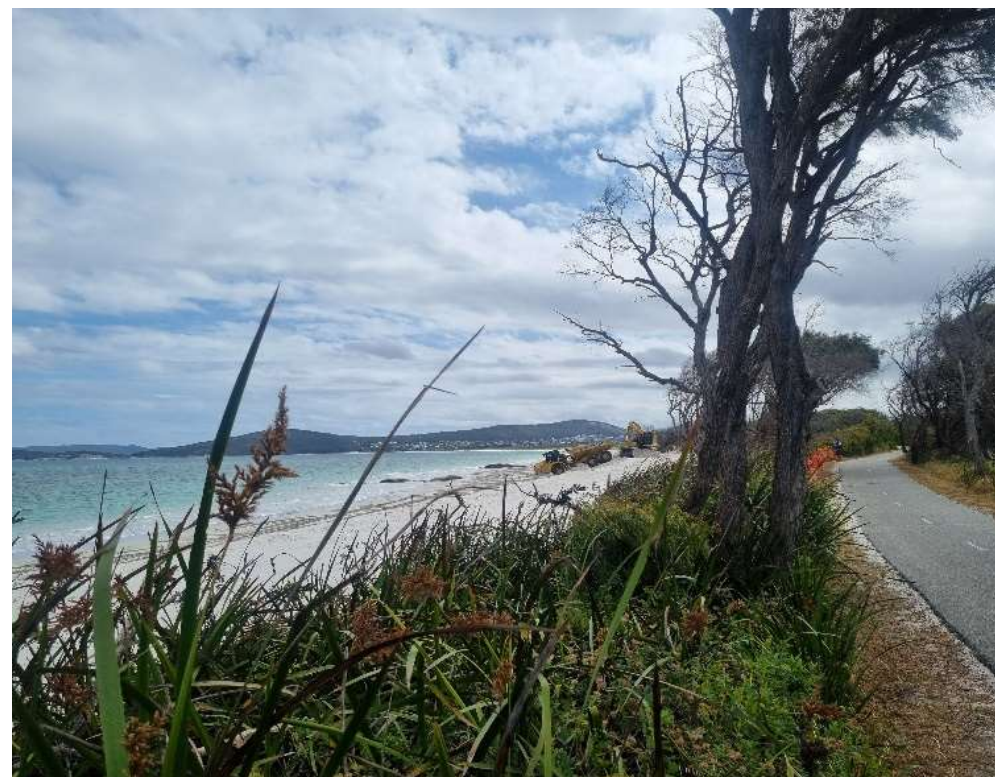
*Figure 12-20: Sand nourishment works at eastern end of Emu Beach (+1000m) with relocated dual access pathway shown on the right. Taken during site visit 5 December 2024.*
