Appendix D.18. Grace Darling Park, Lancelin

Figure D-18: Grace Darling Park, Lancelin schematic

Table D-18: Grace Darling Park, Lancelin summary information

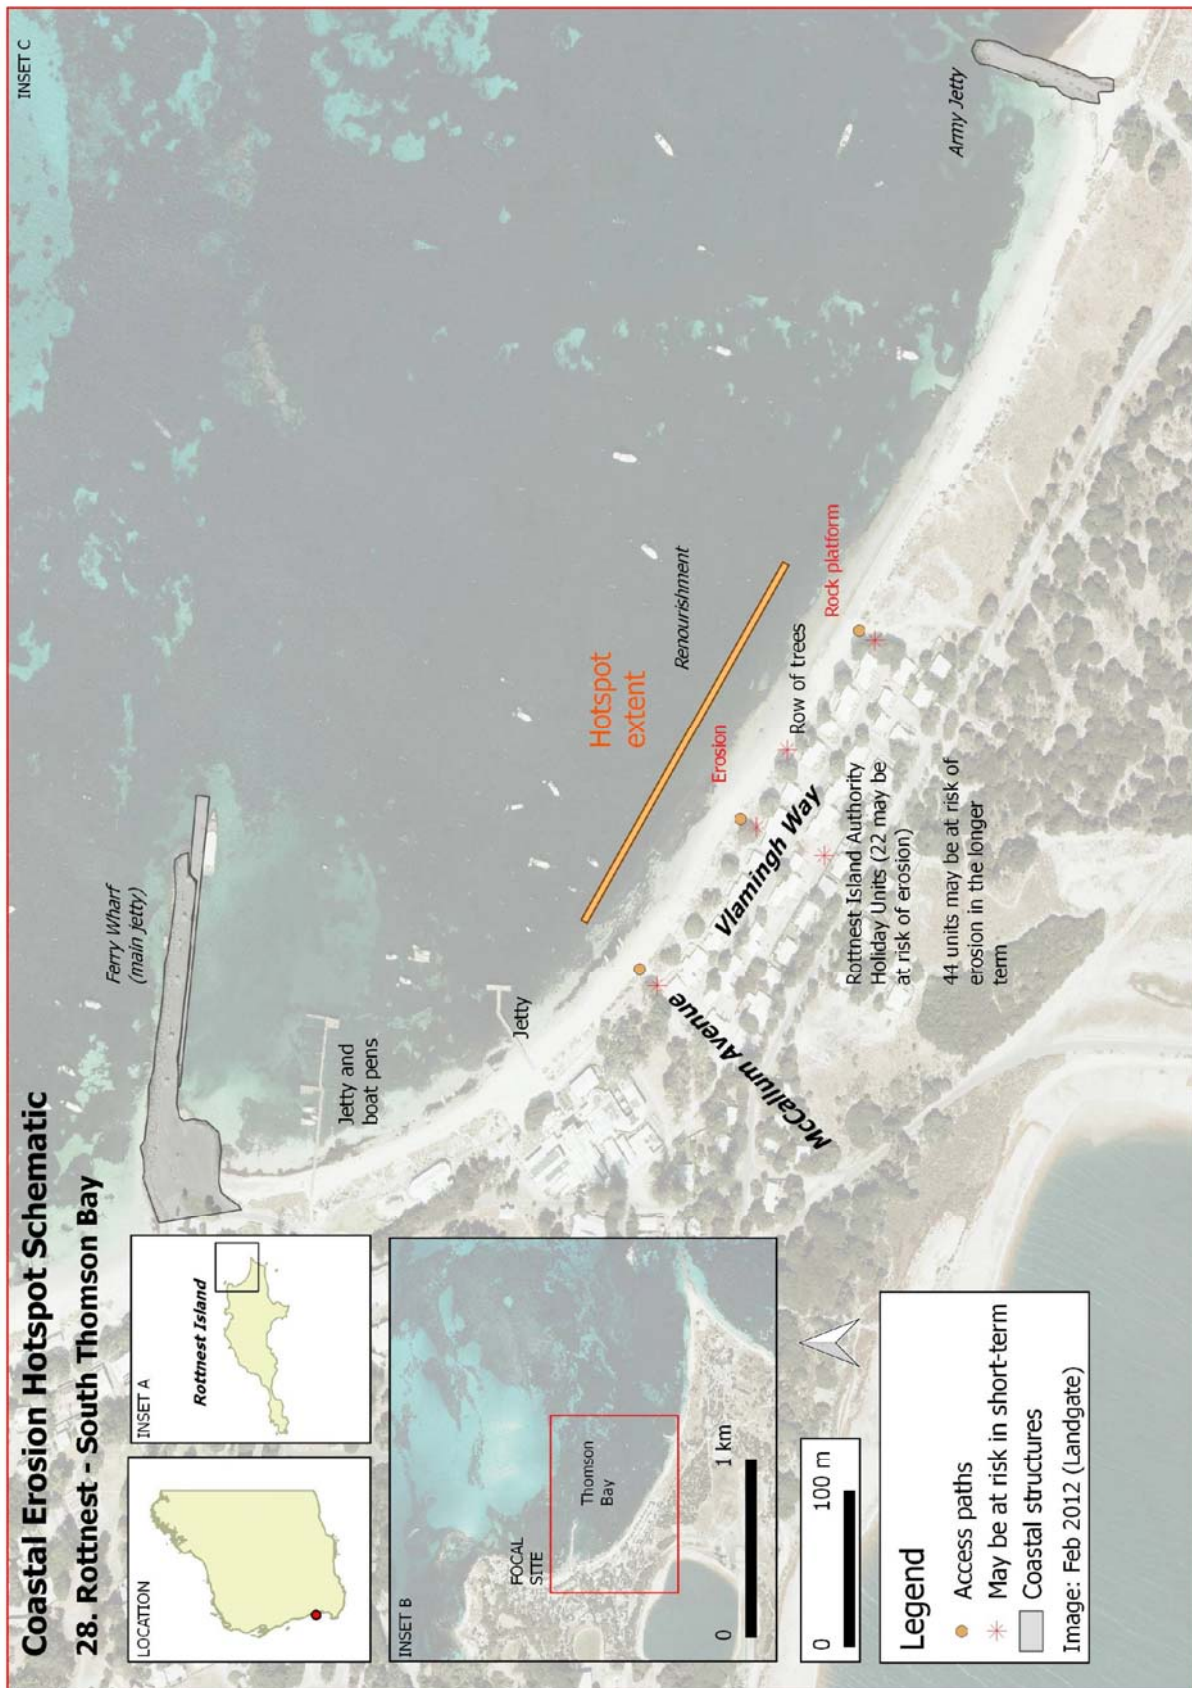
Figure D-28: Rottnest – South Thomson Bay schematic

Extent of erosion problem and hotspot characteristics	<p>South Thomson Bay where holiday units are located along Vlamingh Way.</p> <p>Hotspot characteristics:</p> <ul style="list-style-type: none"> • Infrastructure close to the existing shore, or landward of progressively and rapidly eroding coast (proximity). • Typically subject to progressive or episodic erosion (instability). • Very highly valued by the community, as nominated by local government (community).
CHRMAP status and findings	<p>CHRMAP Status: Not Scheduled</p> <p>Hazard Assessment: Nil</p> <p>Management & Adaptation Options: Nil</p> <p>Additional Comments: Nil</p> <p>Reports:</p> <p>Nil</p>
Coastal dynamics studies for a level 3 assessment. Further detail in Table 4-2.	Renourishment source, possibly geotechnical and ongoing coastal movement data collection
Assets susceptible to erosion hazard in Imminent timeframe (0–5 years)	25 public assets susceptible to erosion hazard. 2 sandy pedestrian access, 1 fenced pedestrian access, single line of trees, Rottnest Island Authority Holiday Units (22 units).
