Esperance Cleanup Recovery Project, Sentinel Monitoring Program Addendum to Esperance Town Site Compliance and Performance Report

1 Introduction

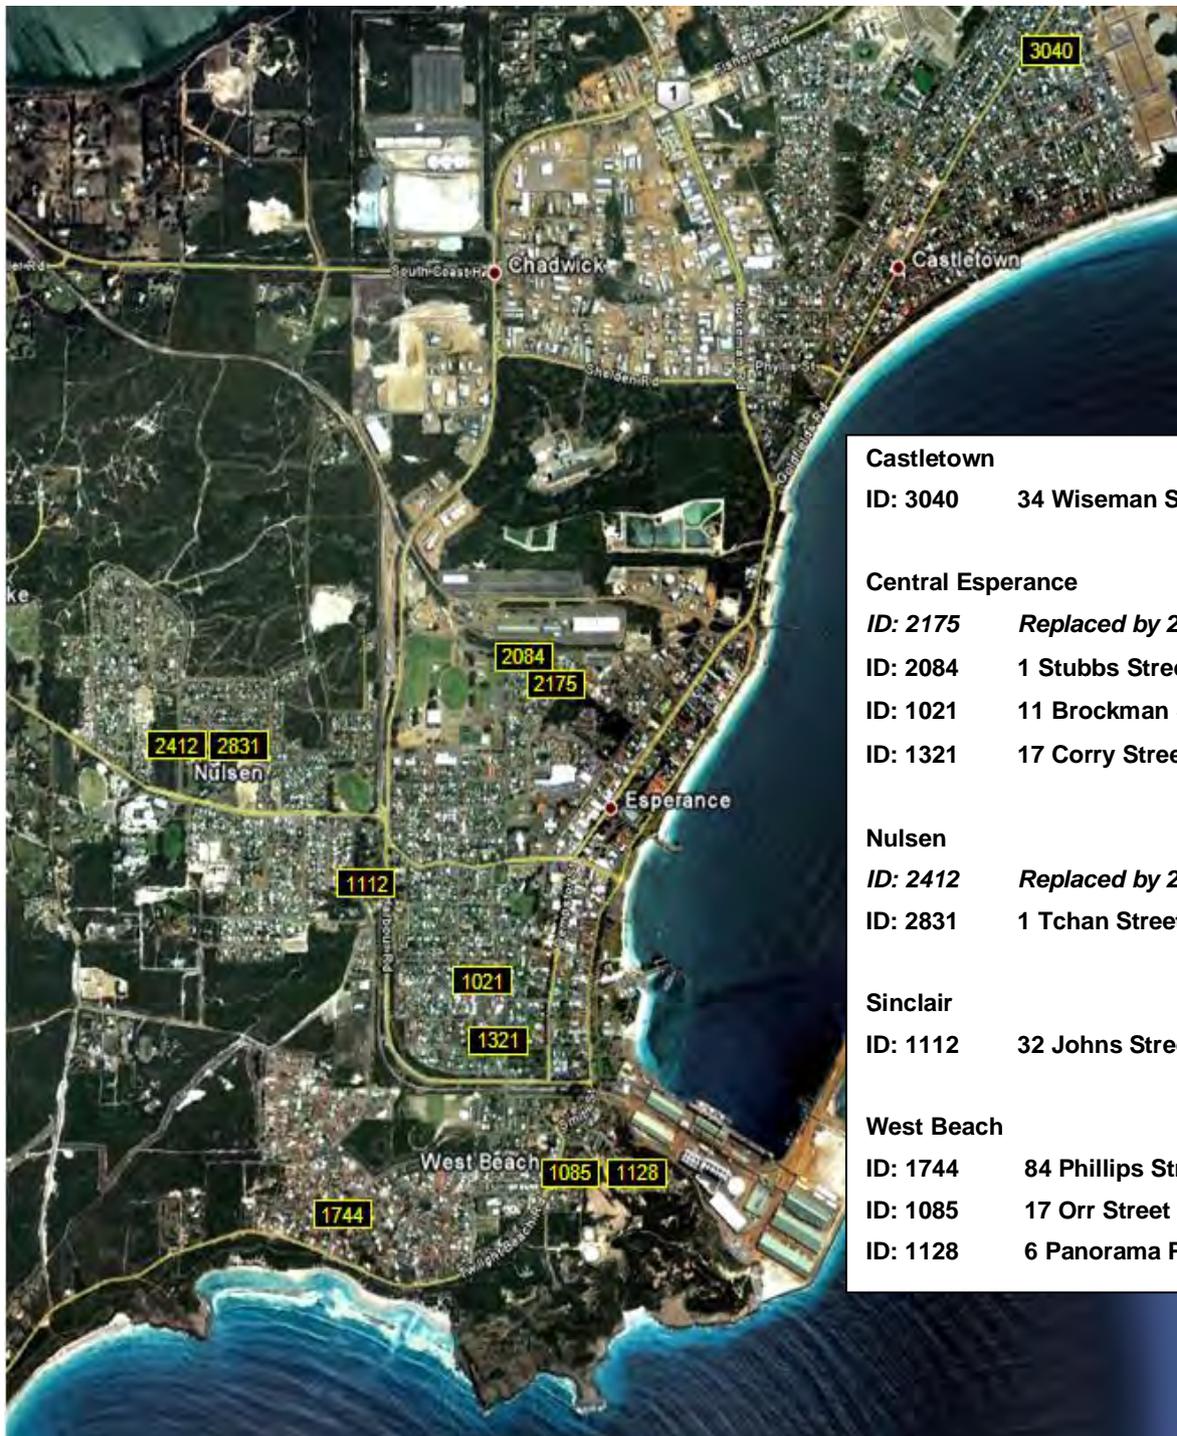
Attachment B: Sentinel Monitoring Locations

Castletown	
ID: 3040	34 Wiseman Street
Central Esperance	
ID: 2175	<i>Replaced by 2084</i>
ID: 2084	1 Stubbs Street
ID: 1021	11 Brockman Street
ID: 1321	17 Corry Street
Nulsen	
ID: 2412	<i>Replaced by 2831</i>
ID: 2831	1 Tchan Street
Sinclair	
ID: 1112	32 Johns Street
West Beach	
ID: 1744	84 Phillips Street
ID: 1085	17 Orr Street
ID: 1128	6 Panorama Place
