## **Department of Transport**

Report for Esperance Clean up  
and Recovery Project

Esperance Port - Compliance  
and Performance Audit Report

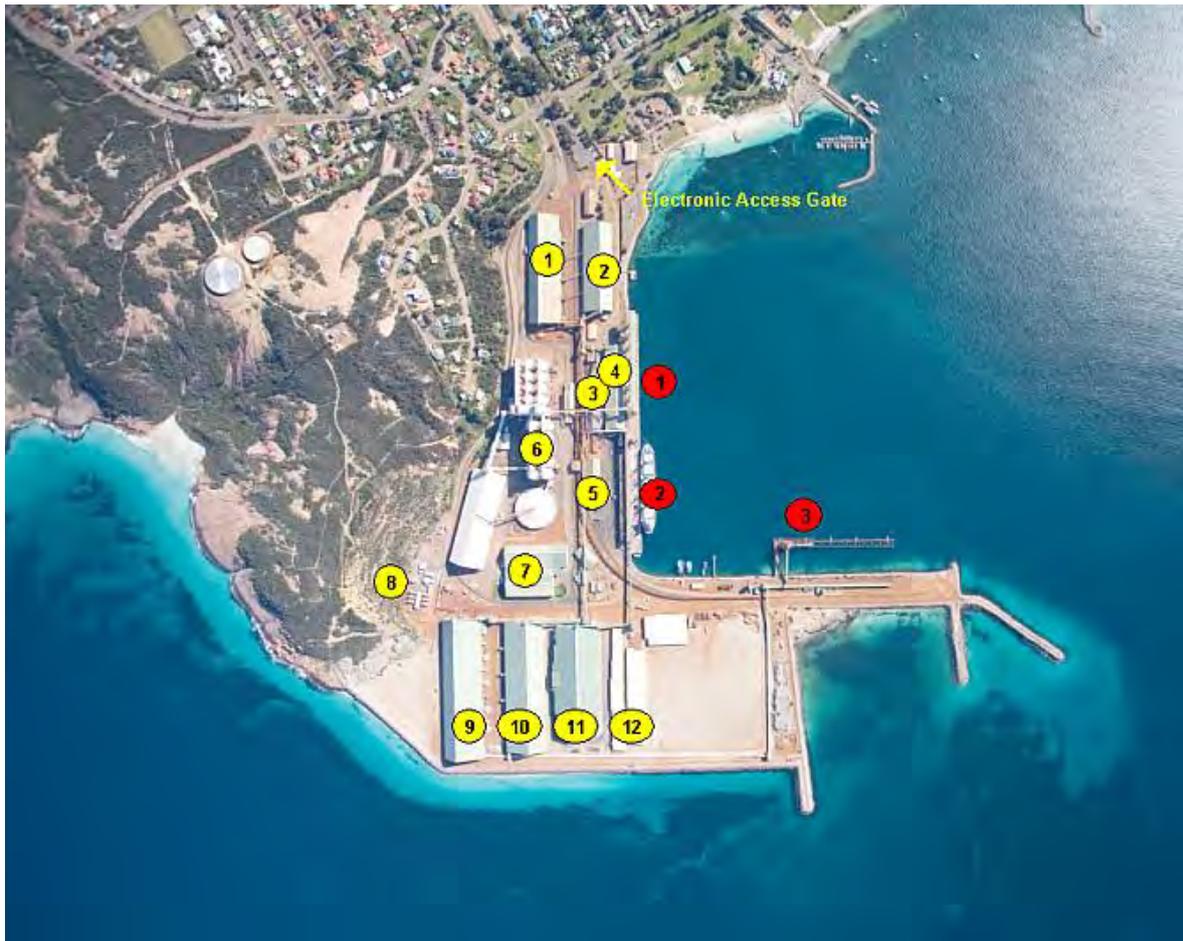
**ESPERANCE PORT**

**Berths (red numbers)**

- 1. Berth No. 1 – Grains
- 2. Berth No. 2 – Mineral Concentrate, Fertiliser, Fuel
- 3. Berth No. 3 – Iron Ore

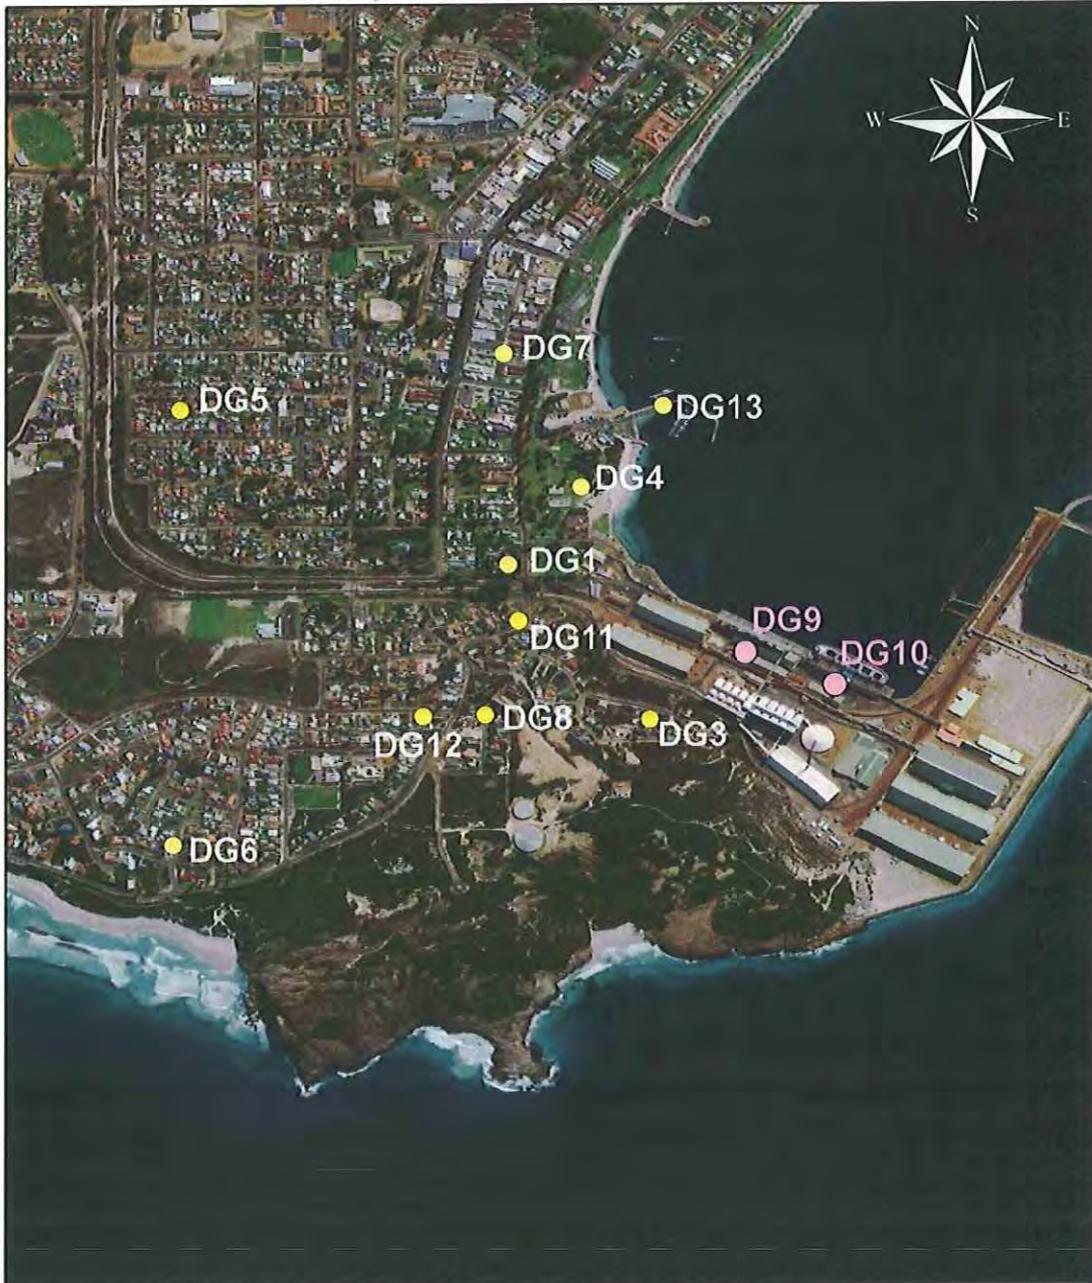
AIR QUALITY MONITORING SITES: Locations of Dust Gauges

**Title: Location of dust deposition gauges required by operating licence of Esperance Port Sea and Land**

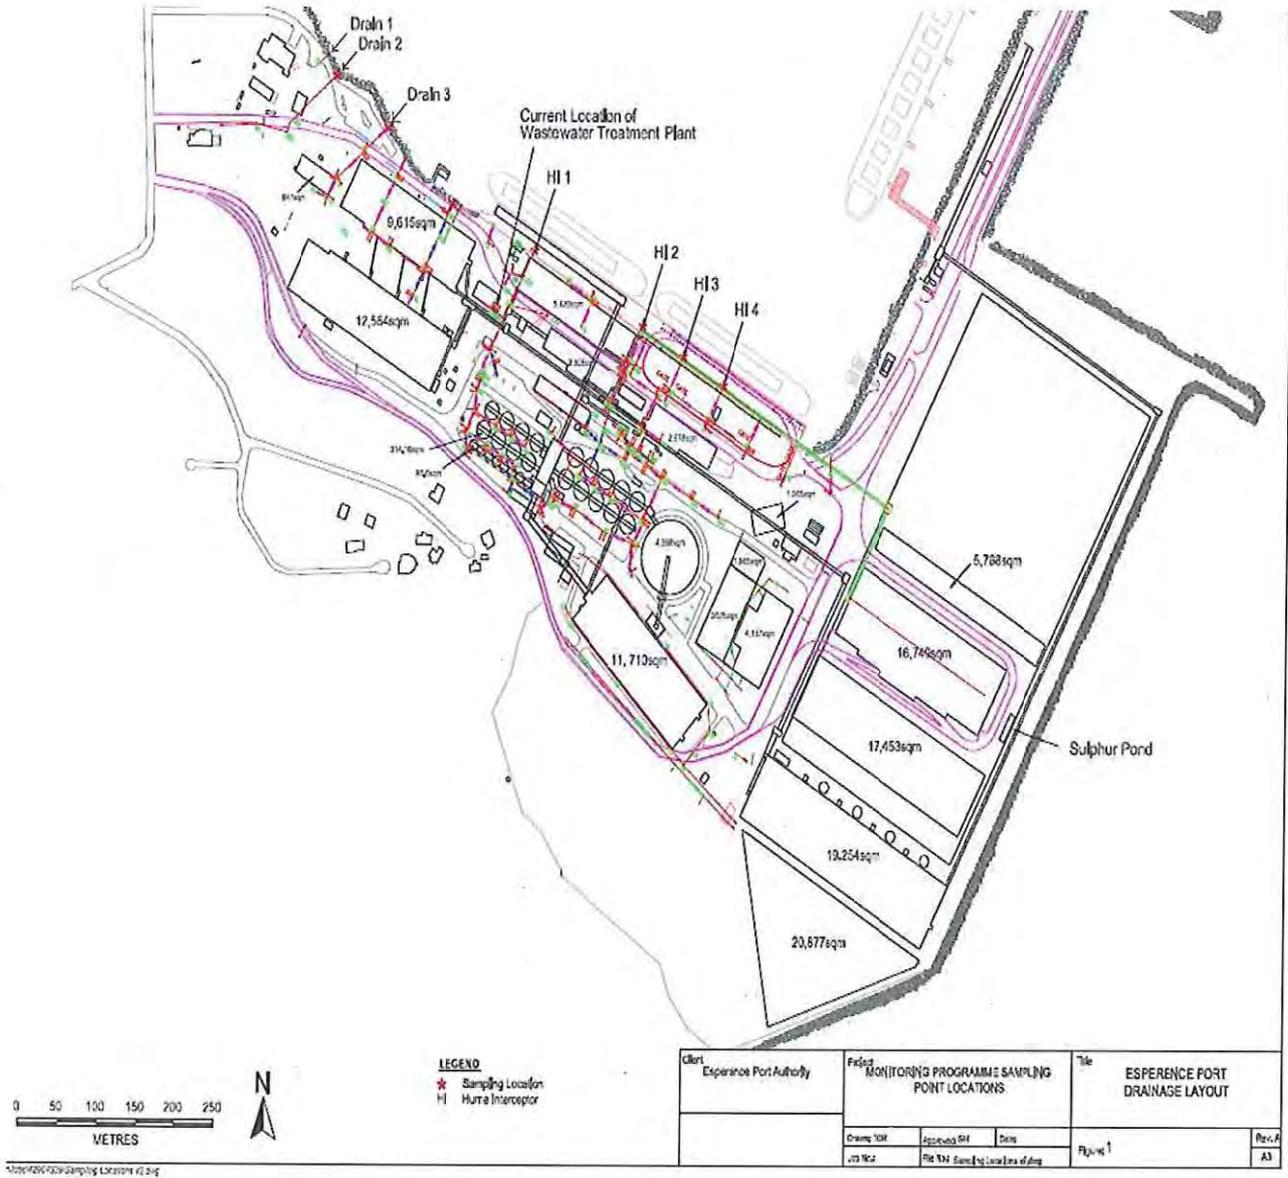
## STORMWATER MONITORING SITES

Client Esperance Port Authority	Project MONITORING PROGRAMME SAMPLING POINT LOCATIONS	Title ESPERANCE PORT DRAINAGE LAYOUT
Drawn By JTB	Approved By RFB	Date 11/03/11
File No 2010-007474	File No 2010-007474	Page No 1
		Rev A3

- ▶ Given the persistent detections of nickel concentrations in stormwater which exceed marine quality guidelines, it is recommended that the source of the nickel is investigated and remediated or appropriately managed. It is understood that at the time of this audit report EPSL had implemented or plans to implement remedial measures such as reduction of bulk nickel export, cleaning and surveying of stormwater infrastructure and land topography
